**REPORT
TO
CLARENCE VALLEY COUNCIL**

**TECHNICAL REPORT 3
RISK ASSESSMENT AND STABILISATION**

**FOR
PILOT HILL YAMBA, NSW**

**30 August 2017
Ref: 19314L3rpt – Technical Report 3 Final**

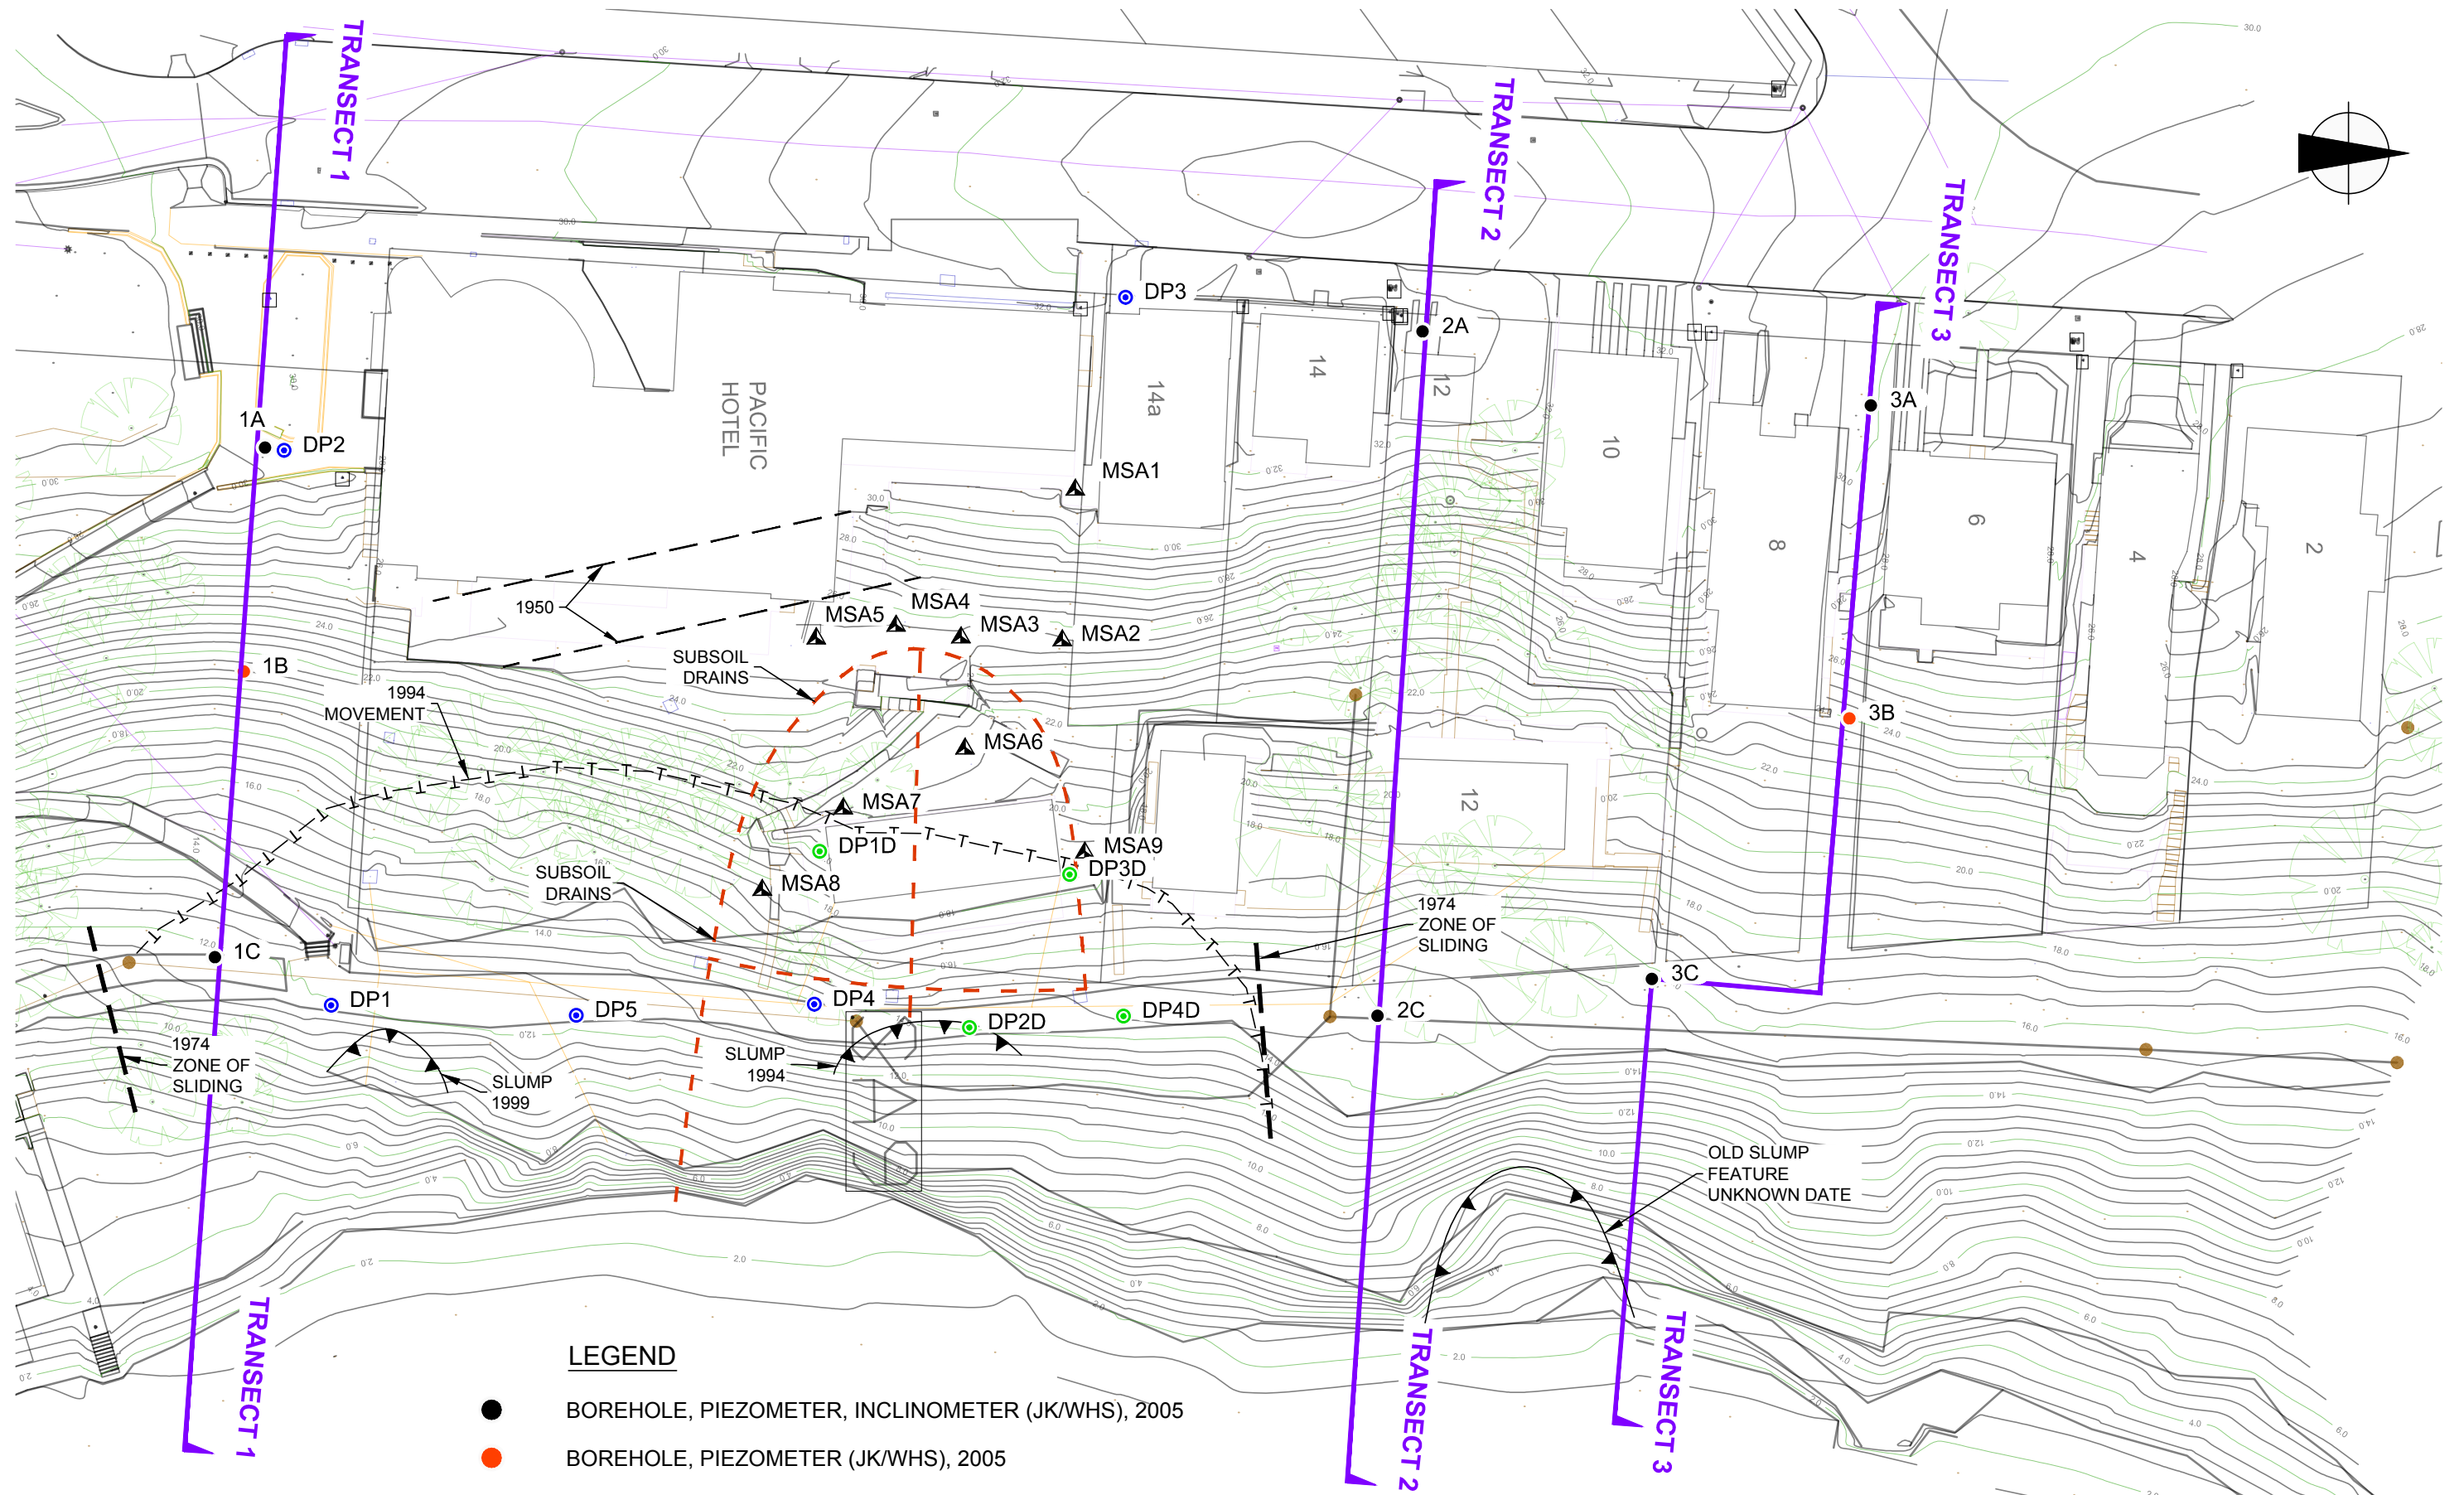
Title: PLAN SHOWING PREVIOUS SLIPS & SUBSOIL DRAINS	
Location: PILOT HILL YAMBA, NSW	
Report No: 19314L3	Figure No: 3
JK Geotechnics

Date	Origin/Source	Location & Comment
1994	Publican, PH	Landslide in front of managers residence due to stormwater drainage pipes problem.
Easter 1994	DP(1994) DE	Zone 2 and Zone 3 sliding on east slope of Pacific Hotel. (Note: Good Friday was on 1 April 1994) "Yamba was worst-hit town in the valley yesterday with 195mm of rain recorded in the 30 hours to 3pm. The deluge caused local flooding in many parts of the town." DE 1 April 1994.
About 7 April 1988	DE	Earthflow from Yamba Hill: "Residents in Calypso Caravan Park in Yamba had a narrow escape when a mudslide on Yamba Hill dumped tonnes of debris into the park. The debris spewed three metre deep across Harbour Street through the park fence and more than 30m into the park". DE 8 April 1988. "A mudslide at the Calypso Caravan Park is particularly dangerous because the bank is still slipping...". DE 11 April 1988.
1985	Public meeting	No details
