# WOODFORD DALE RIVERBANK EROSION MANAGEMENT PLAN

*Clarence Valley Council*

*December 2004*

Document Reference: J02-11/R51a

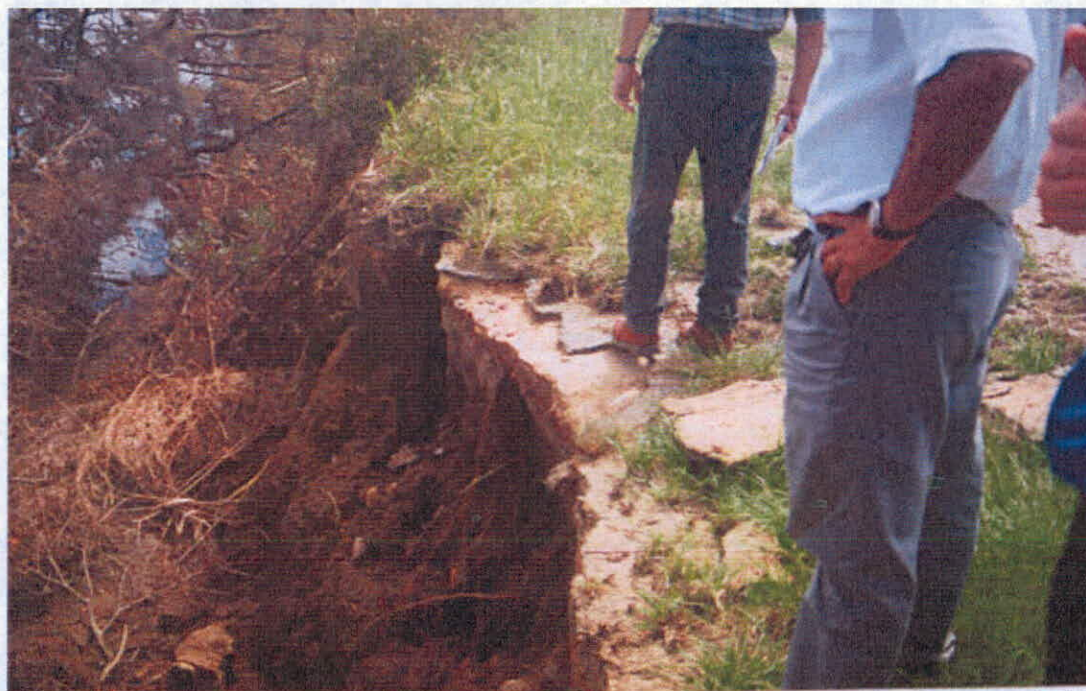
More recently, bank slips have occurred opposite and downstream of Munro Island, particularly following flooding in 2001 (**Photos 1 and 2**). Out of a concern that this activity may have placed the riverbank at further risk of failure, Clarence Valley Council (CVC) initiated a Riverbank Management Study in 2002, and the development of a Riverbank Management Plan.

**Photo 1** Slip at Houghs Lane opposite Munro Island, March 2001.  
Photo courtesy CVC.

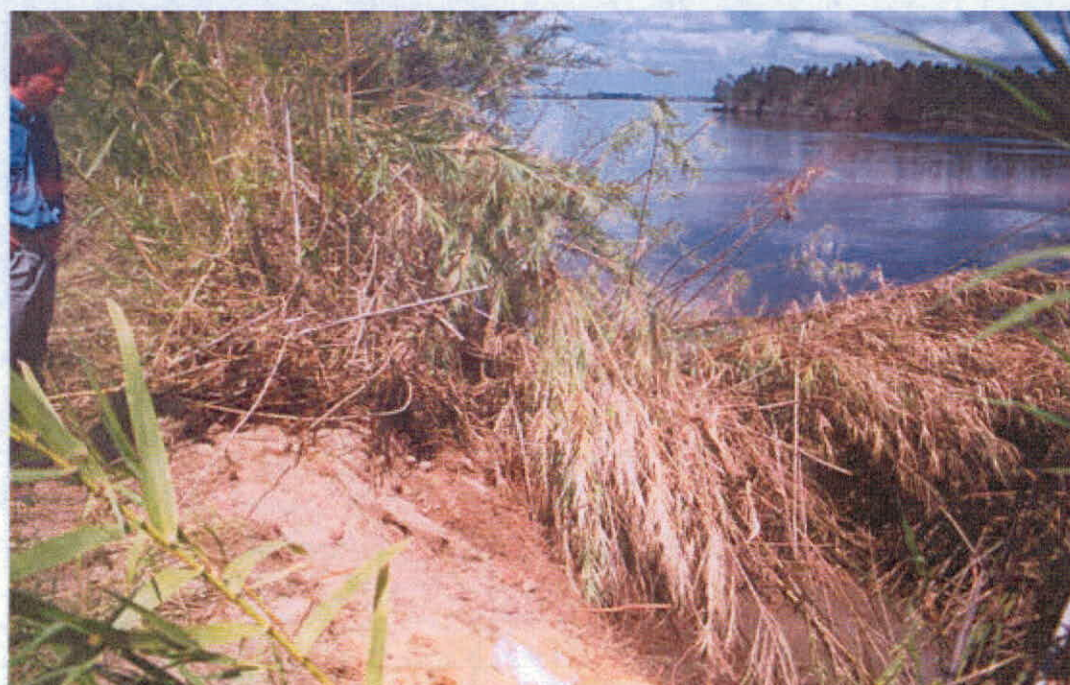
**Photo 2** Slip along Woodford Dale Road in vicinity of Munro Island, March 2001. Photo courtesy CVC.
