NORTHERN NSW COASTAL HAZARD ASSESSMENT

DESKTOP REVIEW

REPORT NO. 4063RMG02C
17 November 2023

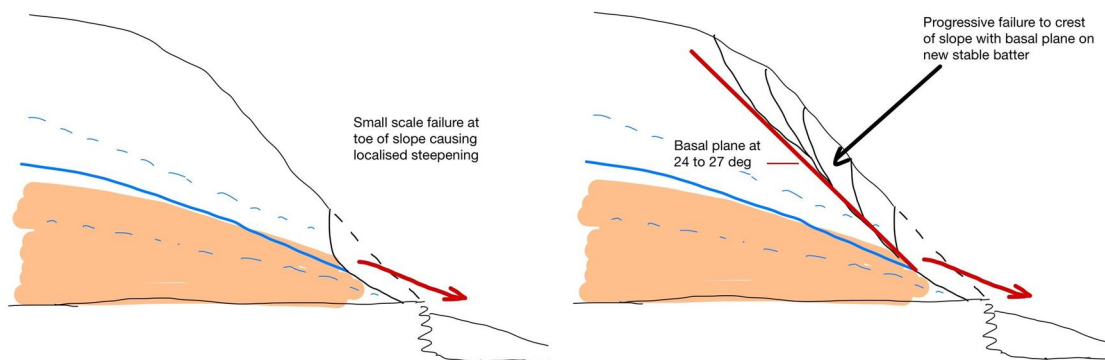
- Minor failure at the toe of the slope, this may be caused by one or more of: localised scour, a tree falling over or other loss of vegetation, elevated streaming groundwater, or retreat of the wave cut platform;
- Material above this minor slip will calve off in small sections in durations of hours to weeks, note that the failure may also spread laterally from the initiation point;
- The basal plane of failures will comprise the angle of repose for the sand material and is expected to be between 24° and 27°, the failed slope will settle with a batter within this range.

Figure 2-2 Schematic expected slope failure for beach facing dune slopes

Both sites are subject to ongoing geological processes and in the long term it is expected that the slope would continue to regress. Any rise in sea level is likely to accelerate this regression, particularly if waves are able to break directly onto the toe of the dune sand slope.

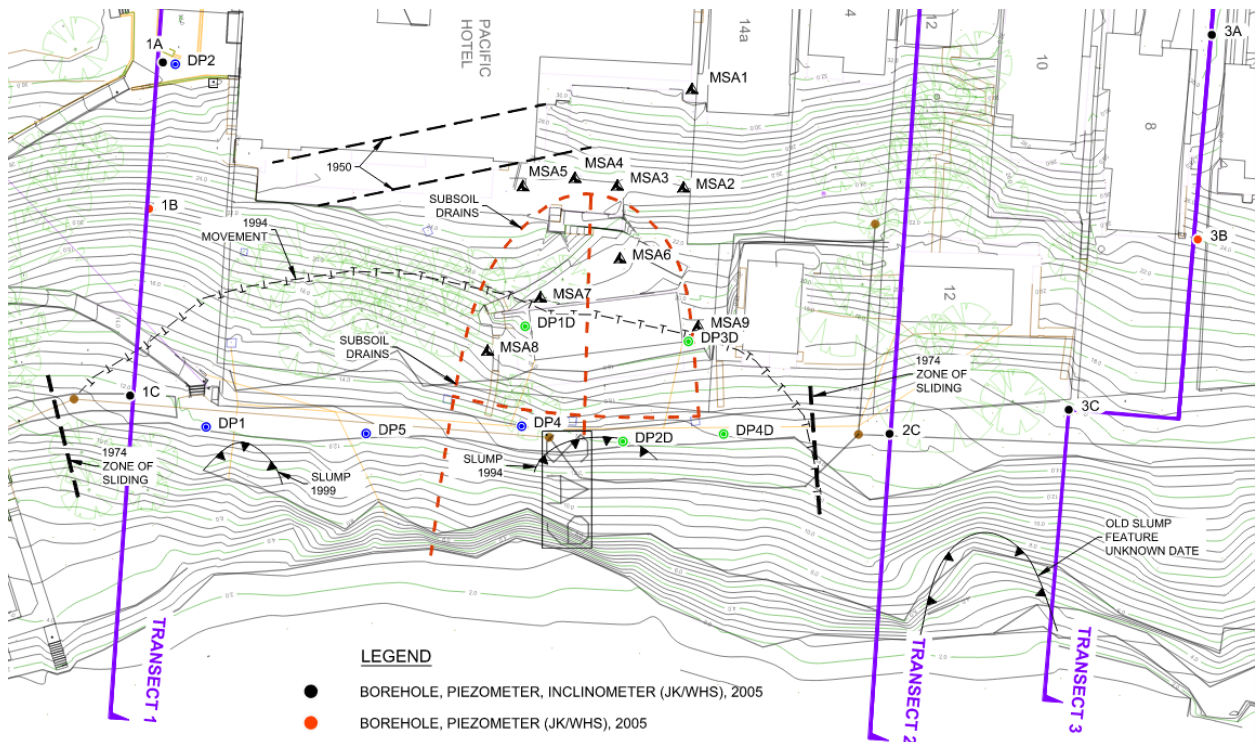
The JK Geotechnics report (2017) indicates that historical landslide events have been recorded around the Pacific Hotel since May 1921. The report does not postulate if instability may have been present at the site prior to this date. Figure 2-1 shows the location of some of these previous landslips. These historical landslips at the Pacific Hotel site appear to be reactivations of the same landslide during peak weather events.

Figure 3-1 Exert from “Plan showing previous slips and subsoil drains” from 2017 JK Geotechnics report, shows several landslide features that have developed around the Pacific Hotel since construction as well as site investigation and monitoring points

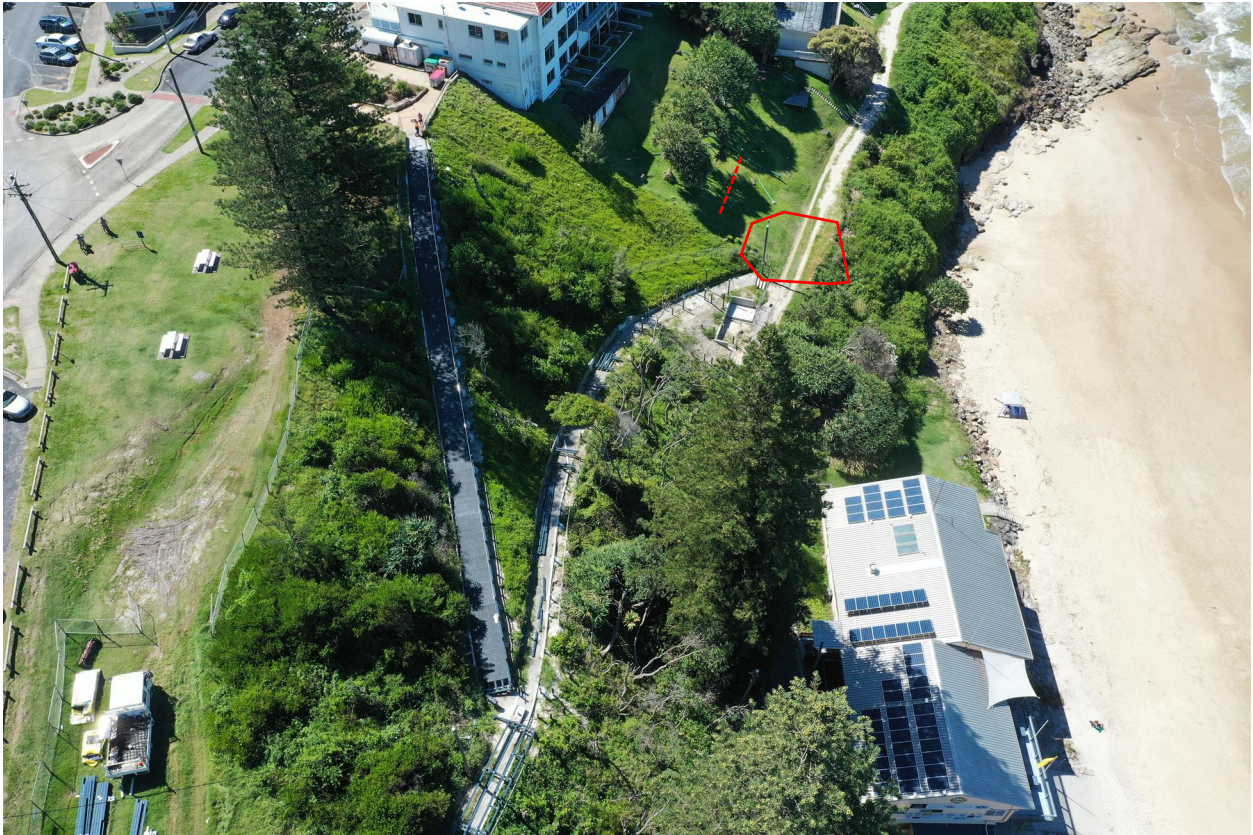
Figure 3-2 Drone imagery of Zig Zag path (taken 10 Feb 2022), an area of land sliding occurred in about the area of red polygon, with tension cracks below the Pacific Hotel shown by red dashed lines. Additional scour and tension cracks affected the road leading to the SLSC (below the photograph above)

In response to this event access to the SLSC and Marine Pde, the boardwalk construction and the walking path below the Pacific Hotel were closed for several weeks. Analysis of the rainfall data and groundwater levels by JK Geotechnics indicated that groundwater levels were at about peak historical levels when previous landslides had occurred. The closure was to reduce the risk to the public and allow time for the groundwater levels to dissipate. These small failures are indicative of the failure modes described in Figure 2-2.

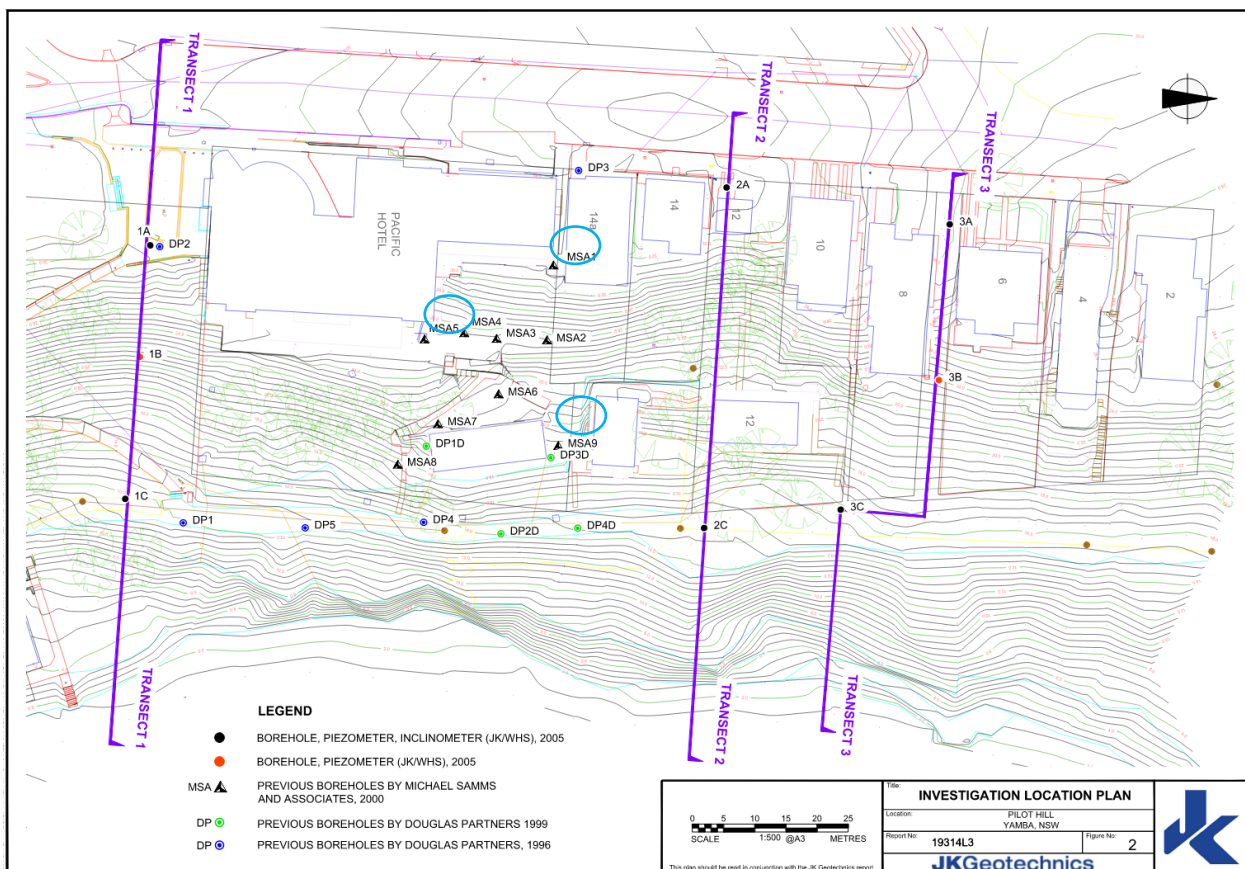
Instrument monitoring has been installed around the Pacific Hotel site and recent historical landslips along three transects as shown in Figure 2-3, below. In total the instrumental monitoring comprises 11 piezometers and 6 inclinometers.

Figure 3-3 Plan from 2017 JK Geotechnics report showing the location of monitoring points. The three Michael Sam and Associates (MSA) boreholes with piezometers installed are indicated by blue ellipses

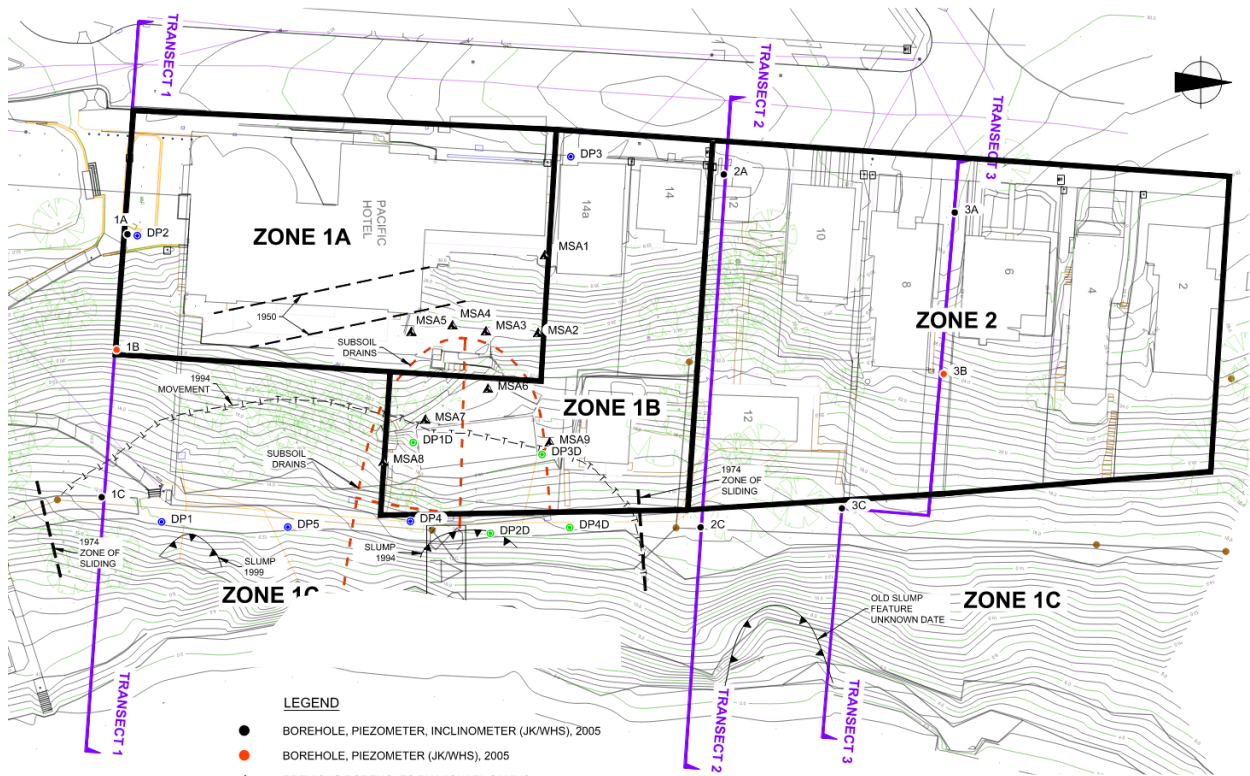
Figure 3-4 Landslide risk zones used for slope risk assessment by JK Geotechnics (2017)

This slope risk assessment is based on the assumption of global slope failure as shown in the slope stability analysis contained in the JK Geotechnics (2017 and 2021) report/s. These failure models are typically circular in nature and may not represent the geological and failure model shown in Figure 2-2. As the “rapid to very rapid movement” land slide speed governs the risk assessment, further investigation should be given to the failure geometries in these slopes stability models to assist in refining the Slope Risk Assessment. Consideration should also be given to better defining the failure geometry and potential variability in material strengths, which could further guide probabilistic slope stability analyses as inputs into the Risk Assessment.

Furthermore, it does not appear to account for the effect of subsoil drainage works, or remediation undertaken on the Pacific Hotel to underpin the foundations. Since the analysis only accounted for loss of life it has been skewed by the higher population density contained in the Pacific Hotel (Zone 1A). It would be expected that the results of the analysis would change if the risk to property was considered, if slope failure is based around the progressive slip mechanism contained in Figure 2-2, and if the effects of slope and foundation remediation were considered.

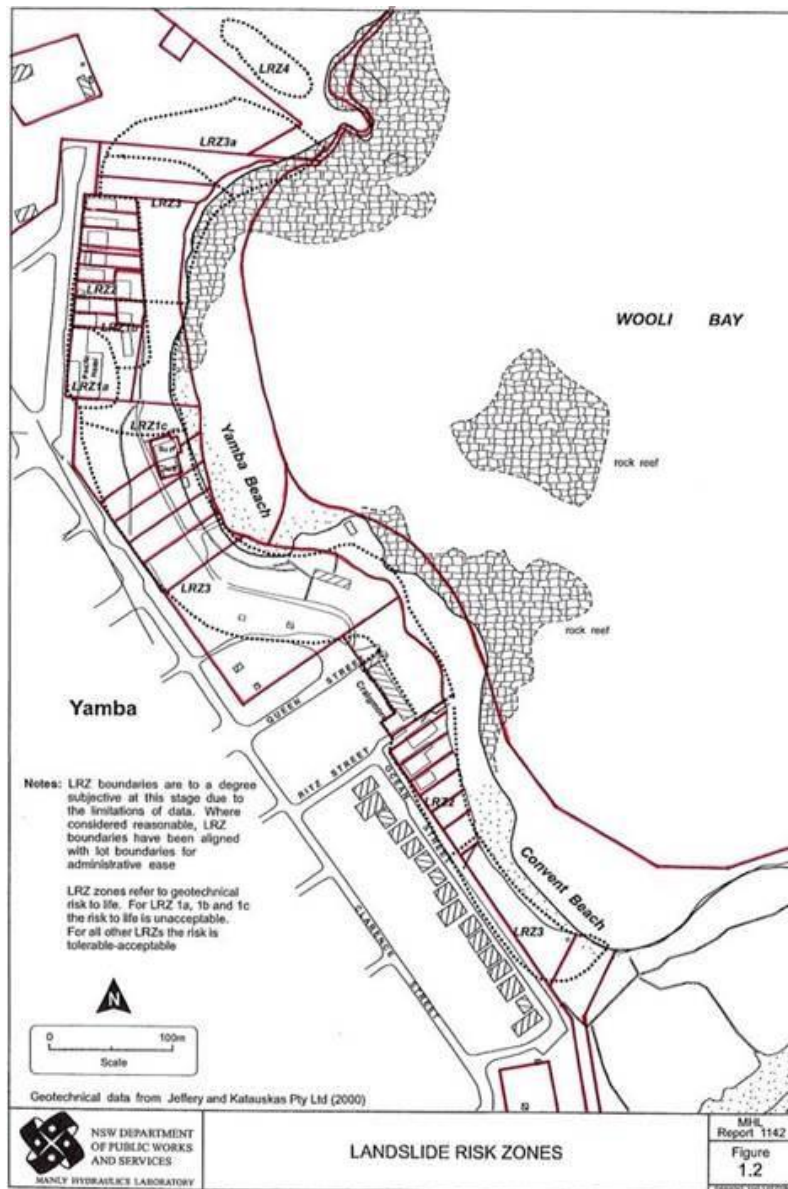
The warning levels apply to land within Landslide Risk Zones (LRZ) 1a, 1b, 2 and 3 shown in Figure 2-5 extending from 2 Pilot Street south to the Pacific Hotel.

Figure 3-5 Landslide risk zones subject to emergency alert levels

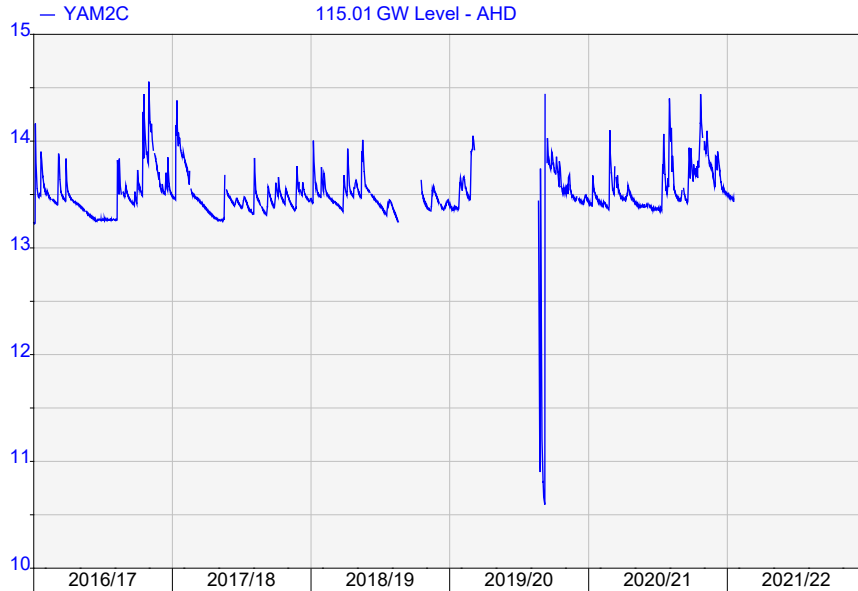
Note that the main report had a duplicate of the YAM2A piezometer and no data for YAM2C, the above plot has been taken from the May 2022 report

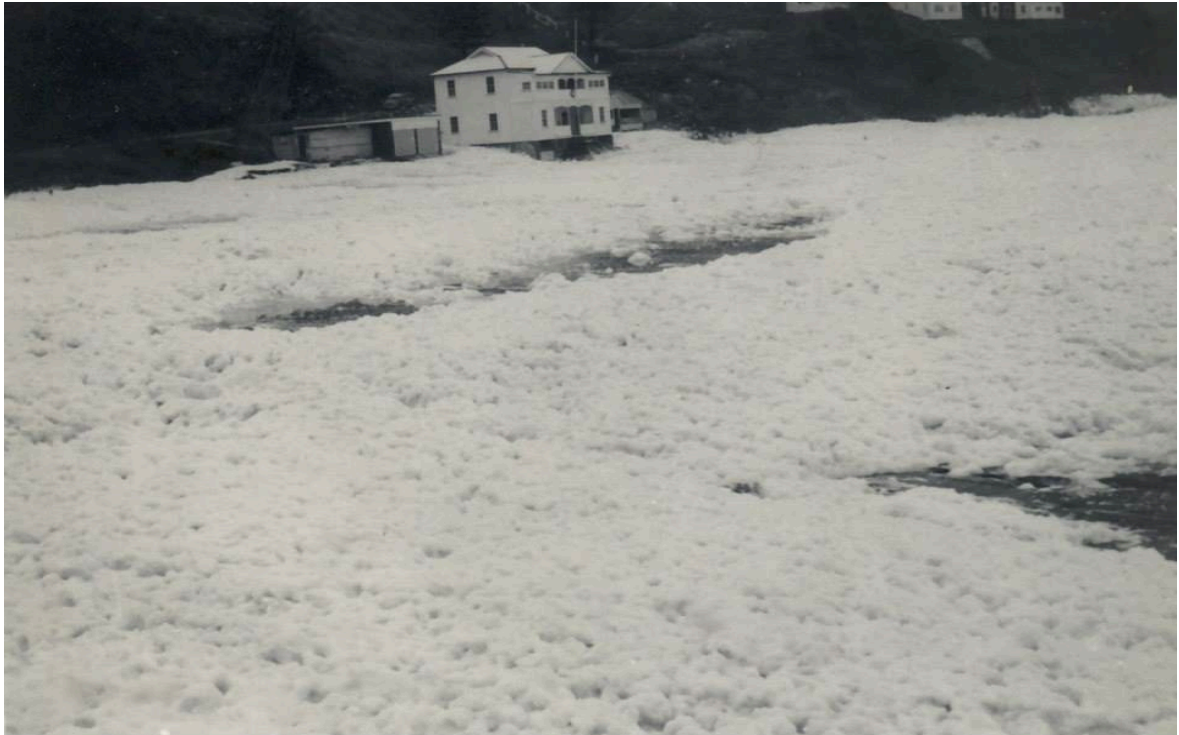
Main Beach on New Year's Day 1963 following from cyclonic swells
