# Clarence Valley Council Heritage Advisory Committee

## MINUTES

<b>REPORT ON BRIDGE AT STORY PARK YAMBA</b>
---

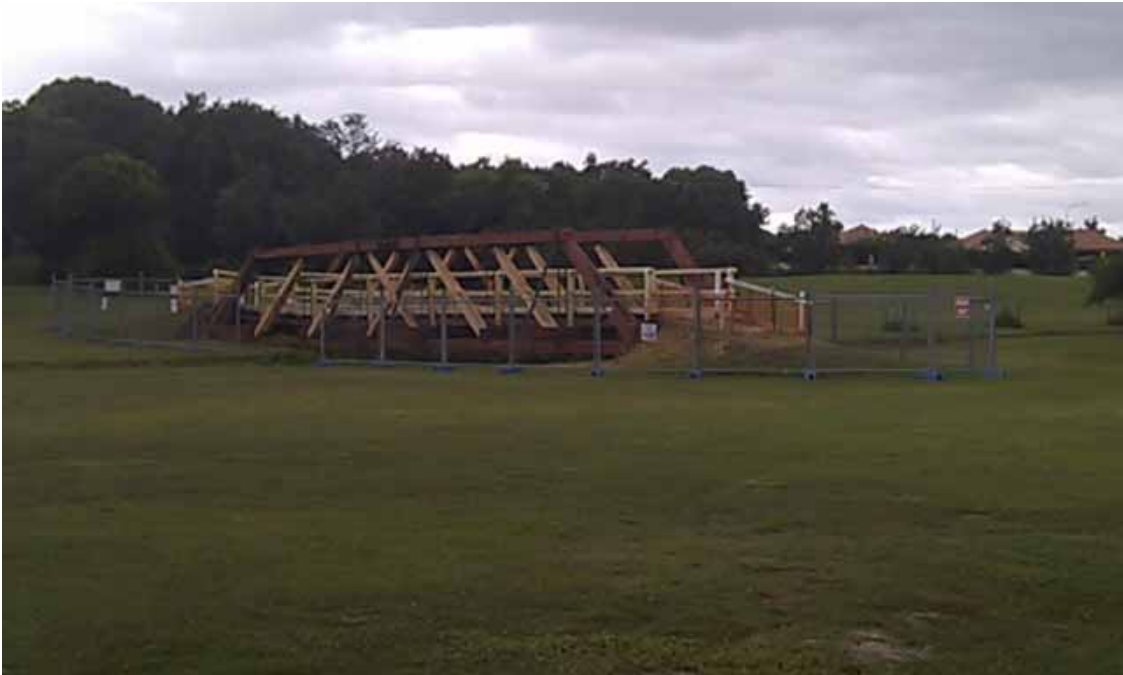
**Figure 1 – Fenced Story Bridge**

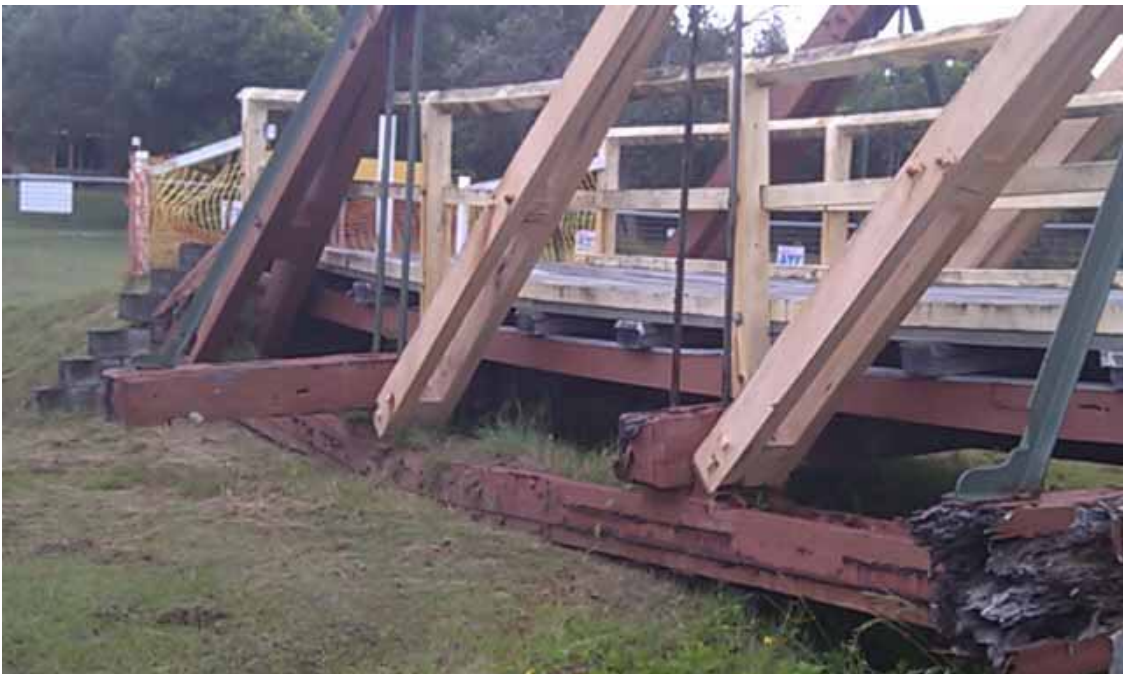
All the major members of the upper and lower chords of the bridge have major rot and have to be replaced. Only some of the diagonals are retrievable. The cross girders have major rot and are not useable. The steel members have varying amounts of corrosion. Most steel members have to be removed, sand blasted and galvanised. Some have to be replaced. All nuts and washers have to be replaced. The condition of stringers is unknown. The deck can be reused. Because of the rot in upper and lower chords, the dismantling of the bridge is impossible and demolition by an excavator is advised.

**Figure 2 – Deterioration of Girders Story Bridge**

It is recommended to remove the existing structure and if required and there is a demonstrated need install a new minor replacement.
