# Draft Coastal Zone Management Plan for Wooloweyah Lagoon

## PART 2: APPENDICES

## APPENDIX A

# WOLOWEYAH LAGOON CONDITION ASSESSMENT

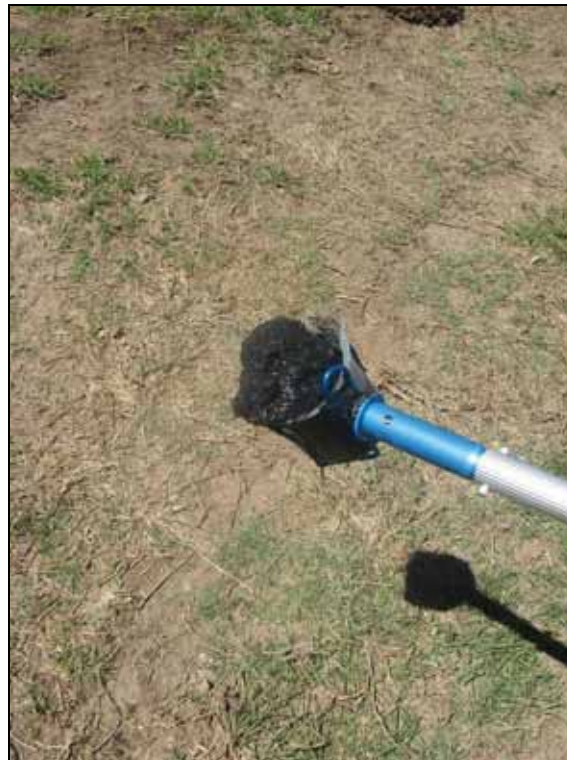
**Figure 5:** The sediment sampling device, showing some sediment collected from one of the drains.

Collection of sediments involved scooping a sample from the top 10 cm of the sediment using a plastic beaker (pre-rinsed in the surface water) attached to a sample pole (Fig. 5). The full beaker was carefully lifted out of the water and excess water drained off, before placing the sediment into a sealable plastic sample bag. Sediment samples were kept in cool, dark conditions until delivery to the EAL.

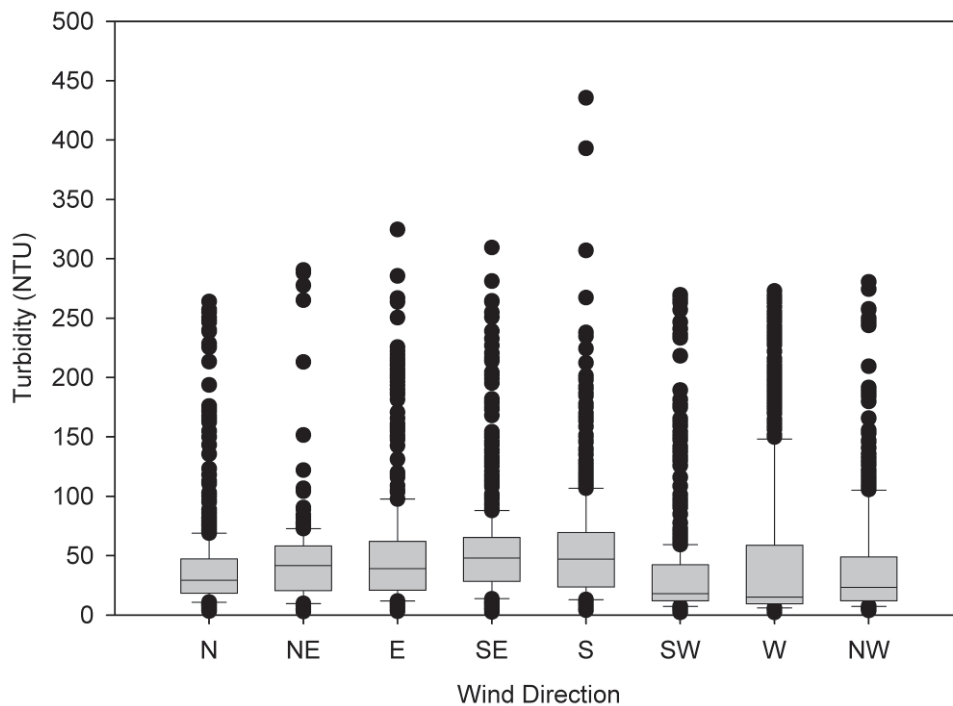
**Figure 12:** Turbidity of Wooloweyah Lagoon in relation to wind direction. The lower boundary of the box indicates the 25<sup>th</sup> percentile, the upper boundary the 75<sup>th</sup> percentile and the line within the box the median. Whiskers above and below the box indicate the 90<sup>th</sup> and 10<sup>th</sup> percentile, respectively. Filled circles represent outliers.

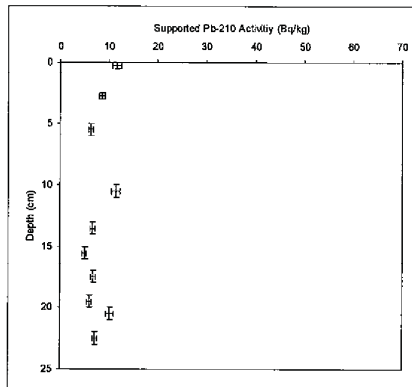
Figure 6 – Lake Wooloweyah Core 2: Supported  $^{210}\text{Pb}$  ( $^{226}\text{Ra}$ ) activity versus depth.

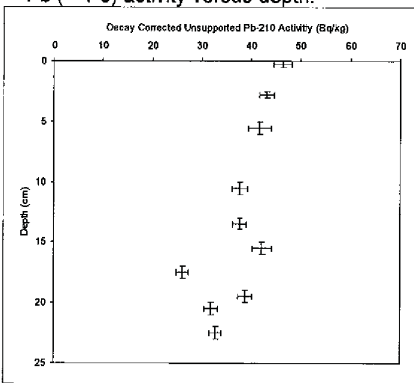
Figure 7 – Lake Wooloweyah Core 2: Unsupported  $^{210}\text{Pb}$  activity versus depth.
