**GEOTECHNICAL OPINION
YAMBA COASTLINE INTERIM EMERGENCY STRATEGY
PILOT HILL YAMBA NSW**

1 INTRODUCTION

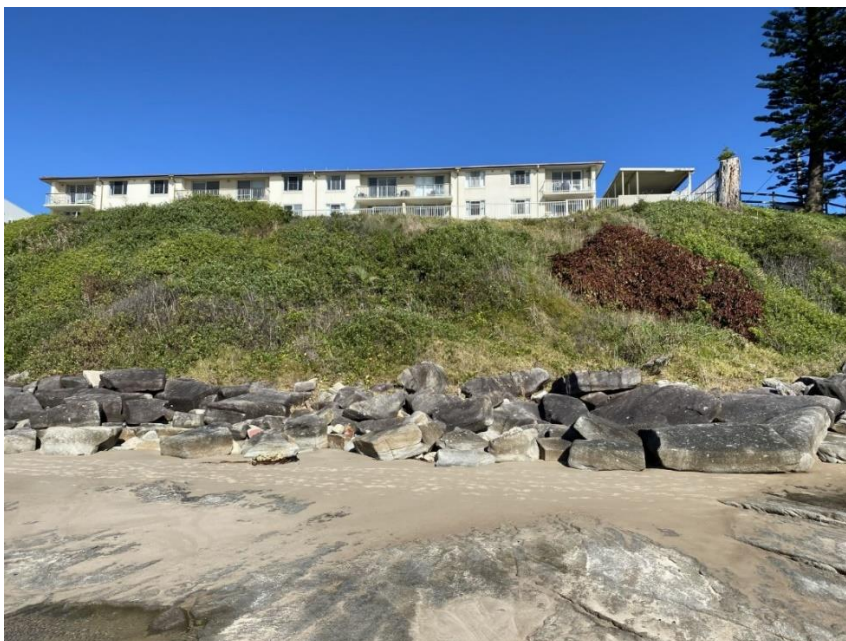
Plate 1 – Craigmore Headland

Craigmore Apartments

The hillside slope on the eastern side of Craigmore Apartments is irregular in shape and slopes down at about 25°. The toe of the slope is protected by large boulders which are founded on the wave cut rock platform below. The apartment structure is set back from the crest of the hillside slope. The slope has a history of instability when a large slump occurred in 1999.

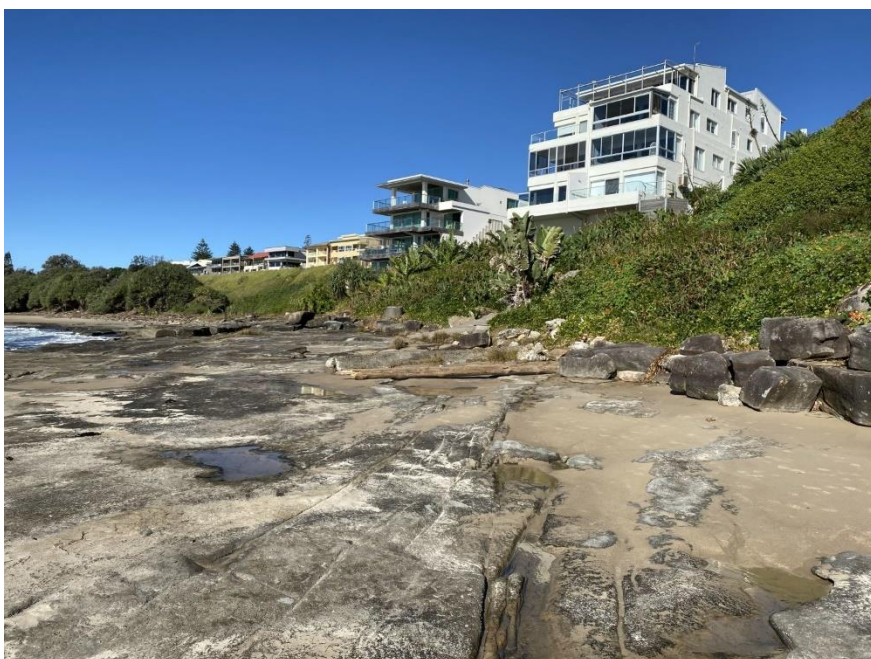
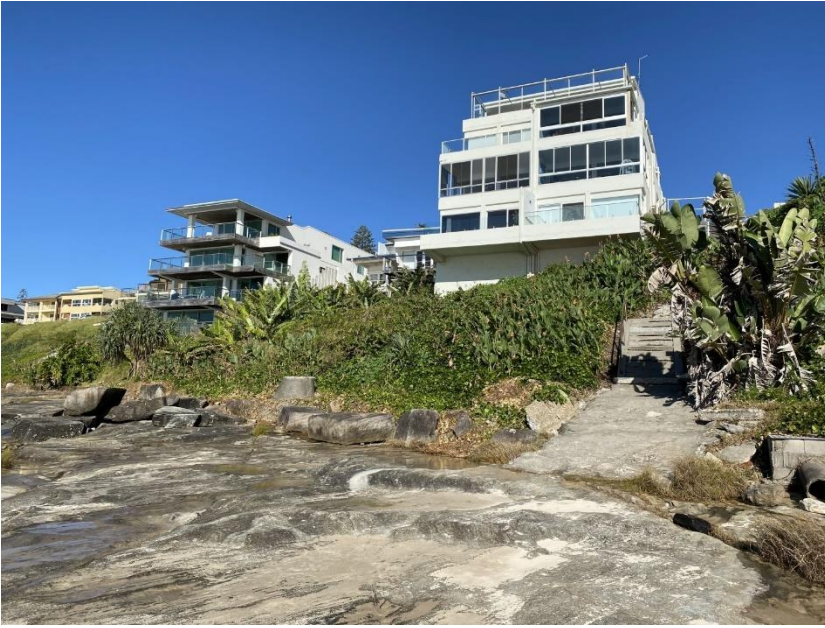
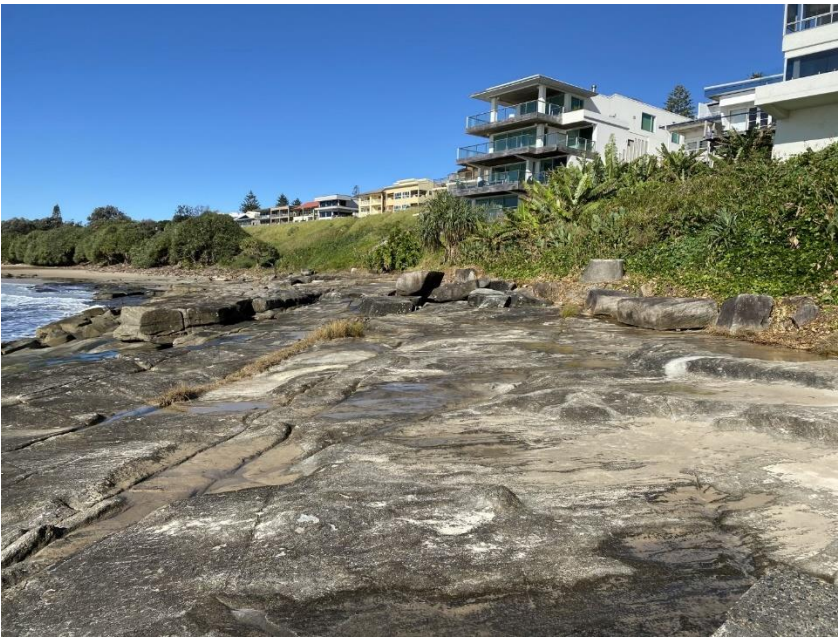
Just to the south of Craigmore Headland, there are a number of properties at the northern end of Convent Beach. Plates 2, 3 and 4 below show these properties. The properties are generally substantial 3 to 4 level buildings, with the exception of one smaller single level weatherboard structure. Our visual observations are that these properties sit generally within the dune slopes above the wave cut platform. Based on the scale of the larger developments we consider that these properties are most likely founded on the underlying bedrock. The smaller single storey weatherboard residence unlikely to be founded on bedrock but is set back

further than the more substantial adjoining structures. Rock boulders are positioned at the junction between the toe of the dune slopes and the wave cut platform. Strong groundwater seepage was evident at the toe of the dune slopes. While the toe of the dune slopes is irregular in nature and likely to be susceptible to some localised slumping or coast erosion processes, in our opinion, the risk of substantial instability impacting structures is likely to be low and therefore acceptable.

Based on our observations, we do not consider that it is currently necessary to advise property owners at Convent Beach when Orange and Red alert zones are reached. However, the properties in this area will be subjected to ongoing hillside erosion processes which left unattended may lead to localised or more significant instability. Therefore, we recommend that Council advise the property owners of the current studies which have been undertaken, including the potential risks, and that they recommend each property obtain their own independent geotechnical risk assessment to ensure ongoing stability of these properties. This would apply to all properties south of Ritz Street and on the eastern side of Ocean Street.

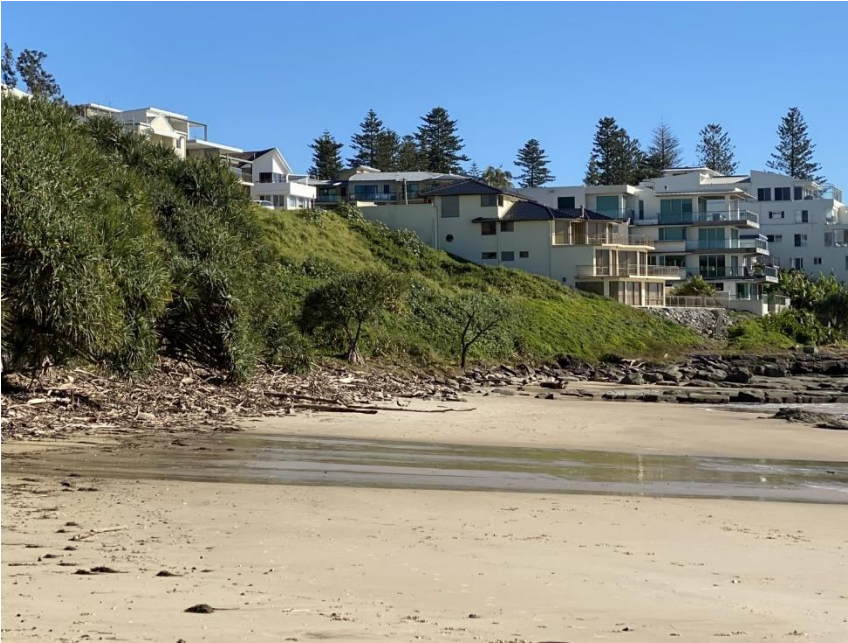
Plate 5 – Convent Beach looking south

Along the main Convent Beach (refer plates 5 and 6 below), the beach area is backed by steeper dune slopes, with Ocean Street (a sealed roadway) running behind the beach area. The dune slopes along Convent Beach vary from about 25° at the southern end to locally as steep as 37°.
