Clarence Valley Coastline and Estuaries Coastal Management Program

Stage 2: Vulnerabilities and
Opportunities

Final Report

**JOB 22-009: CLARENCE VALLEY COASTLINE AND ESTUARIES COASTAL MANAGEMENT PROGRAM
 STAGE 2: VULNERABILITIES AND OPPORTUNITIES**

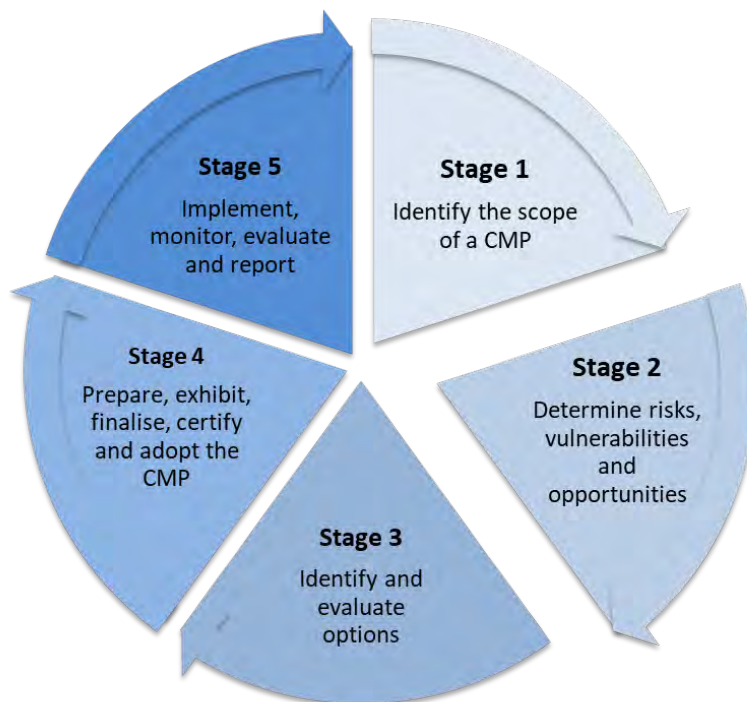
Figure 1: The five-stage process for developing a coastal management program

The manual outlines a five-stage process for developing and implementing a CMP (Figure 1). Stage 1 of the CMP development, the Scoping Study (Hydrosphere Consulting, 2021) was completed in March 2021. The Scoping Study provided a review of progress of actions in the existing management plans for the coastal areas and identified the scope of the new CMP. This report addresses Stage 2 of the CMP process for the Clarence Valley coastline.

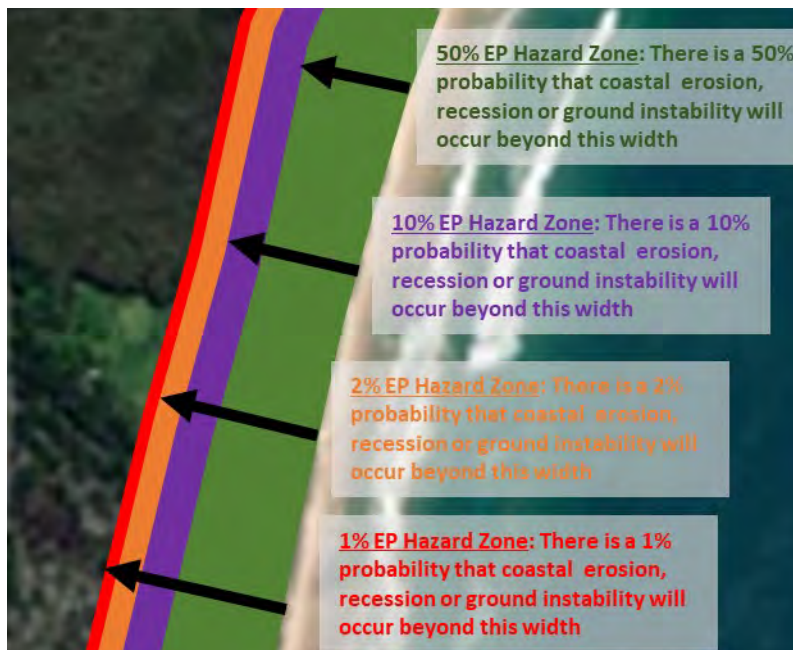
Figure 7: Width of hazard zone (coastal erosion, recession or ground instability) for each event frequency

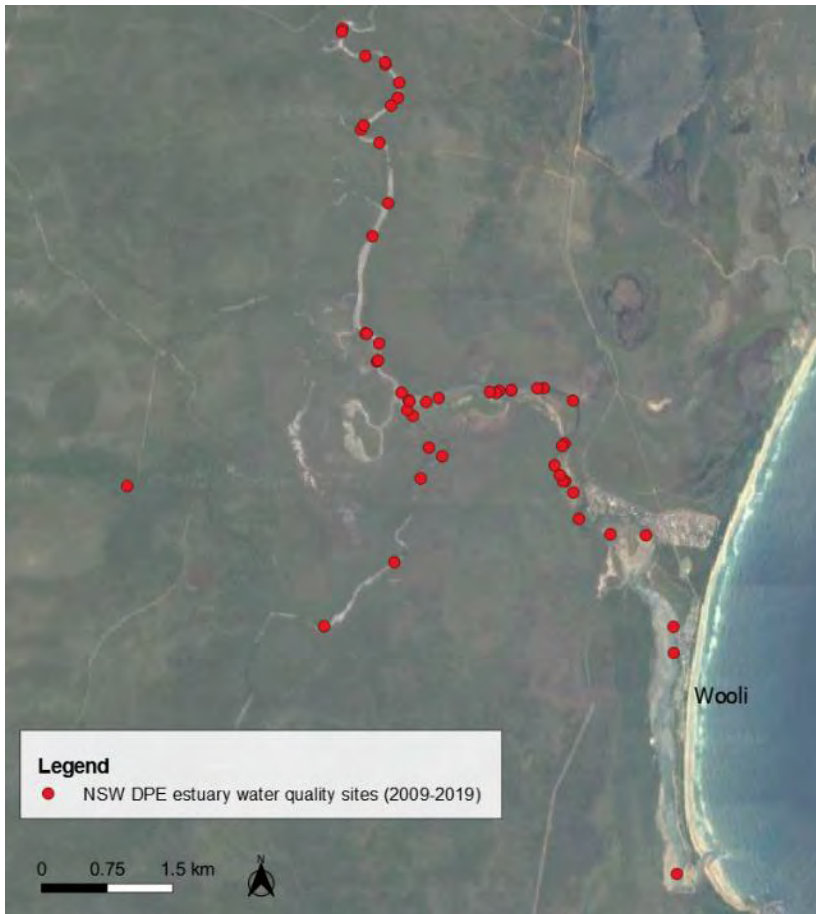
Figure 11: NSW DPE estuary water quality monitoring sites (2009 - 2019) - Woolli Woolli River

The DPE estuary health monitoring program included sampling within the Wooli Wooli River from 2009 - 2019 at a range of sites throughout the estuary, most (90%) of which are upstream of Wooli urban areas (Figure 11).

The grades indicate that water quality recorded from sites throughout the estuary and predominantly in the mid and upper estuary, upstream of Wooli urban areas has been consistently good throughout the monitoring periods from 2009 - 2021. This is expected of a largely undisturbed catchment area within a National Park. The DPE estuary health water quality program is not considered to have sufficient replication

of sites in proximity to the urban areas of Woolli to adequately assess potential water quality pollution from urban sources (only 6 samples in the lower estuary from 2009 - 2019).

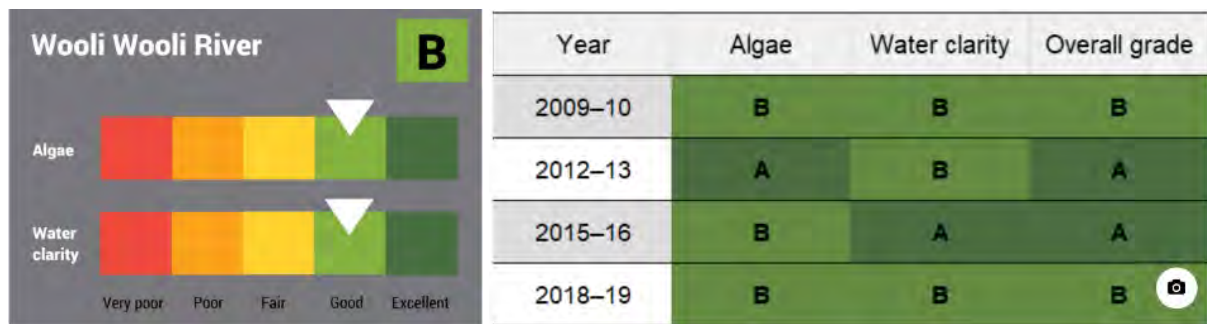
Figure 12: Woolli Woolli River estuary: Report card 2021/22 summer (left); Historical grades 2009 - 2019 (right)

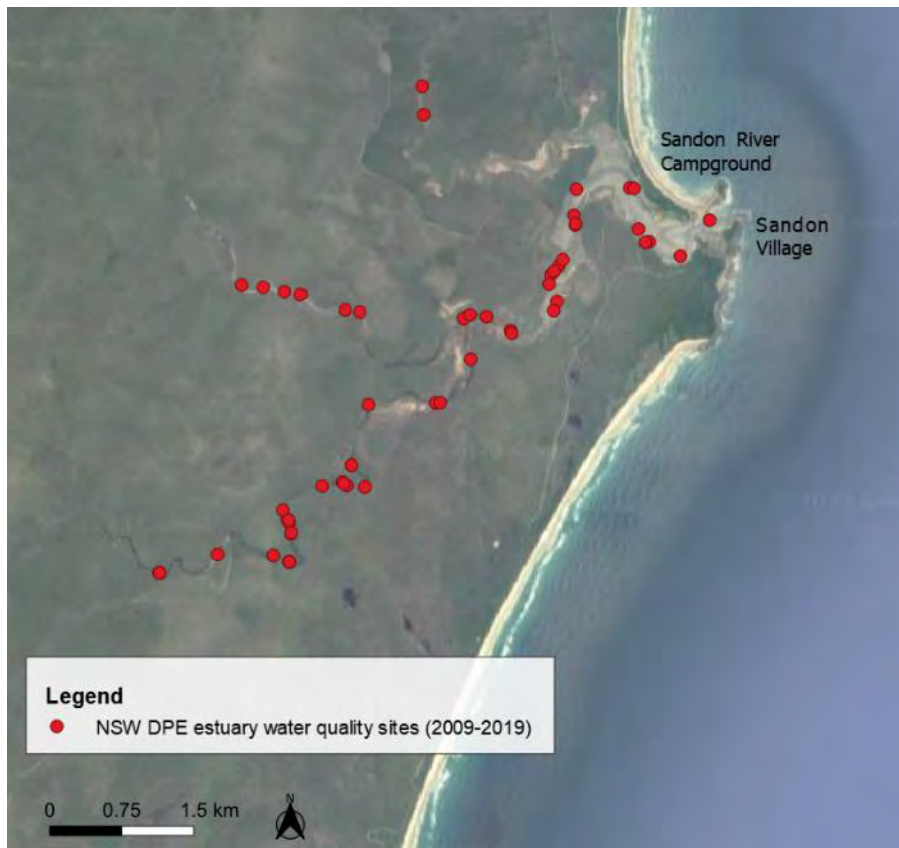
Figure 13: NSW DPE estuary water quality monitoring sites (2009 - 2019)

The DPE estuary health monitoring program included sampling within Sandon River from 2007 - 2022 at a range of sites throughout the estuary, most of which are upstream of potential pollution sources in the lower estuary (e.g. Sandon River campground and Sandon Village, Figure 13).

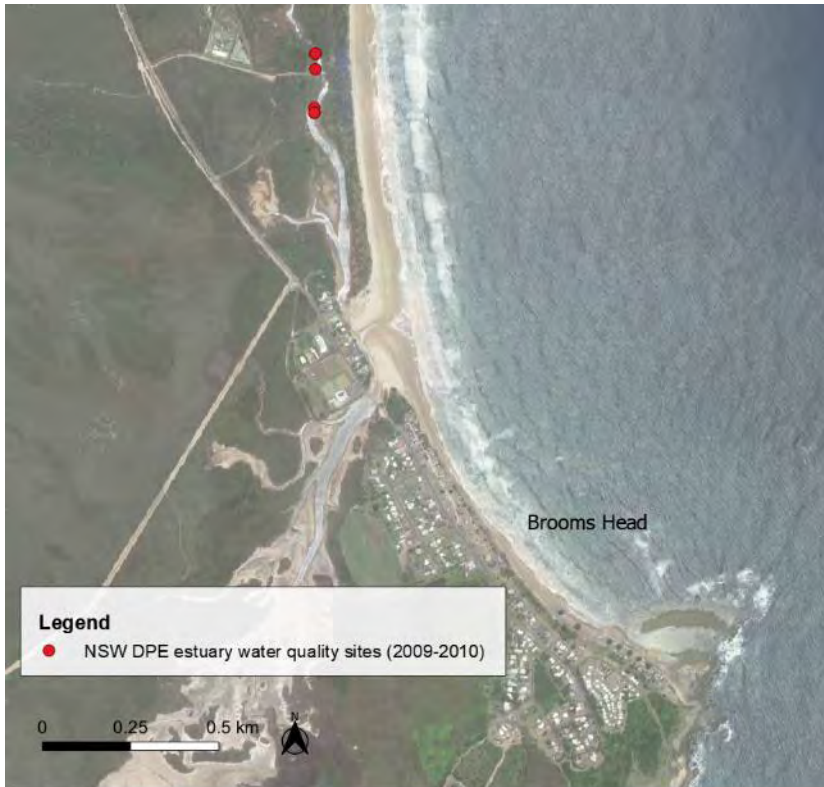
Figure 15: NSW DPE estuary water quality monitoring sites (2009 - 2010)

The DPE estuary health monitoring program included sampling within the northern arm of Lake Cakora in 2009/2010 (Figure 15) and again in 2021/2022, although the location of these more recent samples was not documented.

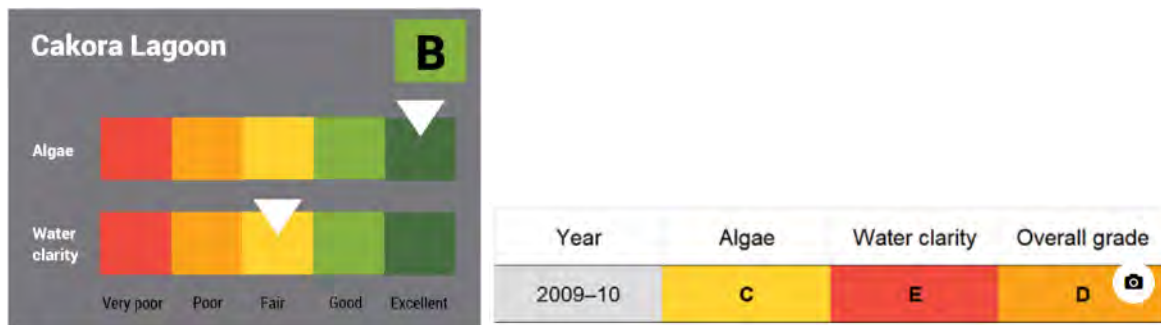
Figure 16: Lake Cakora: Report Card 2021-22 summer (left); Historical grades 2009/2010 (right)

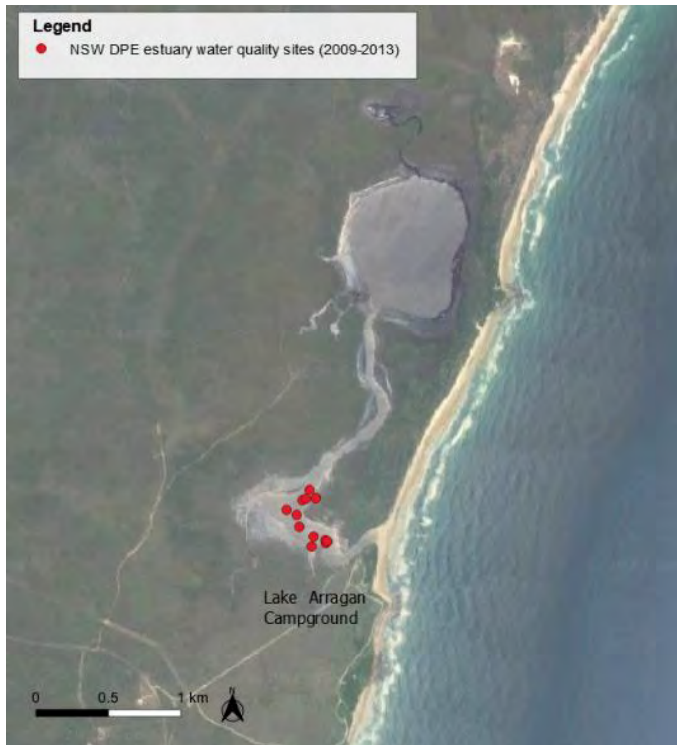
Figure 17: NSW DPE estuary water quality monitoring sites (2009/2010 and 2012/2013)

Lake Arragan and Mara Creek are ICOLLs with untrained and unmanaged entrances. The entire Lake Arragan catchment lies within Yuraygir National Park. The catchment is generally in a natural, vegetated condition with minimal sources of disturbance from fire trails/ access roads and the Lake Arragan National Parks Camping Ground in the lower extent of the estuary near the entrance (Figure 17). The majority of the Mara Creek catchment is also within Yuraygir National Park with some roads and urban residential areas (Angourie) in the north east portion of the catchment. The DPE estuary health monitoring program included sampling within Lake Arragan in 2009/2010, 2012/2013 (Figure 17) and 2021/2022. Sampling was typically

completed over the spring and summer months when two sites were sampled on a monthly basis. Mara Creek has not been sampled by DPE to date.

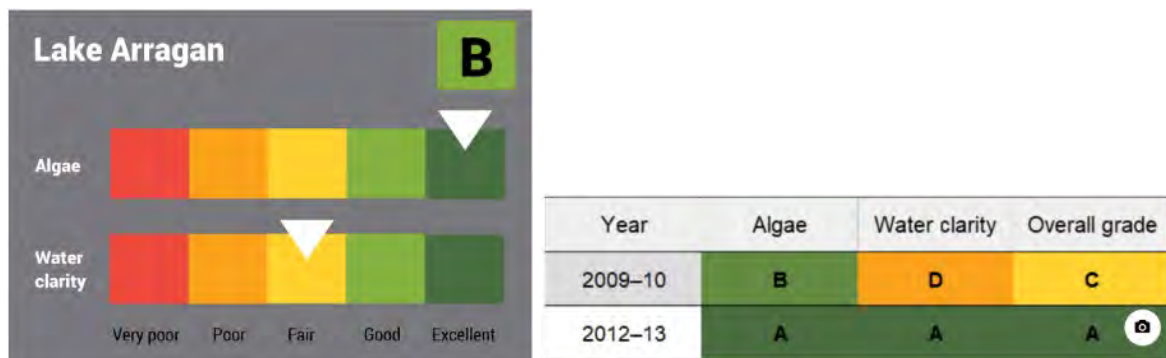
Figure 18: Lake Arragan: Report Card 2021-22 summer (left); Historical grades 2009/2010 and 2012/2013 (right)

Historical water quality results from 2009/2010 and 2012/2013 (Figure 18b) show the overall grade for water quality ranges from ‘fair (C)’ in 2009/2010 to ‘excellent (A)’ in 2012/2013. A review of other parameters available for these years as part of the DPE estuary health water quality dataset indicates that TN levels assessed during each sampling event exceeded the recommended guidelines for healthy aquatic ecosystem function, and in some instances was over four times the recommended level. Poor water quality is associated with extended entrance closure.

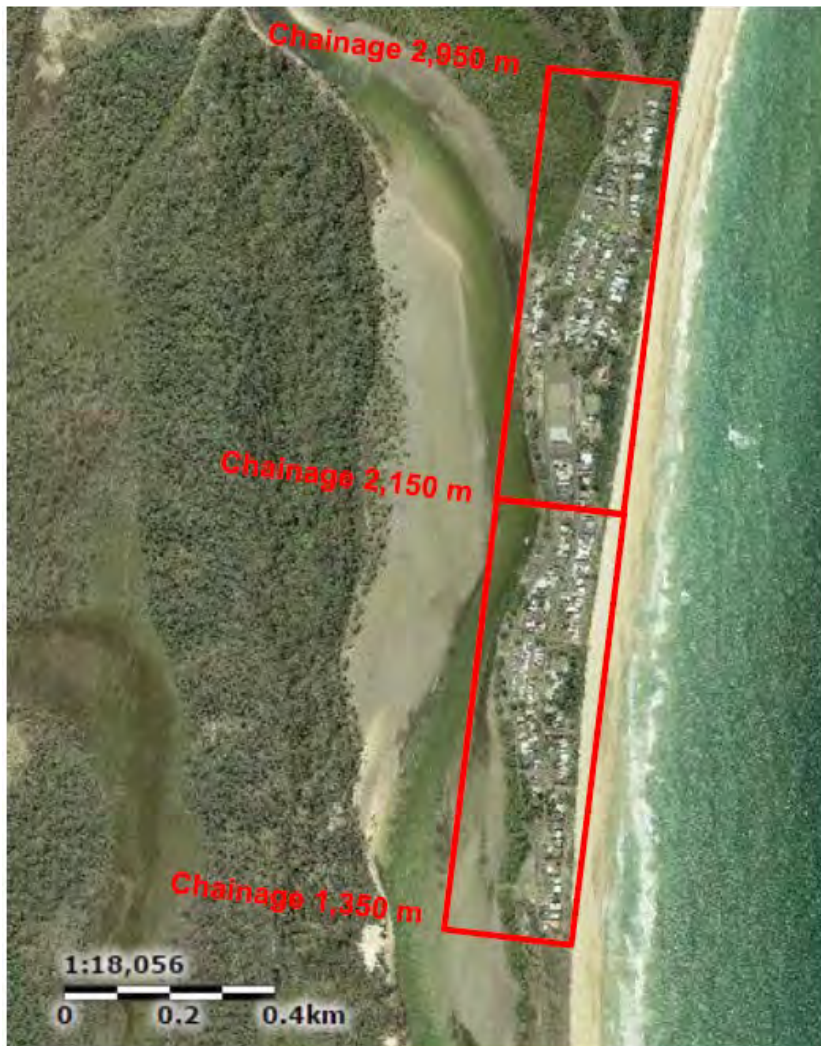
Figure 20: Woolli Village property protection area

The annual volume of sediment required for nourishment (based on the updated long-term average rate of recession of approximately 2 m³/m/year above MSL) is 2,040 m³ above MSL for the southern portion of Wooli Village which was deemed to be most exposed to storm erosion (Royal HaskoningDHV, 2018, Figure 20, 800m between chainage 1,350 m and chainage 2,150 m where chainage is measured from the breakwater at the southern end of Wooli Beach). Including the northern portion of Wooli Village to chainage 3,950 m (additional 1,600 m) would require an additional 2,040 m³ of sediment (Royal HaskoningDHV, 2021a). The total volume of material required to 'hold the line' is the annual volume of sediment for nourishment multiplied by the time between nourishment campaigns in years. However Royal HaskoningDHV (2021a) recommends that significantly larger volumes of sand should be targeted to assist in providing a buffer to offset storm erosion.

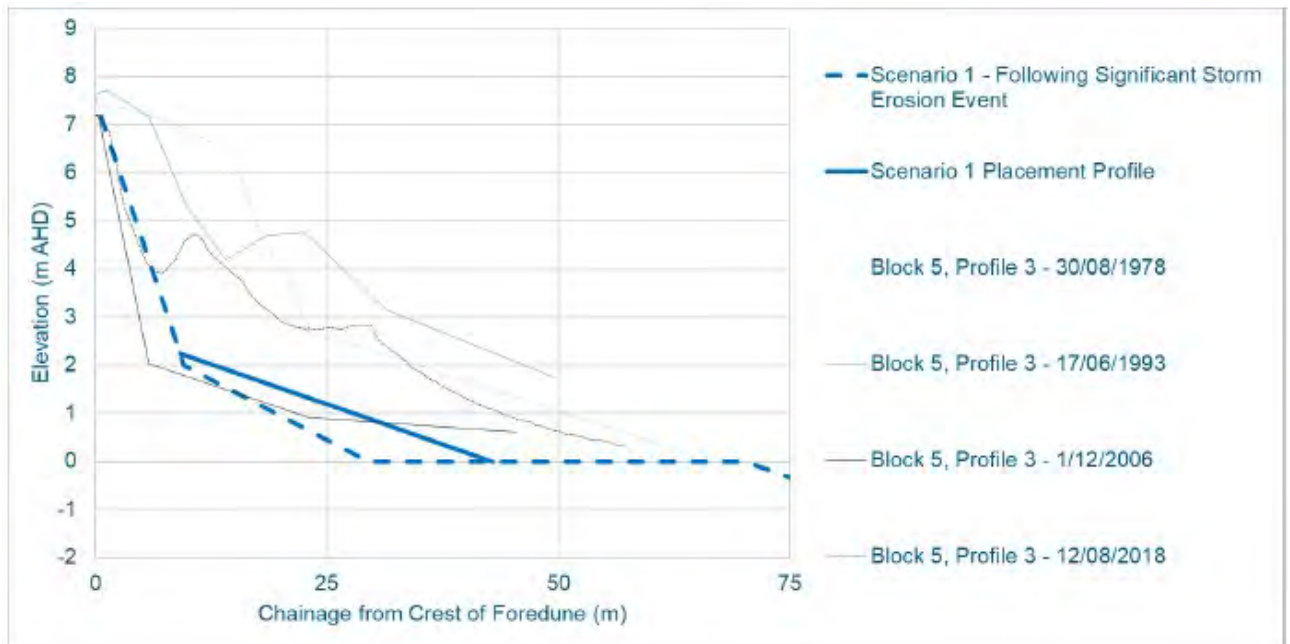
Figure 22: Typical historical photogrammetry profiles and Scenario 1 sand placement profile

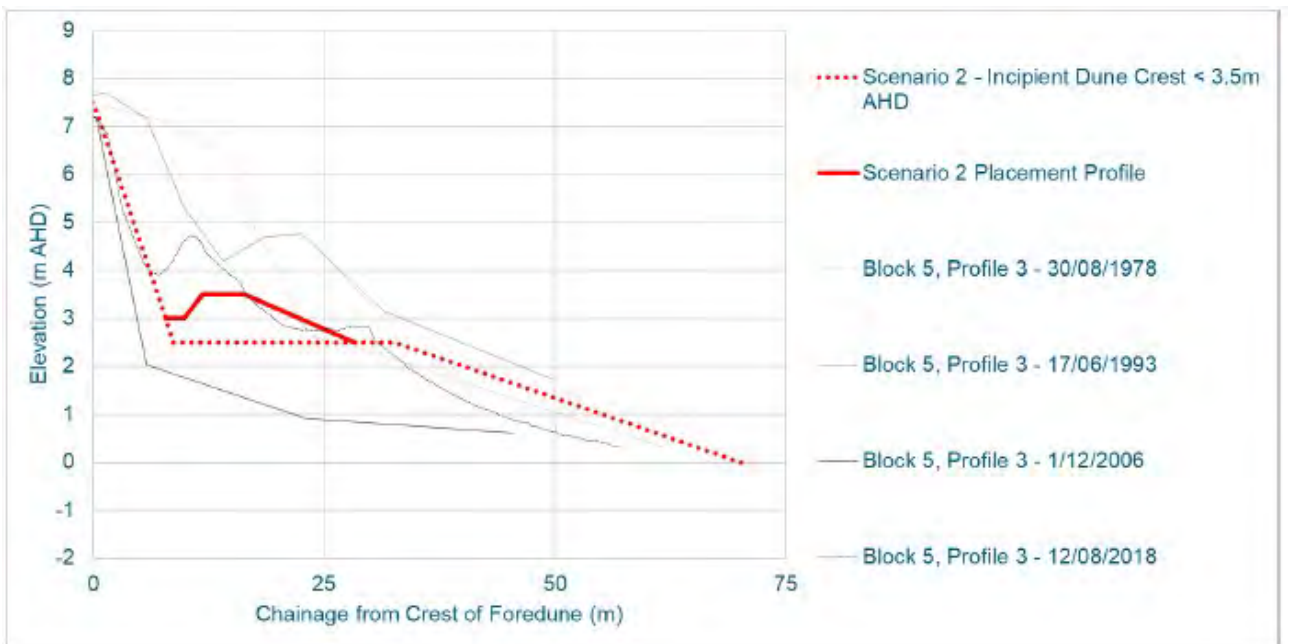
Figure 23: Typical historical photogrammetry profiles and Scenario 2 sand placement profile

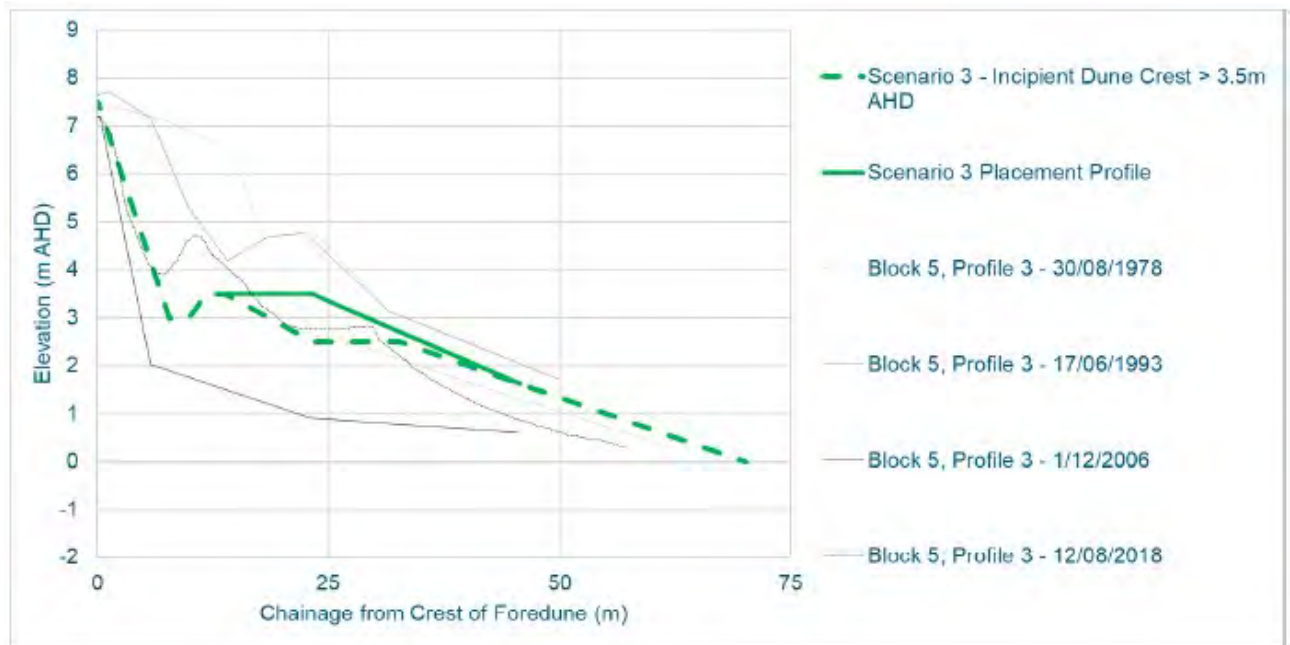
Figure 24: Typical historical photogrammetry profiles and Scenario 3 sand placement profile

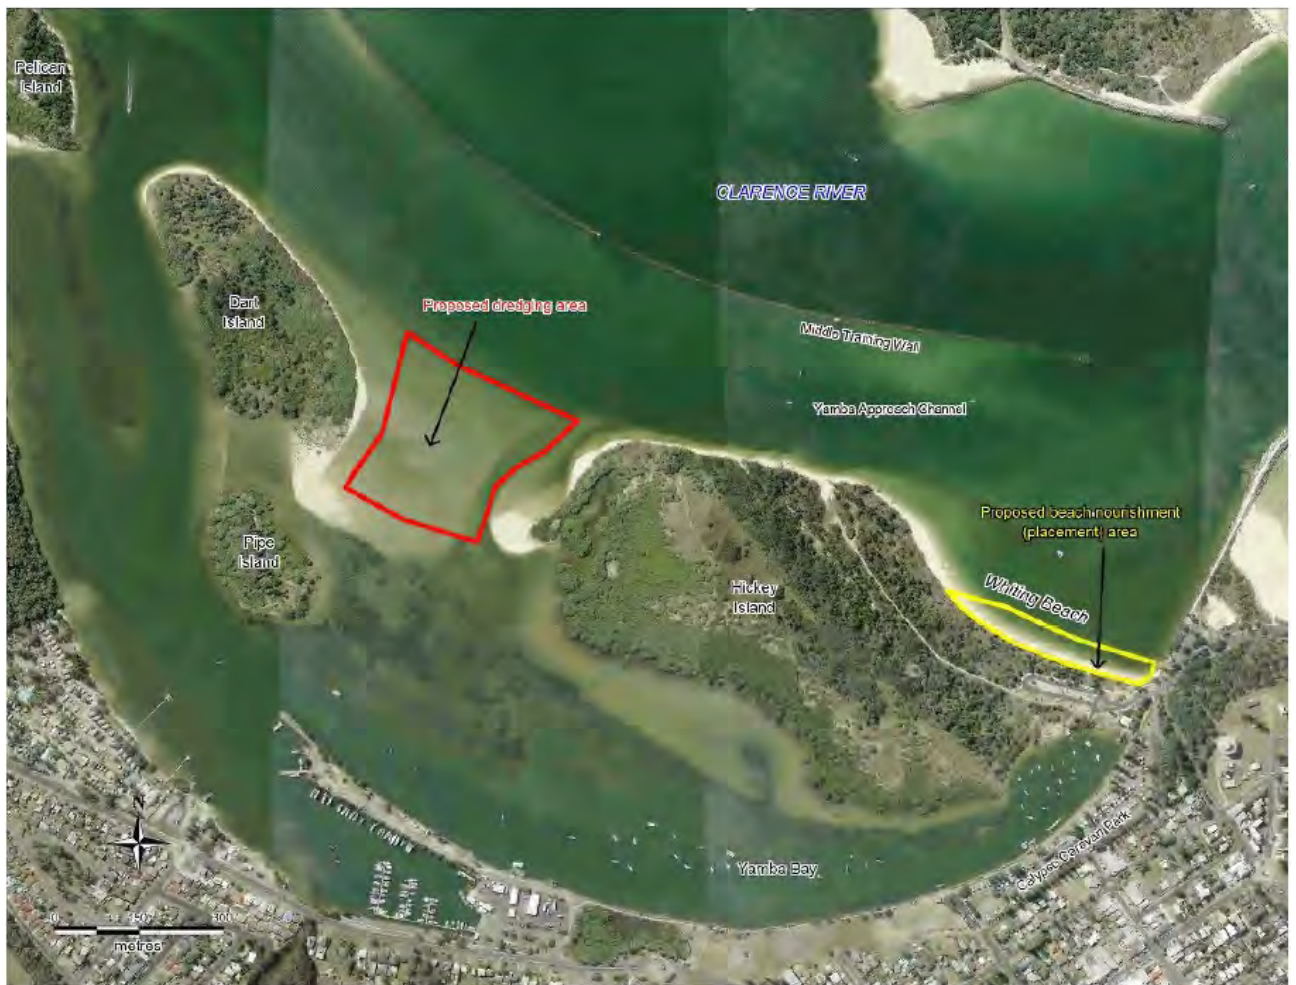
Figure 26: Proposed dredging area between Dart Island and Hickey Island and White Beach nourishment area

Stage 3 of the CMP should consider the options proposed in RoyalHaskoningDHV (2015a), potential risks (e.g. sand depletion, seagrass impacts, recreational fishing impacts) and other potential sand sources such as the Yamba approach channel near middle wall.

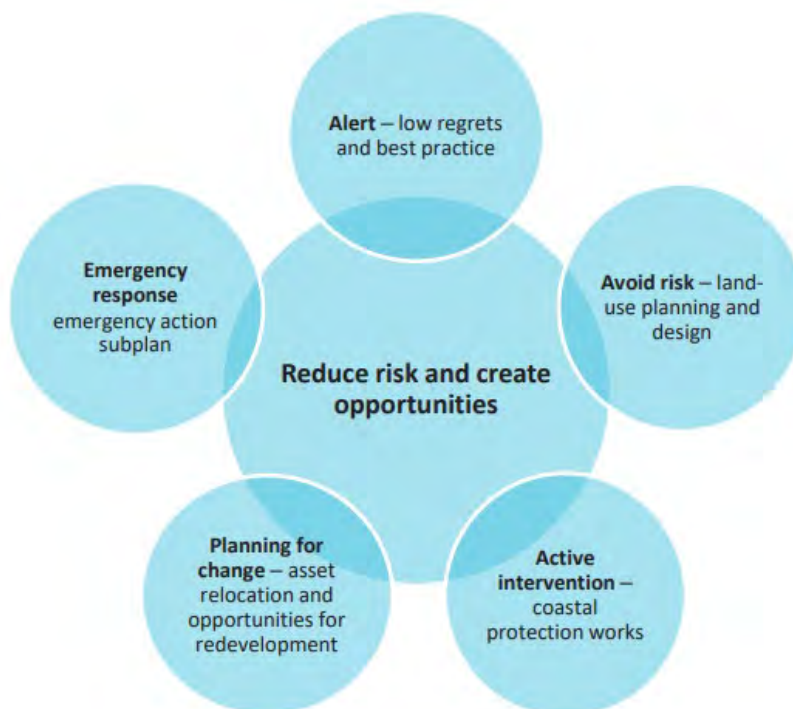
Figure 37: Strategic risk management approaches to address coastal hazards

The broad strategic approaches that will be applied are shown on Figure 37. Management approaches will aim to enhance natural defences and/or avoid future risk by encouraging land uses that reduce exposure to coastal hazards.

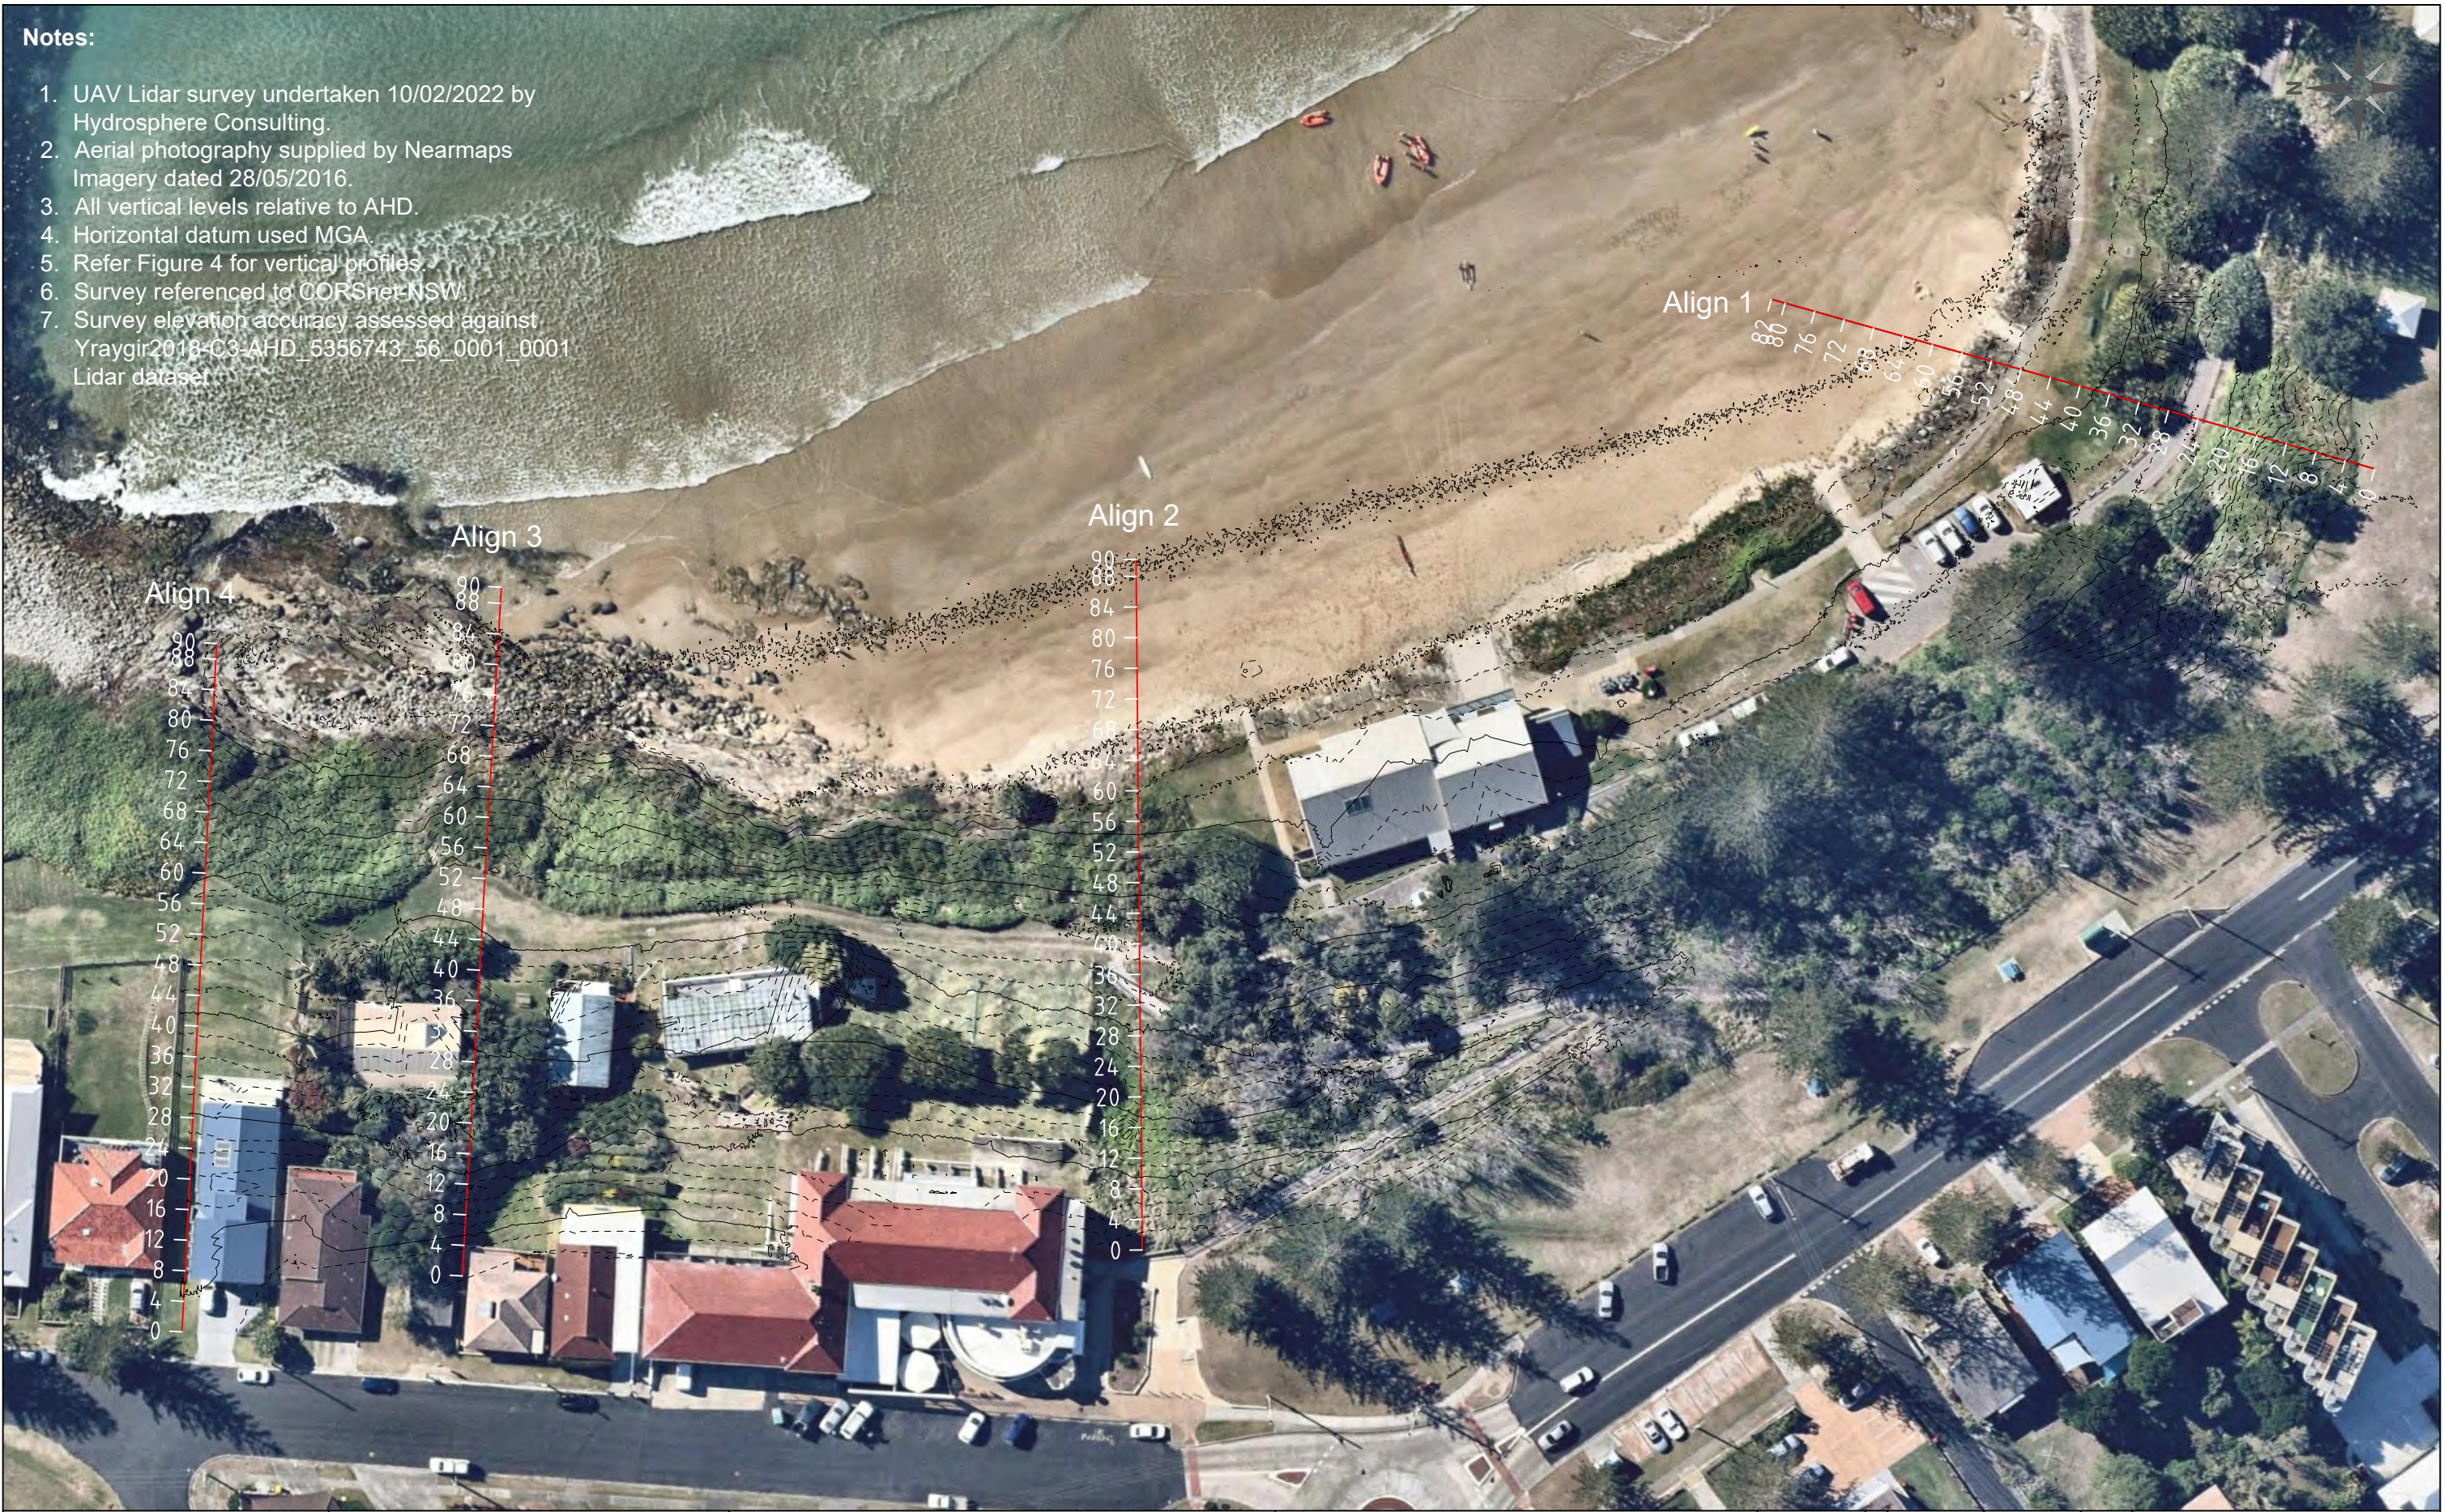
1. UAV Lidar survey undertaken 10/02/2022 by Hydrosphere Consulting.
2. Aerial photography supplied by Nearmaps Imagery dated 28/05/2016.
3. All vertical levels relative to AHD.
4. Horizontal datum used MGA.
5. Refer Figure 4 for vertical profiles.
6. Survey referenced to CORSnet-NSW.
7. Survey elevation accuracy assessed against Yraygir2018-C3-AHD_5356743_56_0001_0001 Lidar dataset

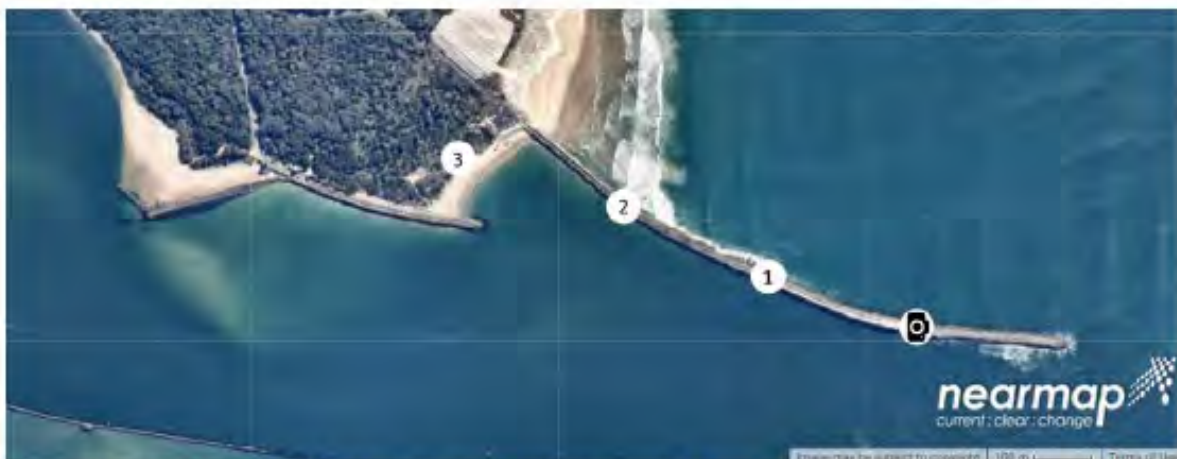
Clarence Northern breakwater, showing the (1) northern breakwater; (2) Shipwreck HMAS Waree; (3) mullet haul beach
Credit: nearmap

- Maintain breakwater fauna refuge area
- Adjacent osprey tower
- Increase submerged habitat complexity
- Key fish habitat enhancement along training wall

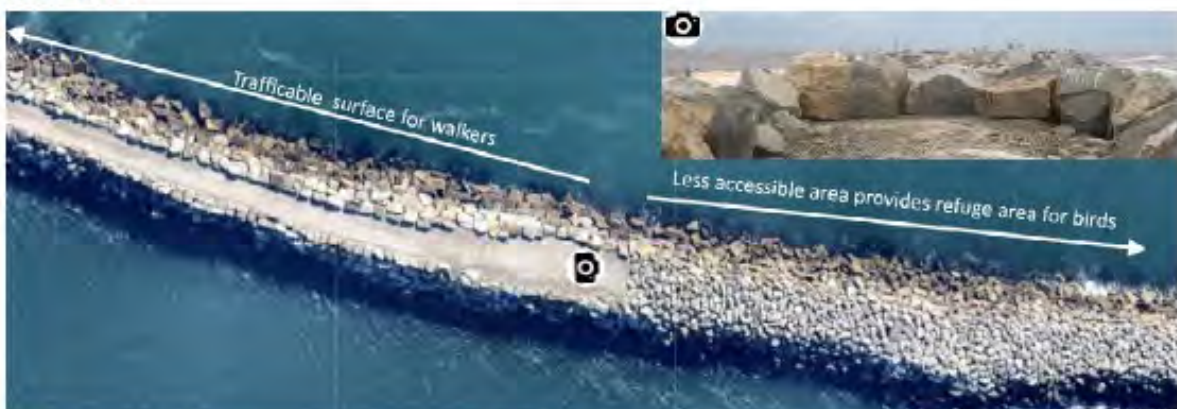
The last 250 metres of the breakwater is inaccessible, and this creates a refuge for breakwater fauna
Credit: nearmap

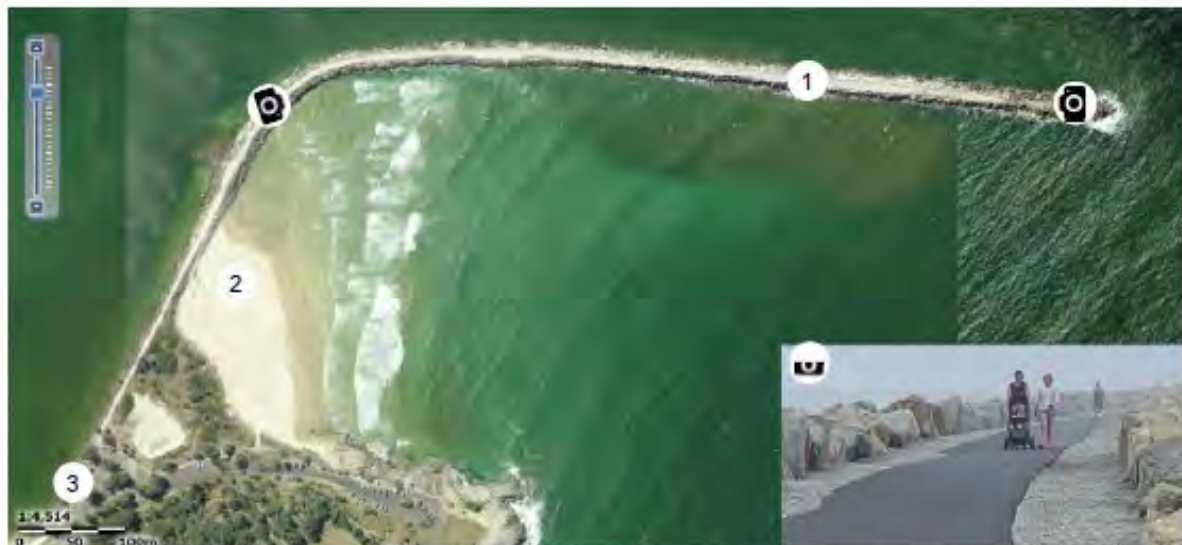
Clarence River Breakwater: (1) the southern breakwater; (2) Turners Beach; (3) interpretative signage acknowledging the engineering heritage of the Port of Clarence breakwater infrastructure. Credit: Six Maps

- Adjacent osprey tower
- Increase submerged habitat complexity
- Key fish habitat enhancement along training wall

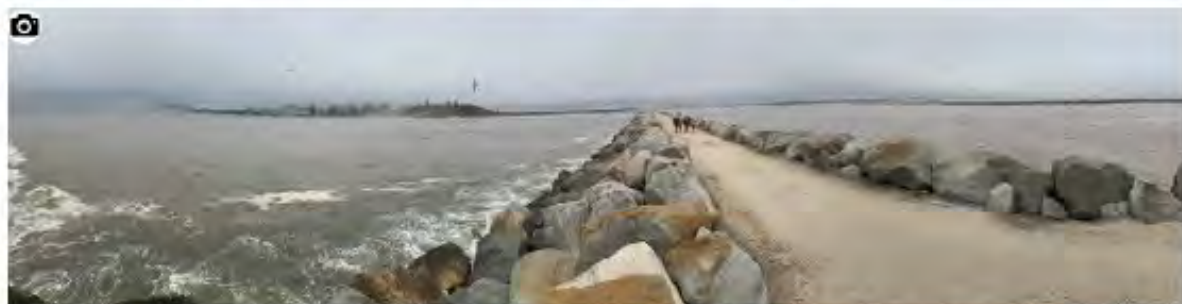
The view back to land from the end of the Clarence River southern breakwater provides a unique perspective as sea birds arc and dive for fish. The first two-thirds of the breakwater has a smooth, tar-finished trafficable surface and the last third is a coarser gravel.

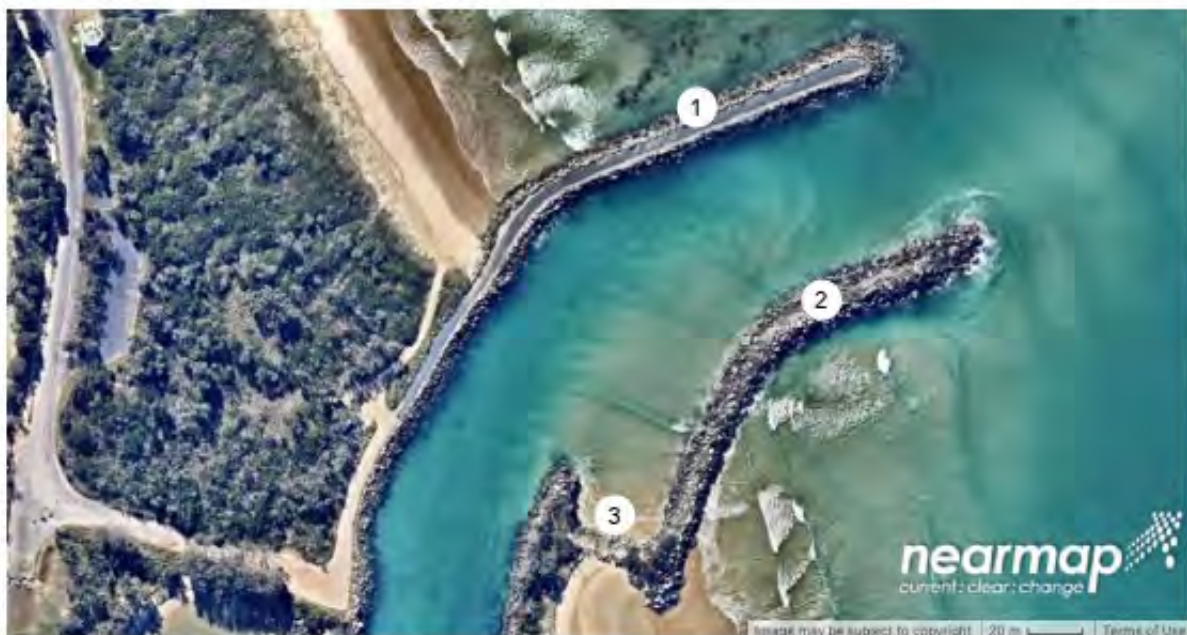
Aerial photo of the Wooli estuary showing (1) northern breakwater; (2) southern breakwater; (3) wave-trap beach

Future multi-use features <ul style="list-style-type: none"> – Maintain existing pedestrian walkway surface – Install CoastSnap photo point – Rock placement for emergency safety stairs 	Future eco-features <ul style="list-style-type: none"> – Key fish habitat enhancement along training wall
--	---

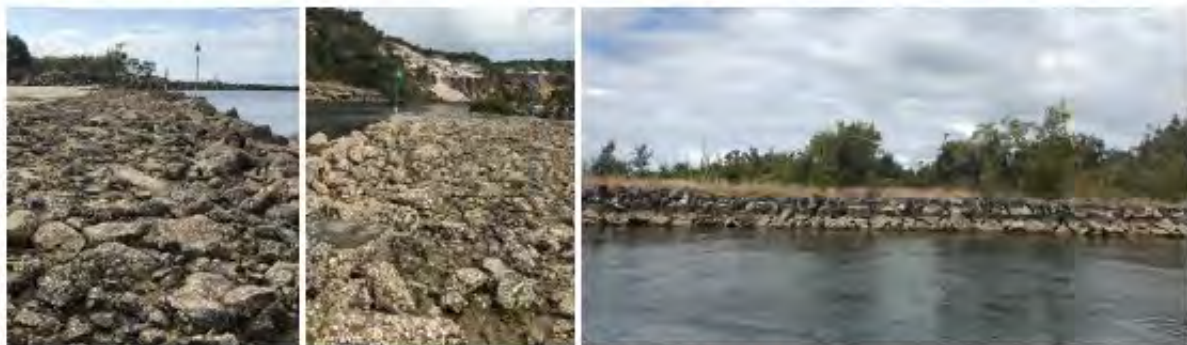
Wooli breakwater rubble has been colonised by oysters to create a valuable oyster reef habitat
Credit: Charlie Jenkins

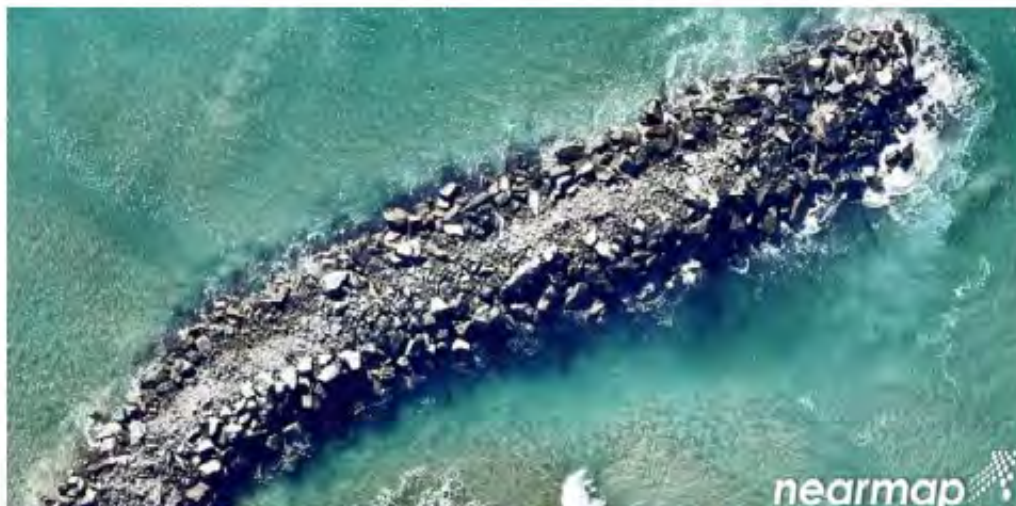
The Wooli River southern breakwater does not have a smooth surface for walking *Credit: nearmap*

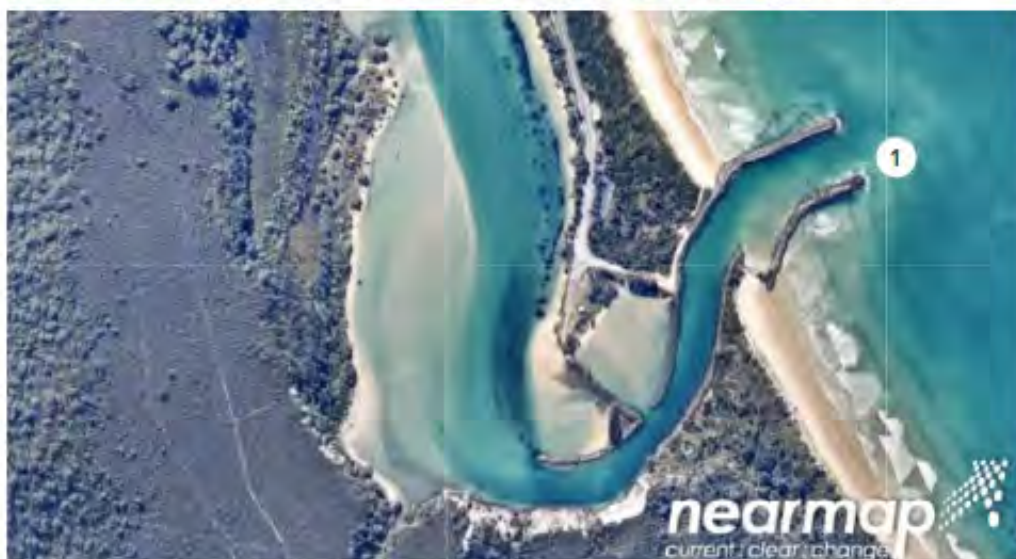
The trained entrance of the Wooli River estuary showing (1) the southern breakwater, the wave-trap beach and the lack of access to the southern breakwater *Credit: nearmap*
