**REPORT
TO
CLARENCE VALLEY COUNCIL**

**TECHNICAL REPORT 3
RISK ASSESSMENT AND STABILISATION**

**FOR
PILOT HILL YAMBA, NSW**

**30 August 2017
Ref: 19314L3rpt – Technical Report 3 Final**

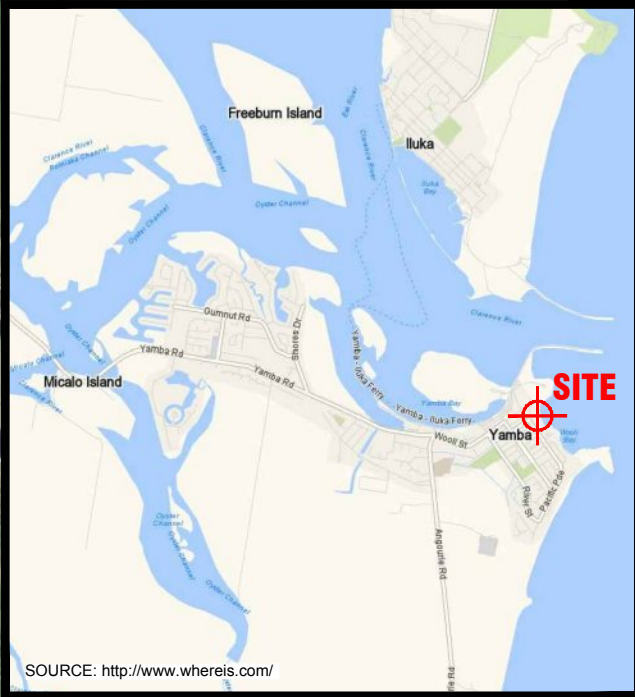
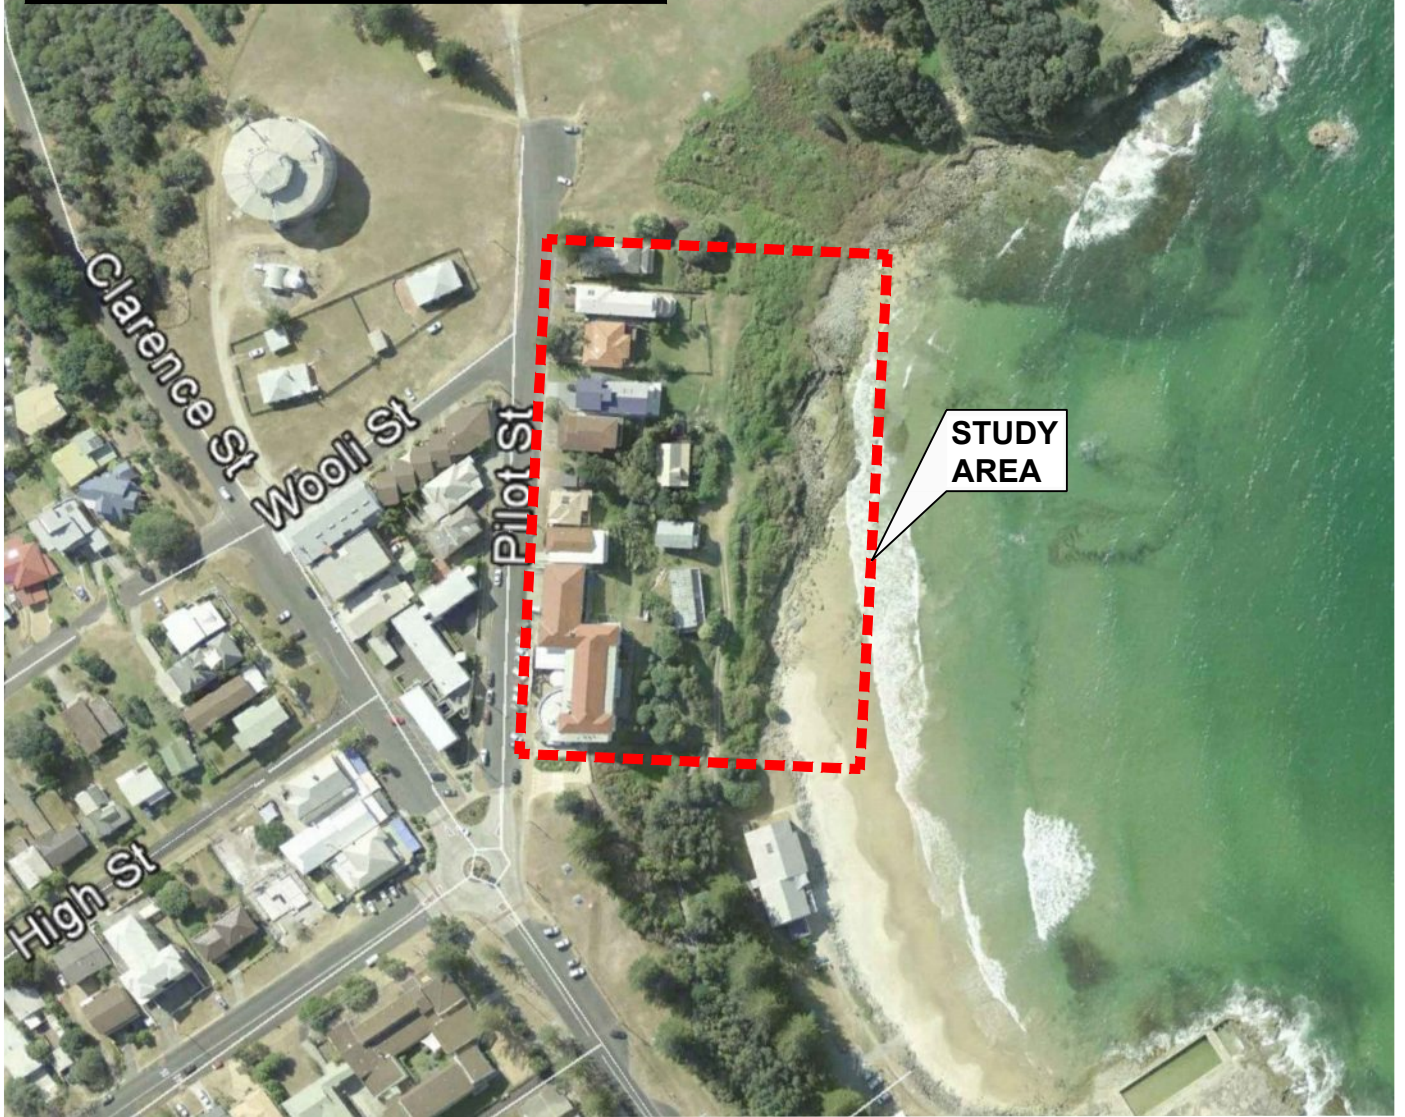
Title:		STUDY AREA	
Location:		PILOT HILL YAMBA, NSW	
Report No:	19314L3	Figure No:	1
JK Geotechnics

The current study area comprises Yamba Beach which is backed by steep foreshore slopes leading up to Pilot Street which is located on a Plateau area. The Pacific Hotel and various residential dwellings (No's 2 to 14) are located toward the crest of the foreshore slopes, with some minor structures located within the foreshore slopes south of No. 10, and below the Pacific Hotel. The attached Figure 1 shows a general location map showing the study area, while the attached Figure 2 shows a more detailed location plan including the current investigation locations by JK Geotechnics and WRL.

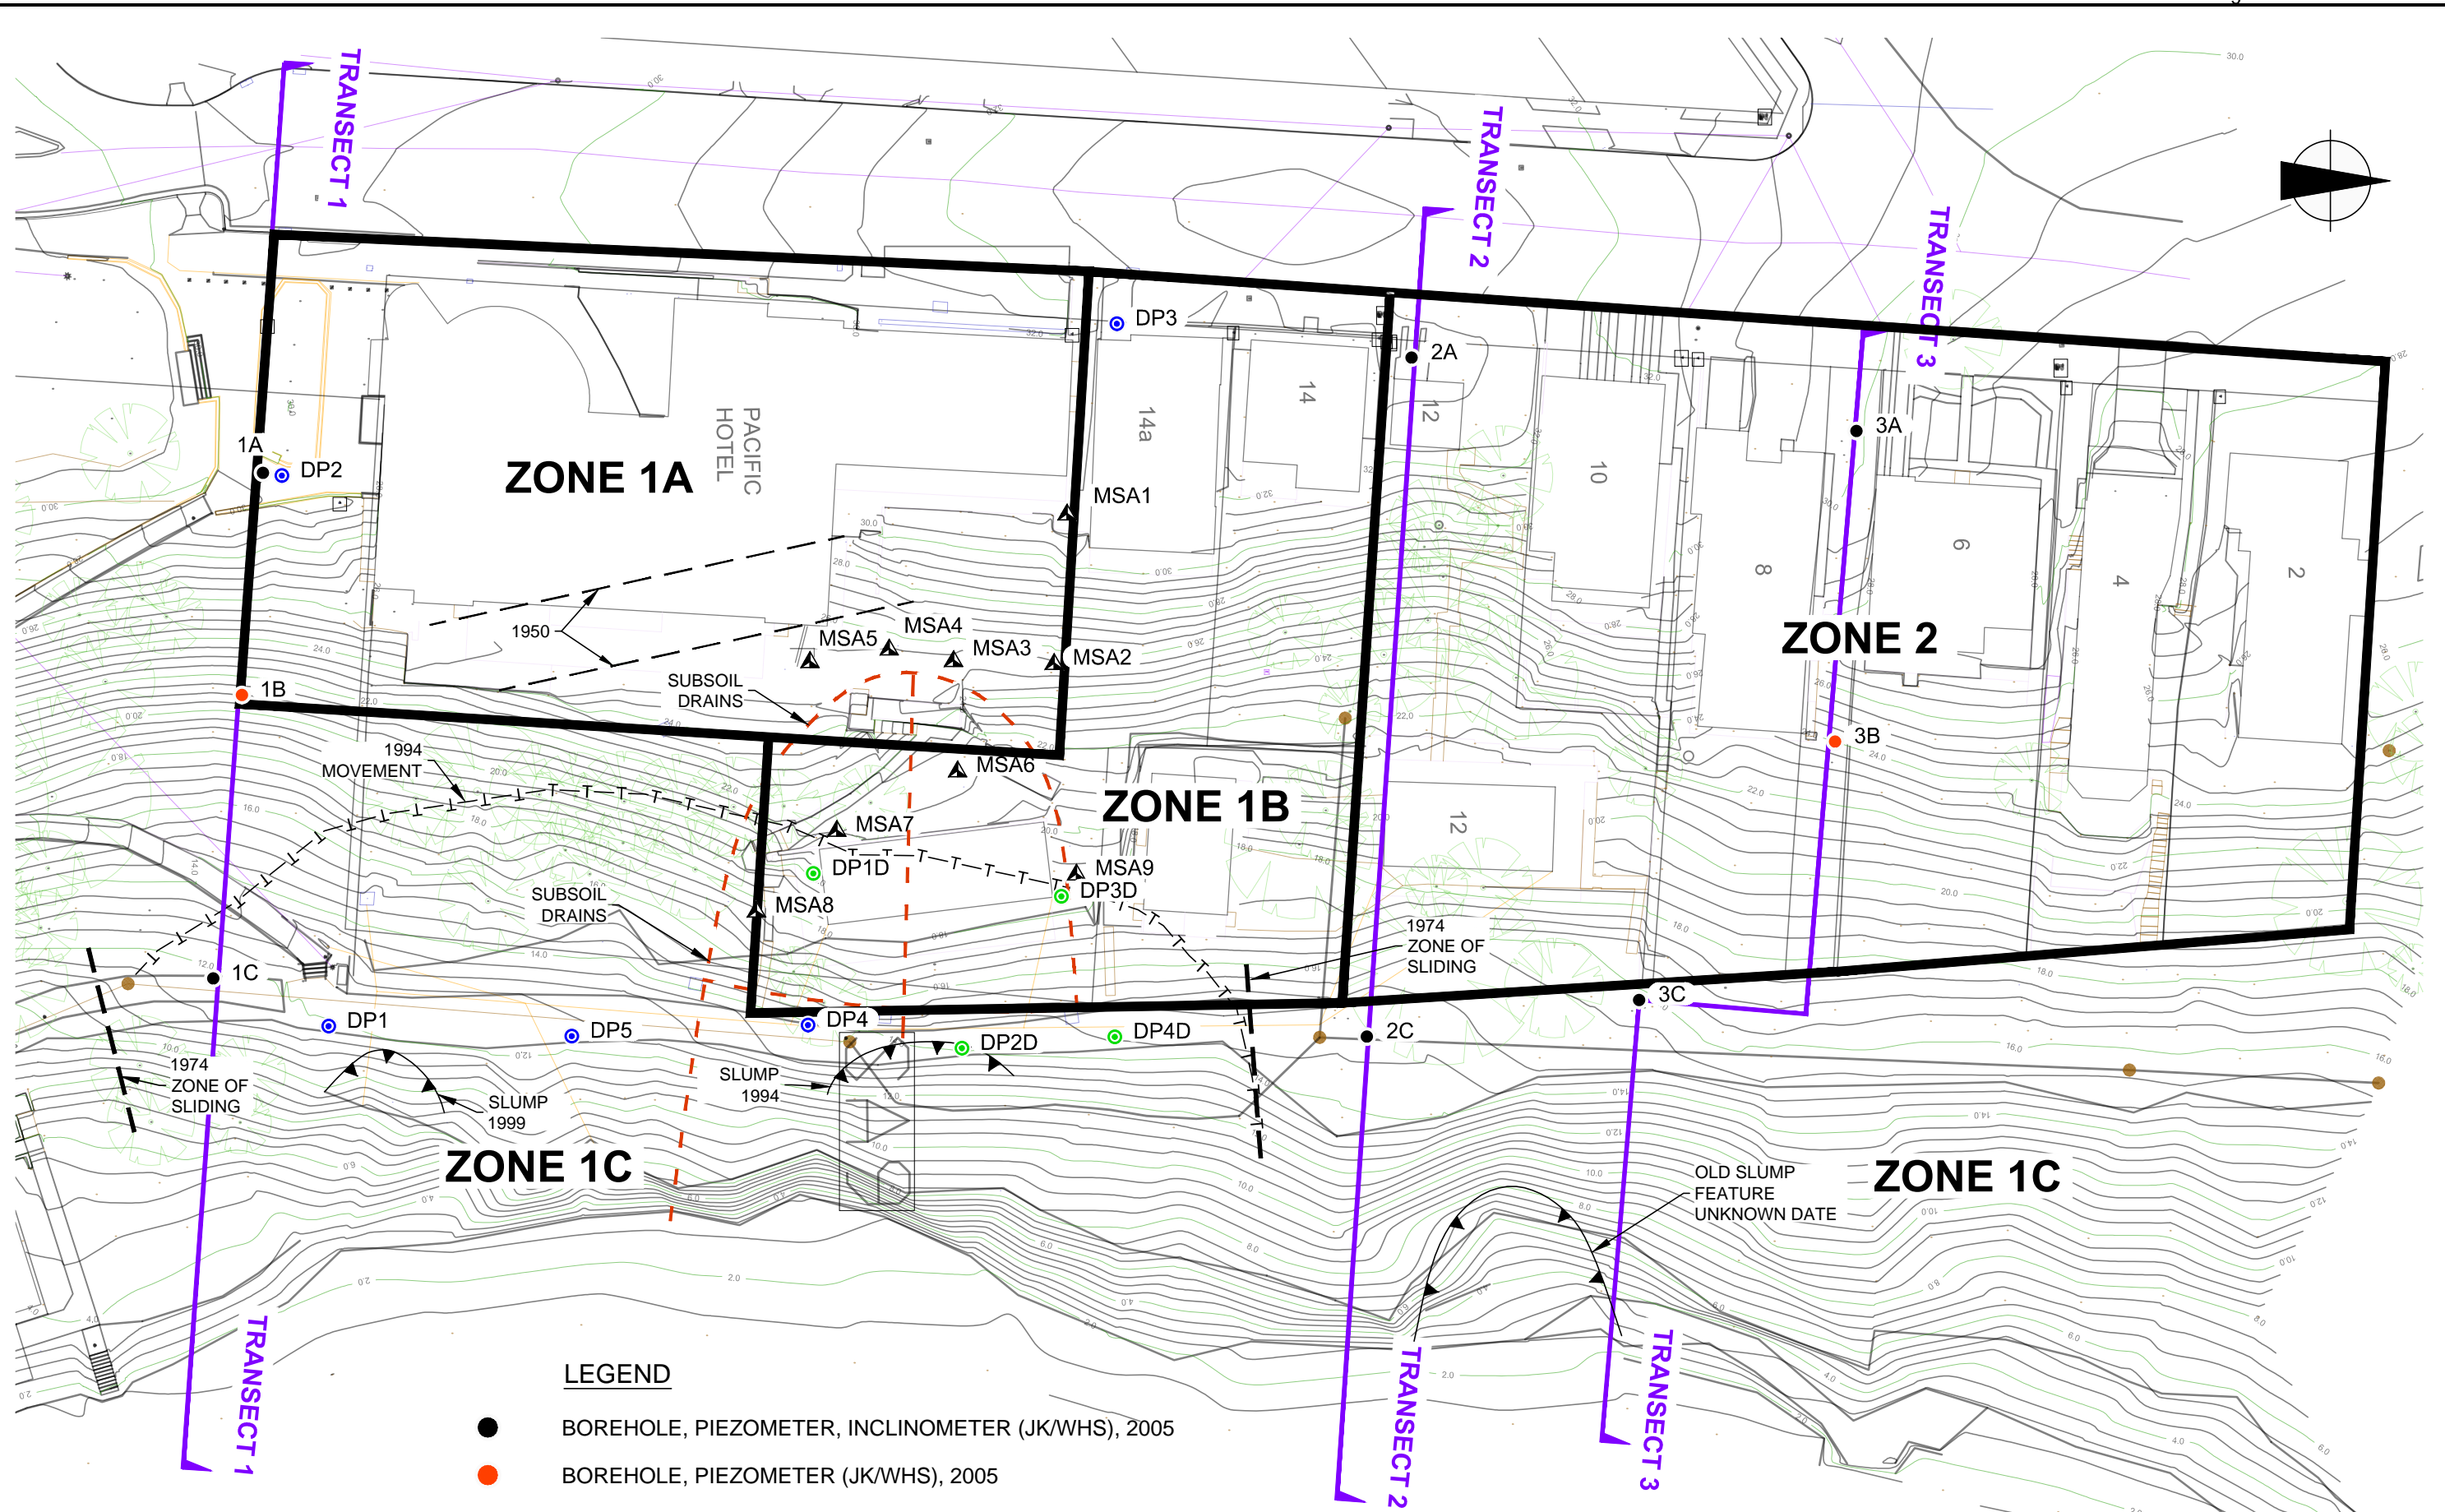
Title: PLAN SHOWING PREVIOUS SLIPS & SUBSOIL DRAINS	
Location: PILOT HILL YAMBA, NSW	
Report No: 19314L3	Figure No: 3
JK Geotechnics

The location of known earthslides within the study area are shown on Figure 3. These include the earthslides located at the toe of the slopes in 1994 and 1974.

Some of the known landslide events discussed above were within the study area and have been plotted on Figure 3. We provide the following commentary on these events.
