NORTHERN NSW COASTAL HAZARD ASSESSMENT

DESKTOP REVIEW

REPORT NO. 4063RMG02C
17 November 2023

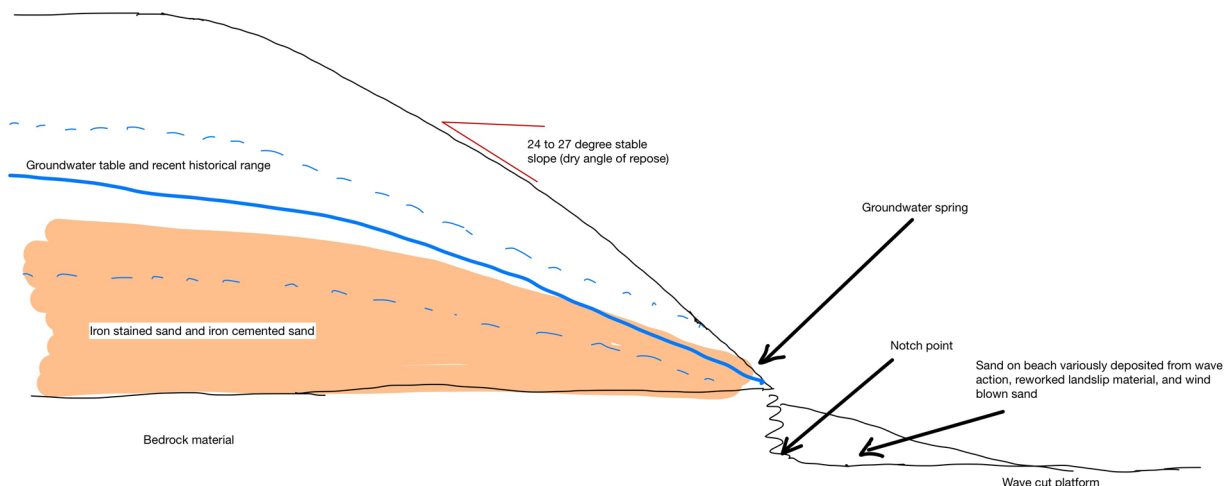
Figure 2-1 Schematic geological section of site based on typical features for this type of geological system

Based on the regional geological context, a sketched schematic cross section of what the local site geology is expected to comprise is given in Figure 2-1. The site is expected to comprise a dune with a seaward facing slope, with groundwater discharging from the toe of the slope from an unconfined groundwater table. The slope is defined by the dry angle of repose of the sand which is typically between 24° to 27° for fine quartz sand. The water table comprises a mound of water within the sand dune which forms an unconfined aquifer; the water table will typically fall towards the discharge point due to streaming effects. For Pilot Hill this will discharge towards the east and north-east, for Convent Beach to the north-east.

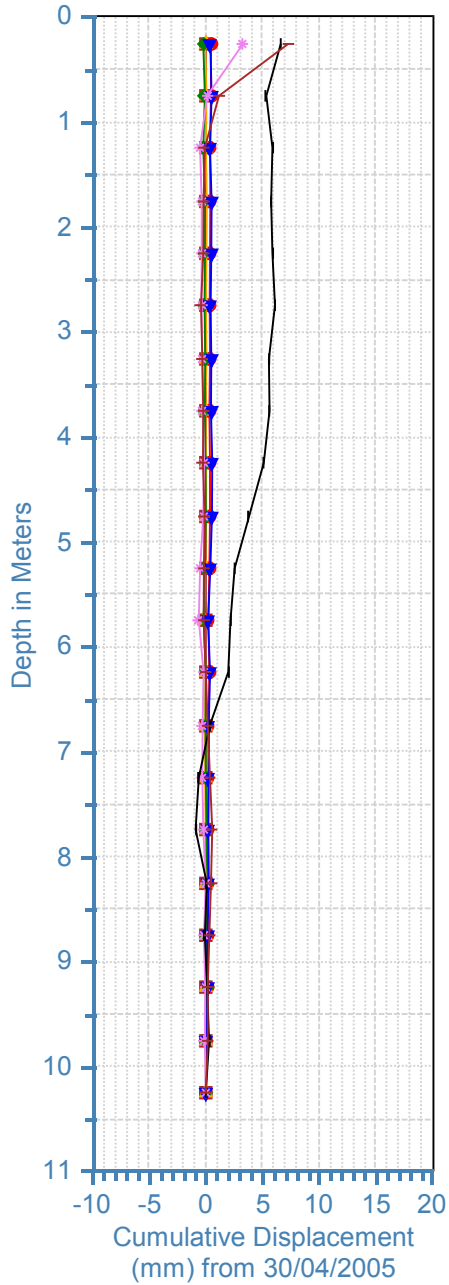
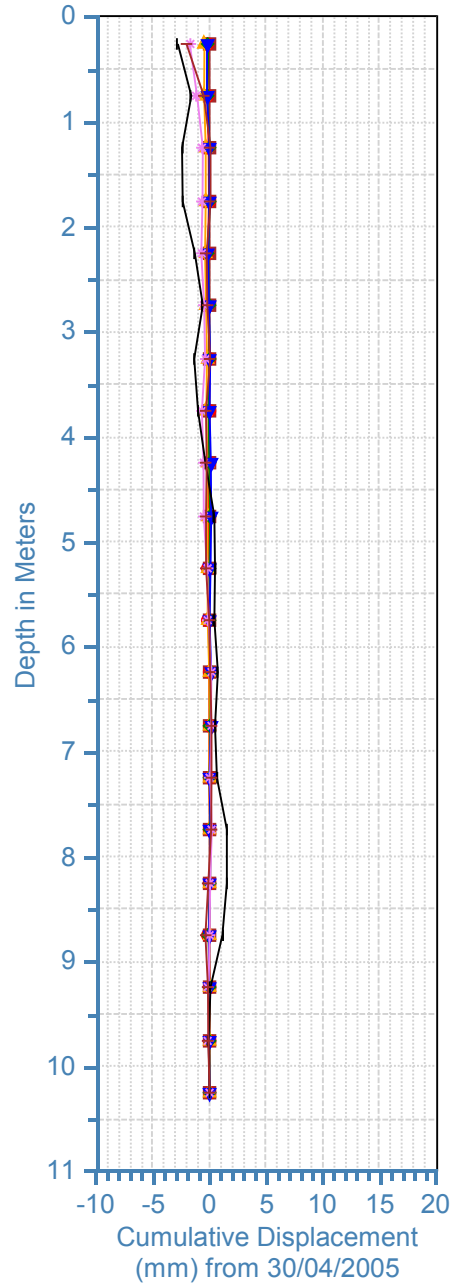
19314L3 INCL3A, A-Axis

Six 70mm PVC inclinometers were installed by JK Geotechnics in 2005 that were drilled through the sand dune materials and socketed into the underlying sandstone bedrock. Monitoring of these inclinometers is infrequent with three readings in 2005, one each in 2006, 2007, 2014, 2016 and 2021; however, it appears that not all the inclinometers have been read at the same time. Copies of the inclinometer data from the JK Geotechnics report are included in Appendix A. It is noted that only inclinometers 2C and 3C show any indication of long-term slope displacement of about 15mm to 20mm over the monitoring period. This movement is occurring within the upper 2m to 3m of the subsurface profile and at the interface between the silty sand and sandy clay layer. Over the period of time that these measurements were recorded, these movements are evidence of very slow to slow creep movement occurring at these locations. It was noted during the last set of measurements that readings could no longer be undertaken in 1A and 2C due to possible blockages. This report attributes the inability to read the instruments to movement within the slope and possible surface damage, but does not indicated how they arrived at this conclusion. The single large movement in 3A in 2016 before a return to previous values in the most recent

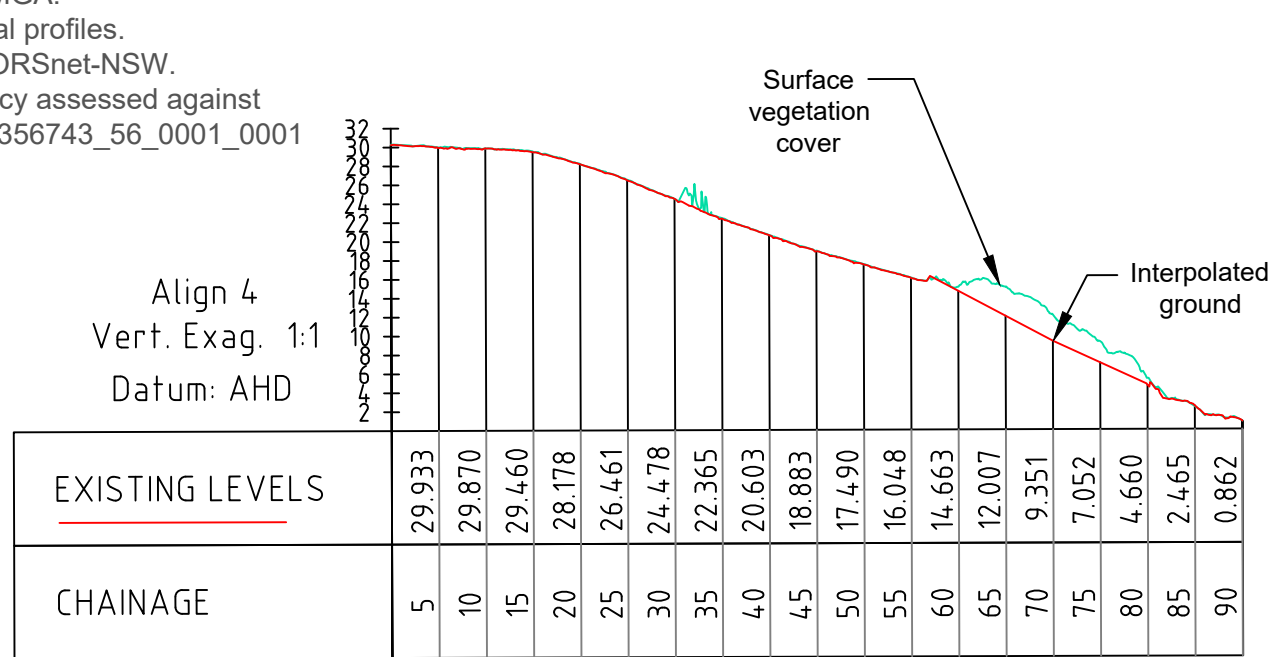
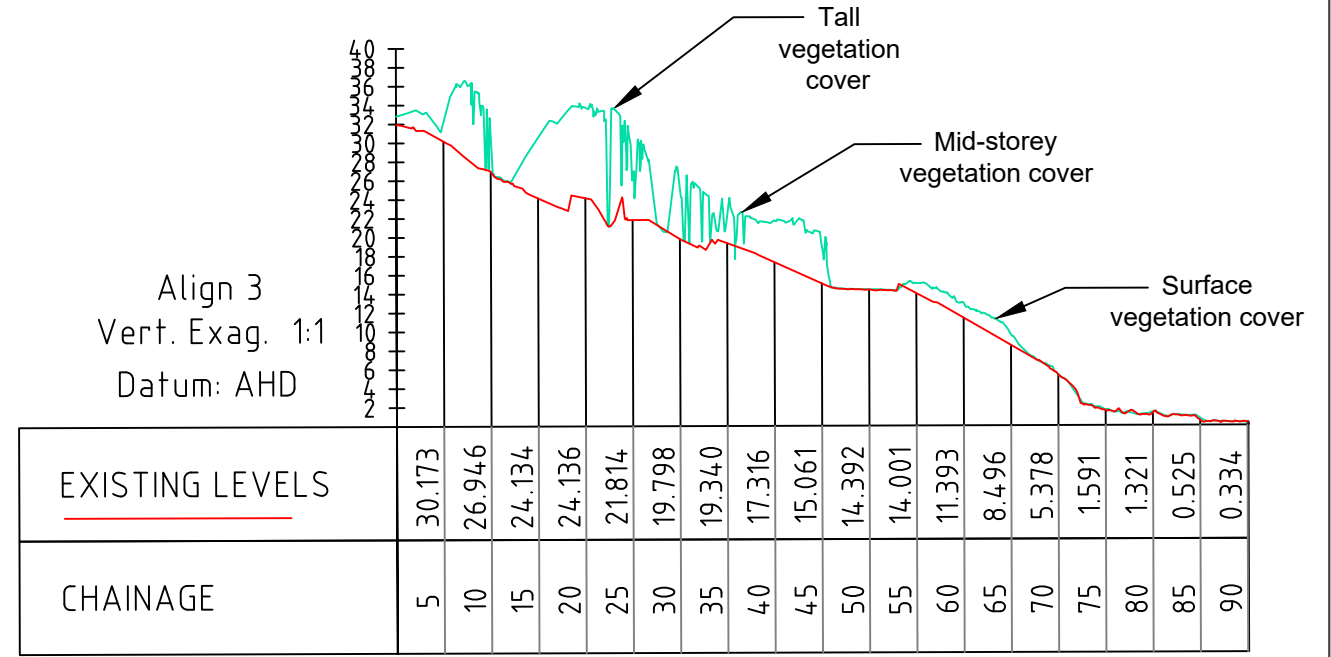
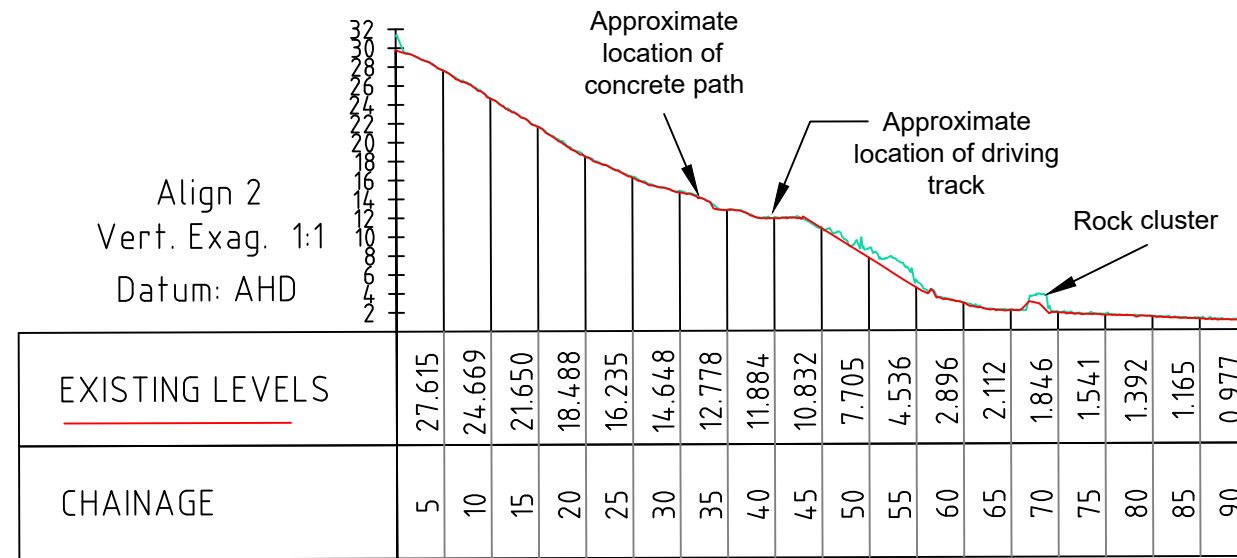
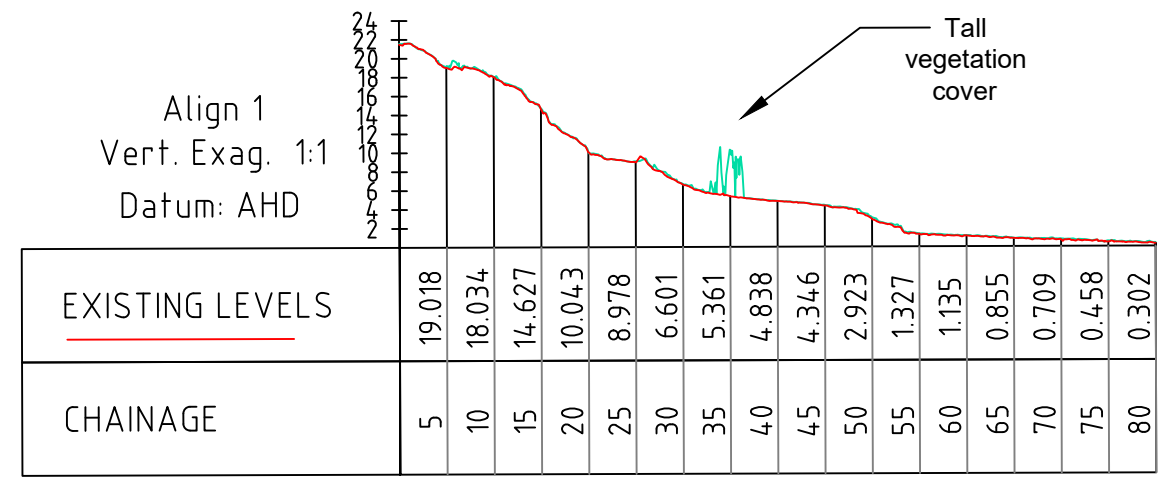
FIGURE 4

- Align 1 – This section is across part of Marine Pde south of the SLSC where the slope has been modified for the installation of a carpark, this section is not representative of the natural conditions;
- Align 2 – Toe slope angle of 32.2° over a vertical height of 6.3m, this section of the slope failed three months after the LiDAR survey;
- Align 3 – Toe slope angle of 29.9° over a vertical height of 8.6m, this section corresponds to Transect 2;
- Align 4 – Toe slope angle of 26.6° over a vertical height of 10m, this section corresponds to Transect 3.

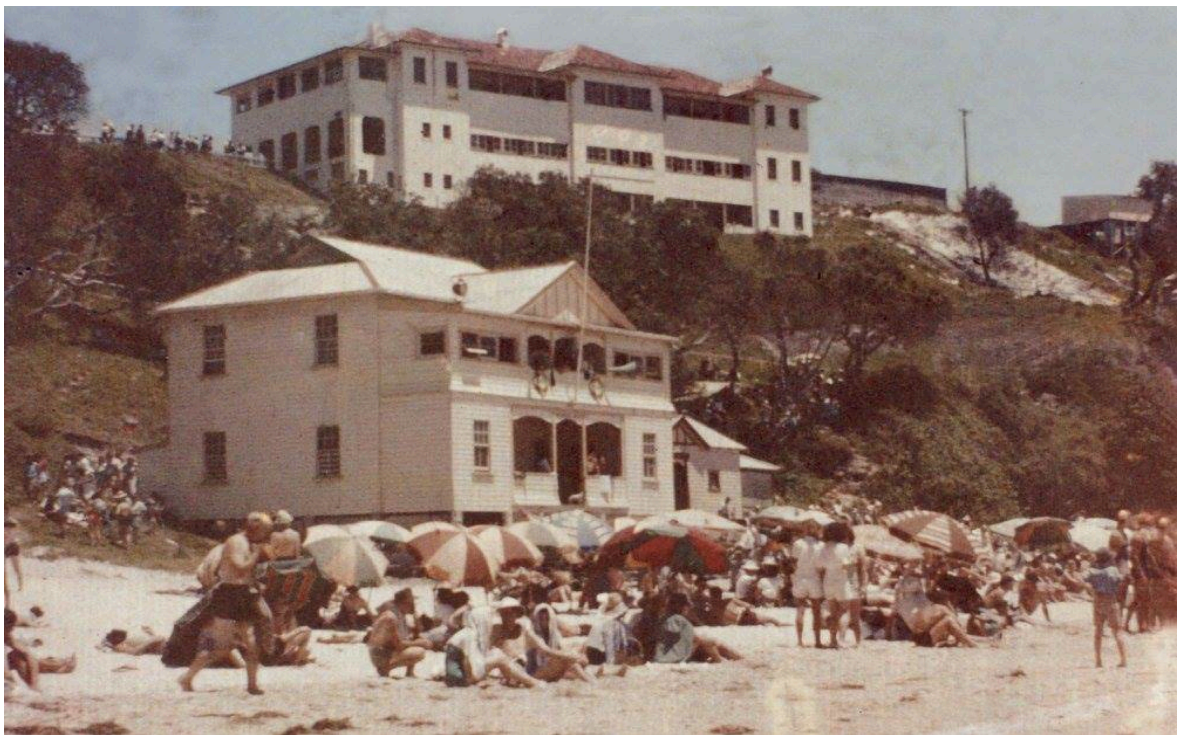
Surf life saving club and Pacific Hotel, photograph taken between 1950 and 1954, prior to slope failure
