Brooms Head Beach and Lake Cakora Coastal Zone Management Plan (CZMP)

Project Name:	Brooms Head Lake Cakora Coastal Zone Management Plan (CZMP)		
Project Number:	30011071		
Report for:	Clarence Valley Council

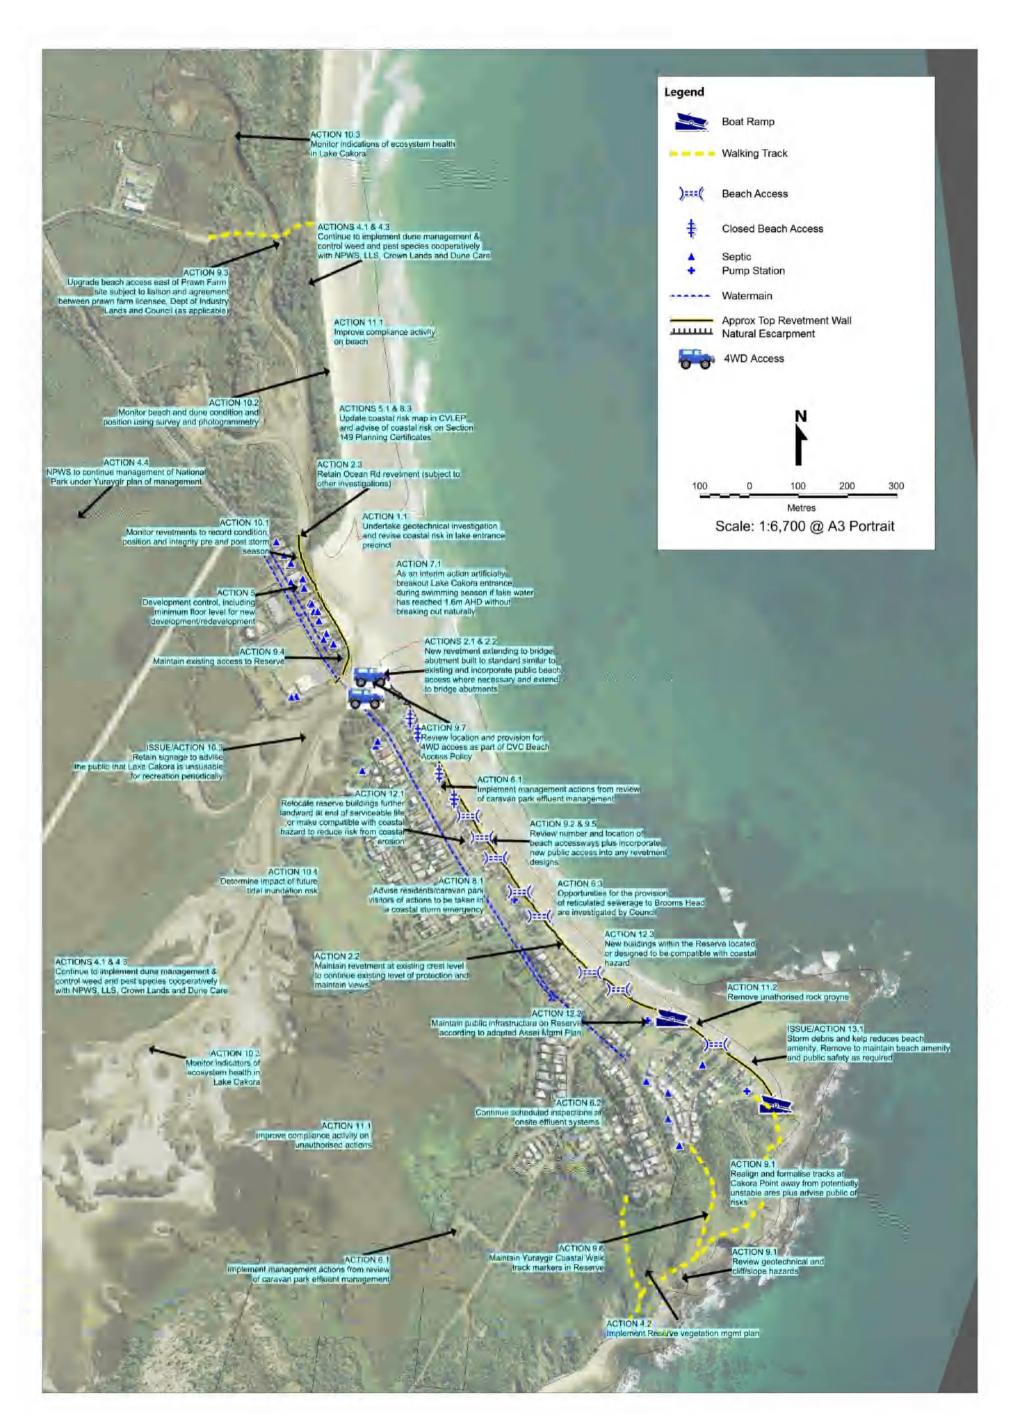
Figure ES-1 Management Actions for Brooms Head

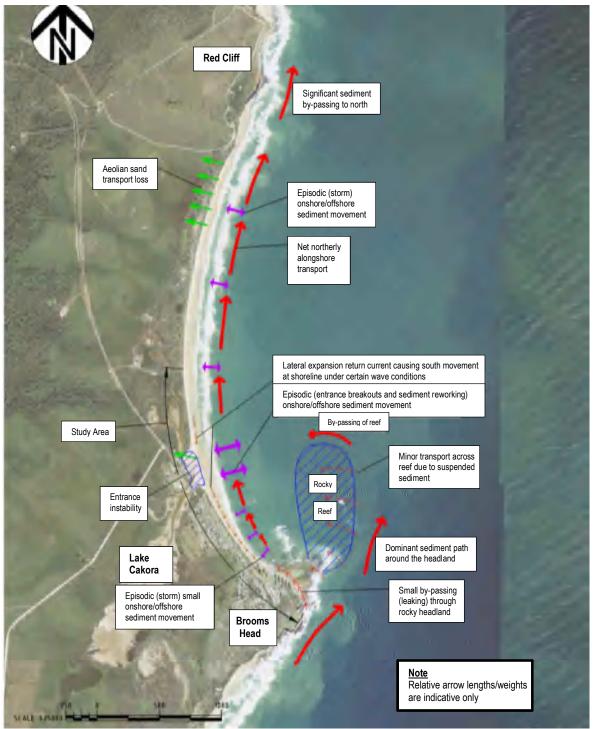
The conceptual model illustrated in *Figure 3* summarises coastal processes affecting Brooms Head Beach. The primary hazards affecting Brooms Head are:

- Storm Erosion
- Oceanic inundation during storm events
- Ongoing long-term recession of the beach
- Predicted rise in ocean level potentially bringing increased inundation and erosion.

Figure 3 Conceptual Processes Model for Brooms Head Beach

The *Coastal Hazard Study* (SMEC 2013b) concludes that a net northwards littoral sand movement exists at Brooms Head, based on the following.

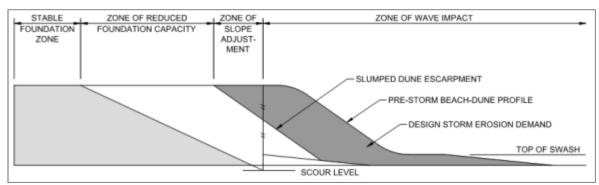
For an unconsolidated (erodible) sandy shoreline, a number of coastline hazard zones can be delineated based on Nielsen *et al* (1992) (refer to *Figure 4*).

Figure 4 Schematic Representation of Coastline Hazard Zones (Nielsen et al 1992)

Taking into account the adopted values for storm demand (40-220 m³/m), estimated width of the zone of reduced foundation capacity (7 to 9 m) and shoreline recession, hazard maps were produced for Brooms Head Beach indicating the immediate hazard line and 2050 and 2100 hazard lines. The hazard lines (i.e. the position of the slumped erosion escarpment due to a major storm event in the vicinity of Brooms Head) take into account shoreline recession due to sand loss from the beach compartment and Sea Level Rise.

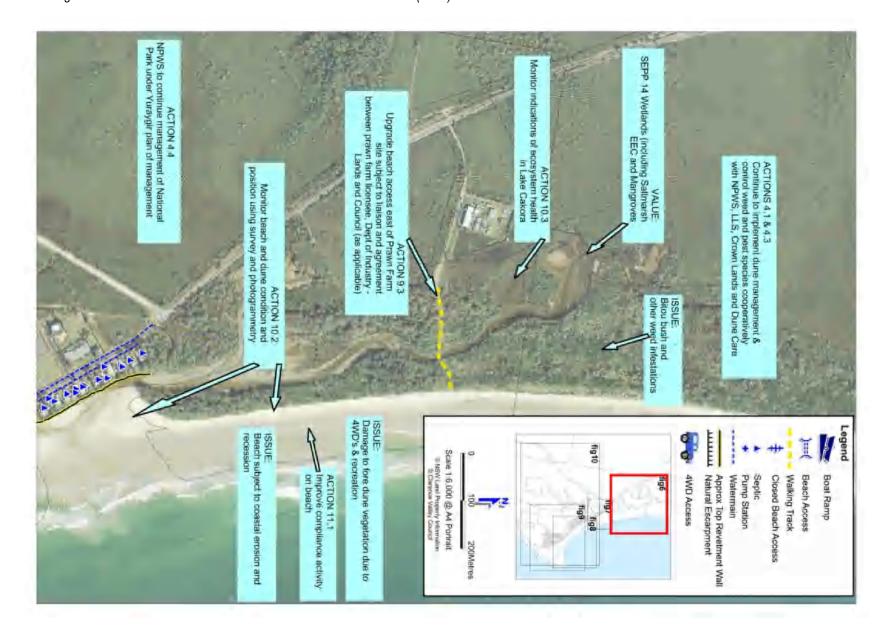
Figure 6 Issues and management actions for the Northern Beach Precinct and Lake Cakora (north)

- Figure 6 details the issues and management actions for the Northern Beach Precincts and Lake Cakora (north).
- Figure 7 details the issues and management actions for the Lakes Entrance Precinct.
- Figure 8 details the issues and management actions for the Foreshore Reserve (North) Precinct.
- Figure 9 details the issues and management actions for the Foreshore Reserve (South) and Cakora Point.
- Figure 10 details the issues and management actions for Lake Cakora (South).

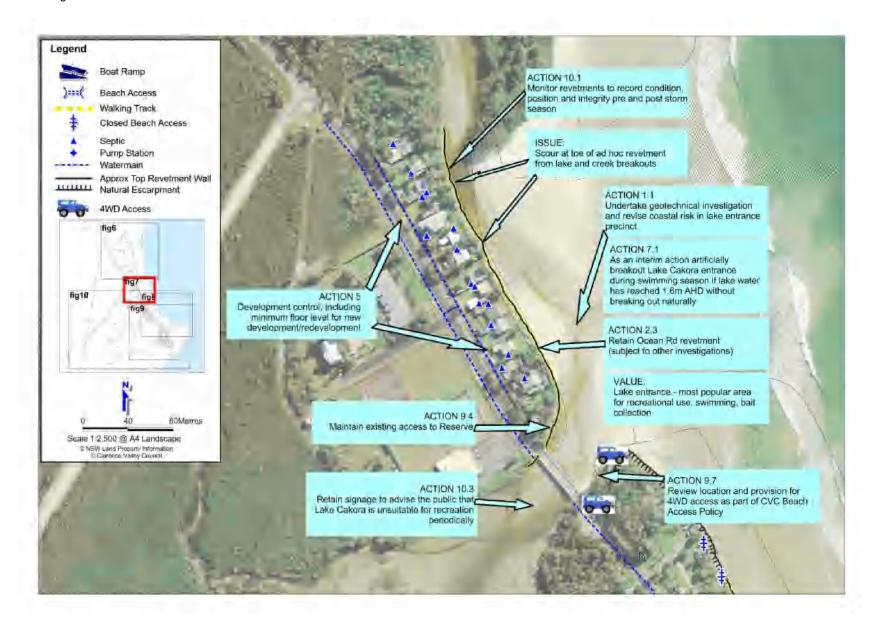
Figure 7 Issues and management actions for the Lake Entrance Precinct

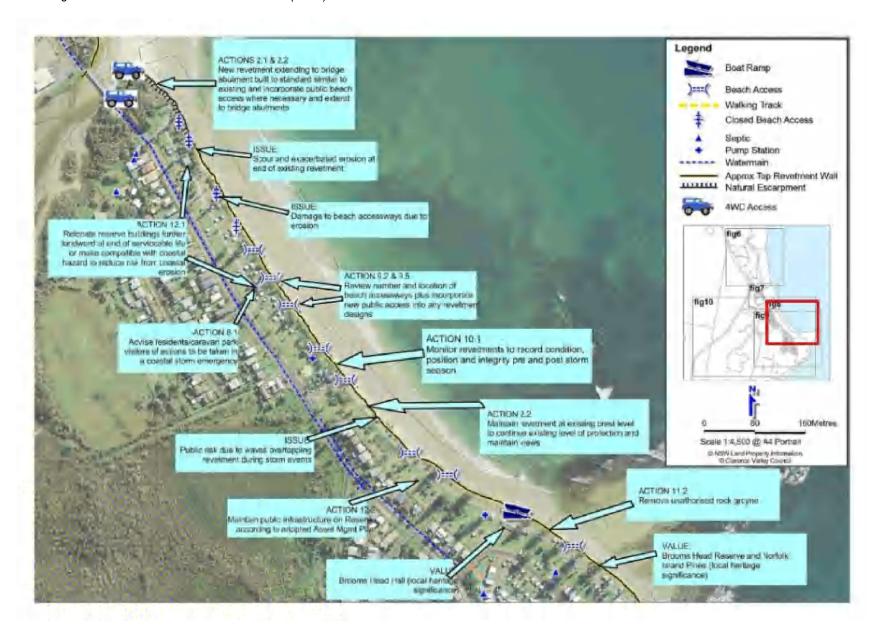
Figure 8 Issues and management actions for the Foreshore Reserve (North) Precinct

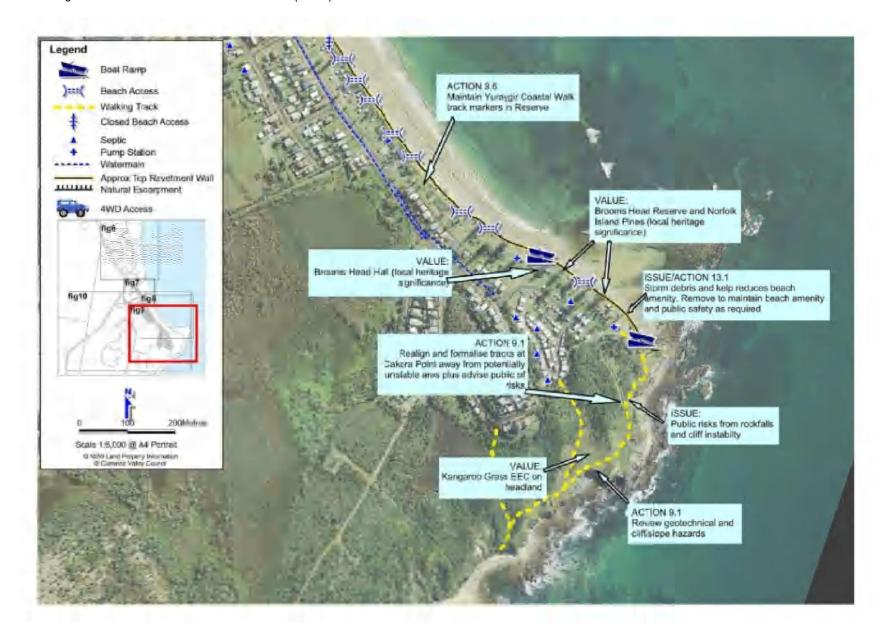
Figure 9 Issues and management actions for the Foreshore Reserve (South) and Cakora Point

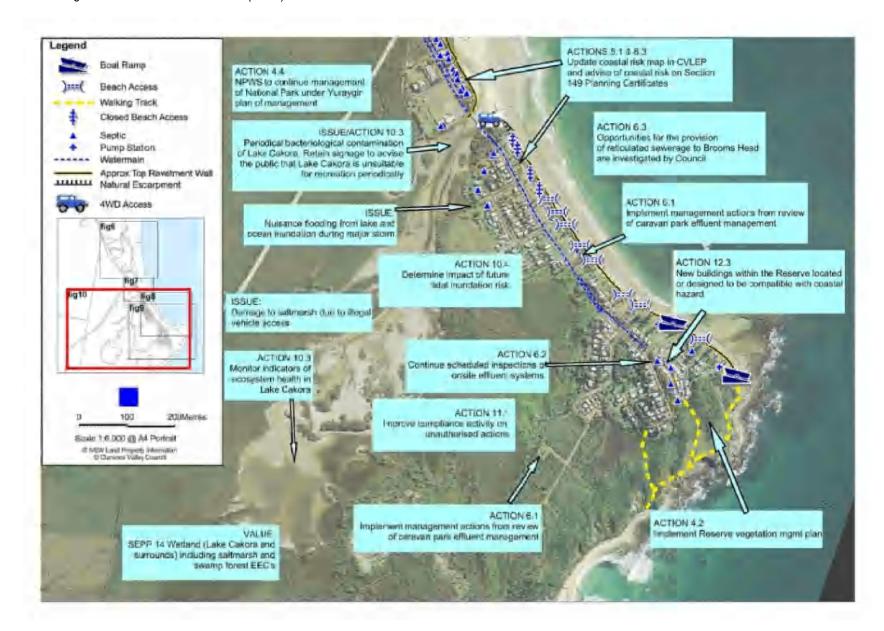
Figure 10 Issues and management actions for Lake Cakora (south)

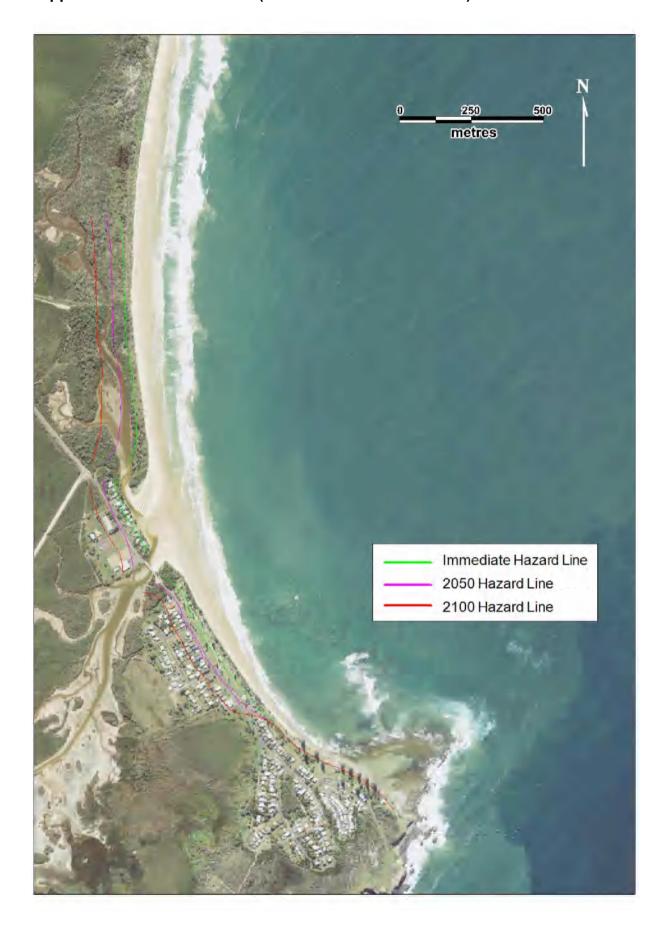
Appendix A1 – Hazard Lines (Rock Revetments Erodible)

Figure A1 (see Appendix A) indicates the position of the hazard lines, ignoring protection provided by the foreshore reserve revetment (see Plate 1) and the ad hoc Ocean Road revetment. Table 4 lists assets at risk under this scenario.

As shown in *Figures A1* and *A2*, in the event of the design storm (which may comprise a series of storms), the spit to the north of the entrance would be eroded and may eventually be breached, with the landward bank of the creek becoming the new shoreline over time. This would leave properties along Ocean Road more exposed to ocean storms from the north.

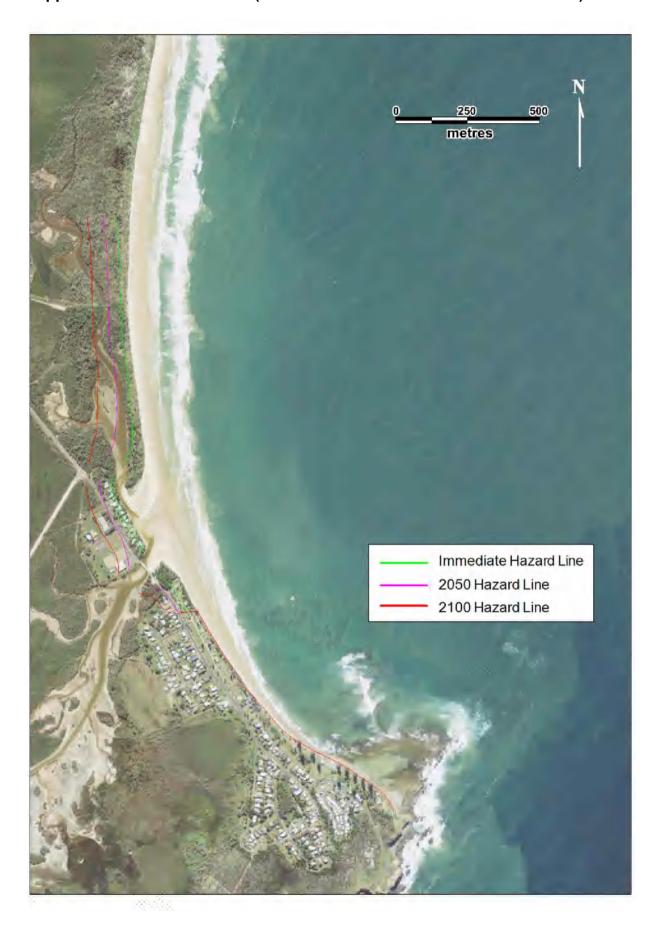
Appendix A2 – Hazard Lines (Foreshore Reserve Revetment Maintained)

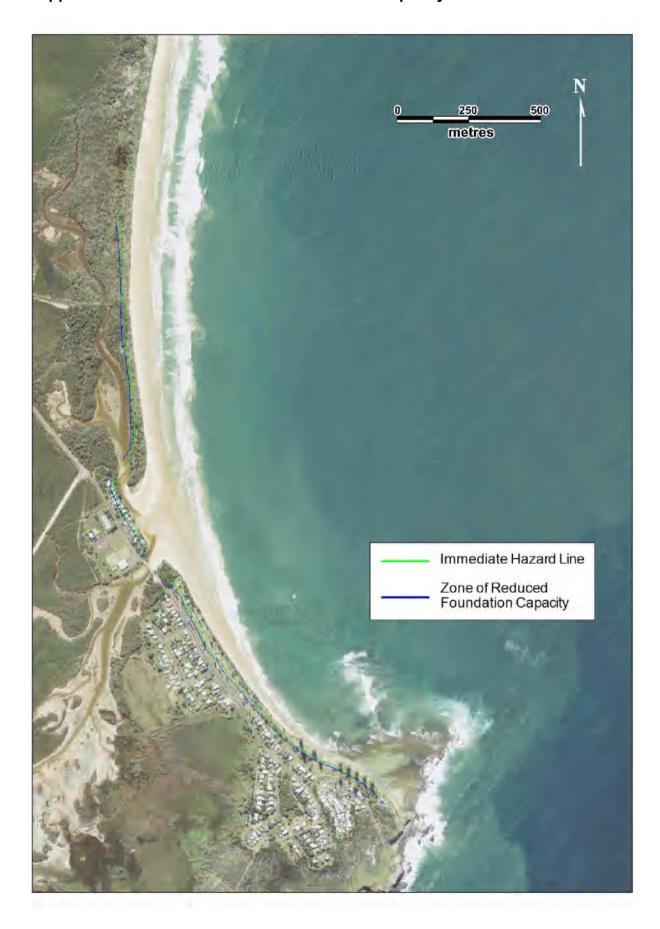
Appendix A3 - Zone of Reduced Foundation Capacity

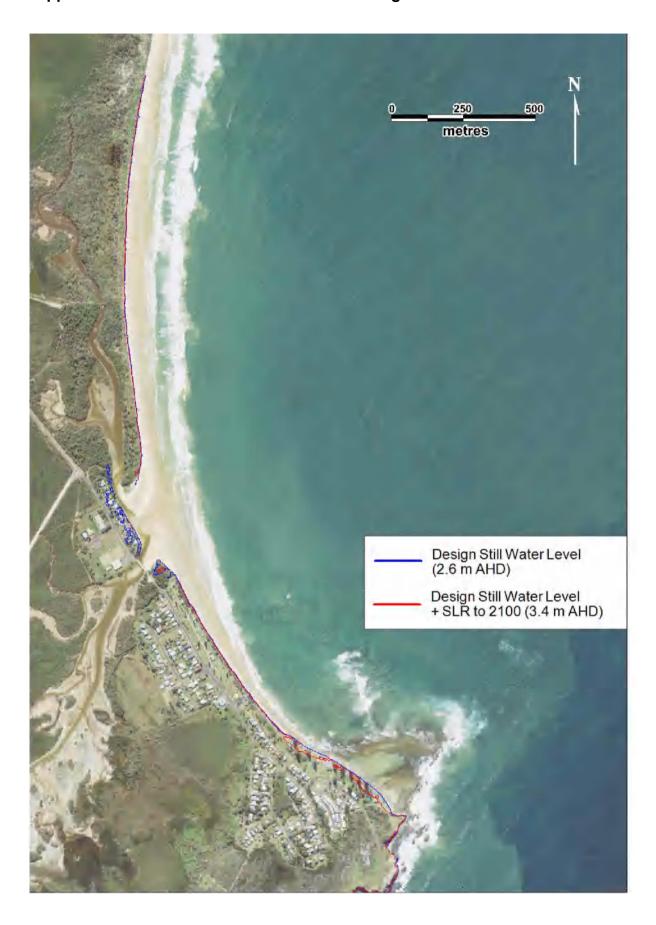
Appendix A4 — Coastal Inundation due to Design Still Water Levels

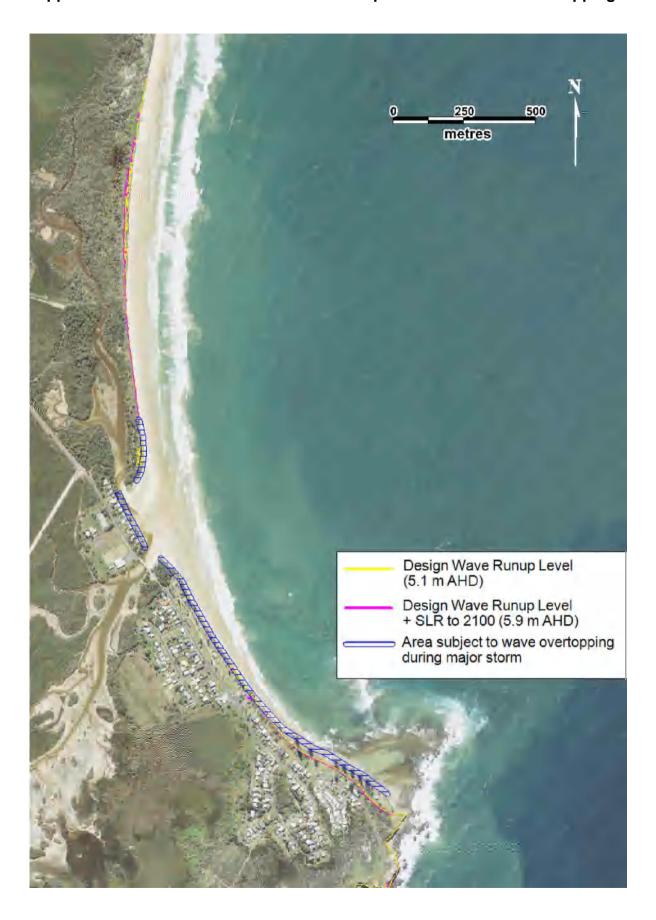
Appendix A5 - Inundation due to Wave Runup Levels and Wave Overtopping

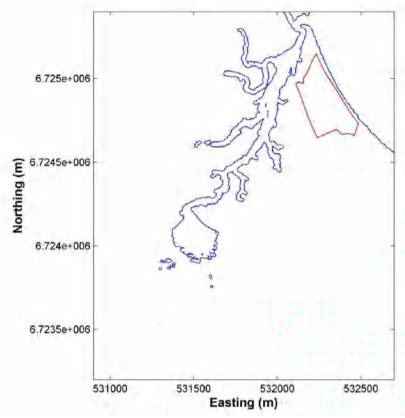
Note: red box shows urban area immediately south of the bridge.

Figure B.1 Flood extent for 1 m water level.

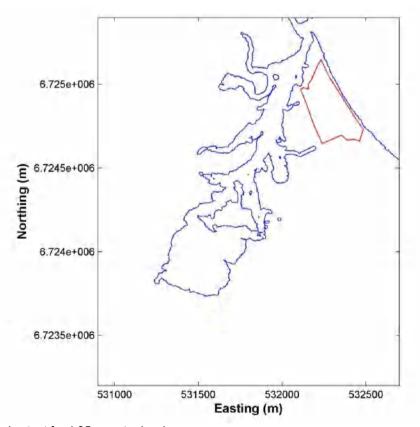
Figure B.2 Flood extent for 1.25 m water level.

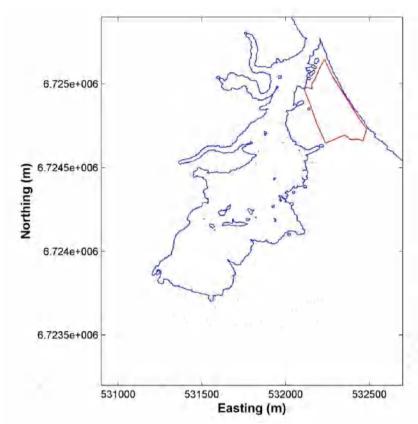
Figure B.3 Flood extent for 1.5m water level.

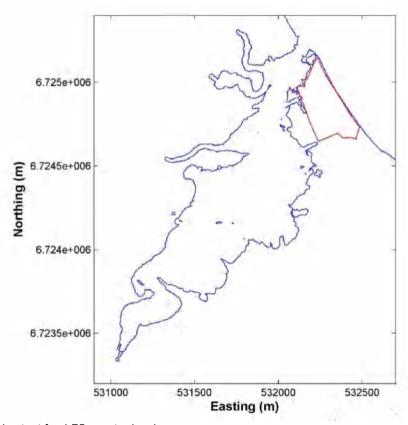
Figure B.4 Flood extent for 1.75m water level.

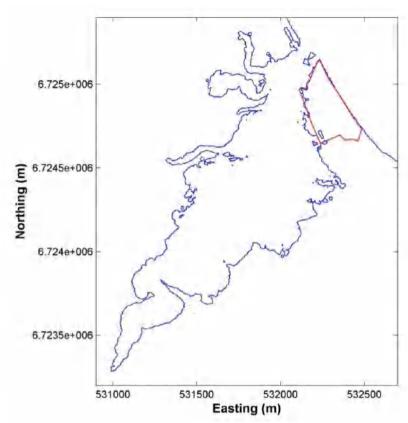
Figure B.5 Flood extent for 2.0m water level.

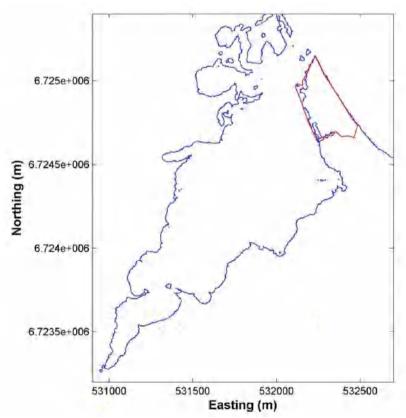
Figure B.6 Flood extent for 2.25m water level.

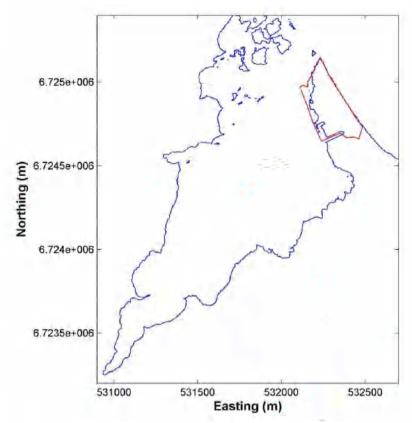
Figure B.7 Flood extent for 2.5m water level.

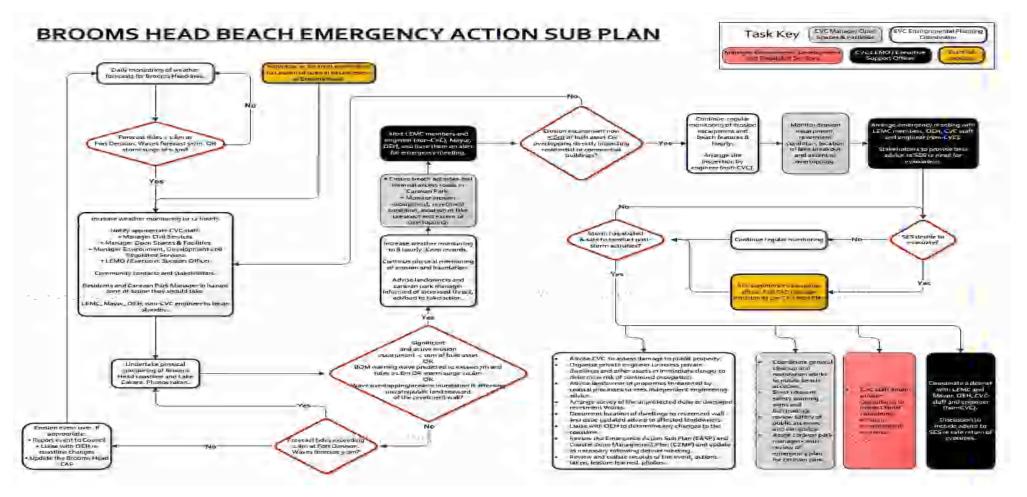
APPENDIX 1. FLOW CHART REPRESENTING THE BROOMS HEAD MAIN BEACH EASP

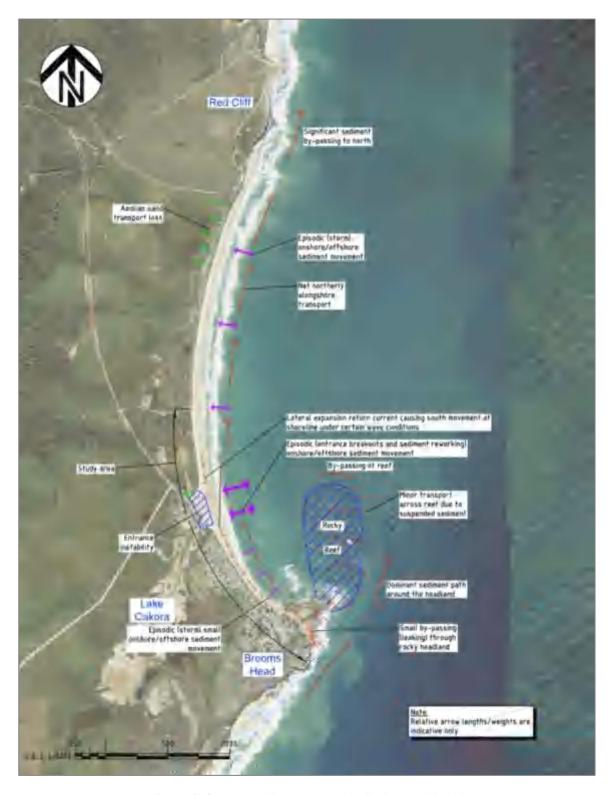
The conceptual model illustrated in *Figure 3* summarises coastal processes affecting Brooms Head Beach. Refer to the *Coastal Processes and Hazards Report* (SMEC 2013b) for more information.

Figure 3 Conceptual Processes Model for Brooms Head Beach

Although available data is limited, net sediment transport along Brooms Head Beach is assumed to be to the north (as shown in *Figure 3*), consistent with the net northerly sediment transport regime along the northern NSW coast. The *Coastal Hazard Study* (SMEC 2013b) concluded this, based on the following.

As shown in *Figure 3*, during ambient conditions, sediment movement to the south would occur close to the shoreline due to lateral expansion return currents generated by the differential in wave heights along the beach (i.e. larger wave heights away from the influence of the rocky reef).

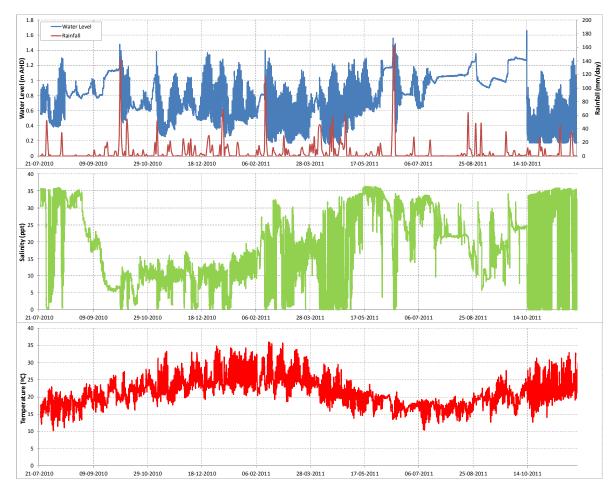
Analysis of water level and salinity data between July 2010 and November 2011 from the automatic recorder in Lake Cakora, indicated that the highest breakout level was about 1.7 m AHD on 13 October 2011, see *Figure 4*. This information, along with rainfall measured at the BoM Yamba Pilot Station between July 2010 and November 2011 (closest location where data was available for the same time period), was also used to determine when the lake entrance opened and to estimate the duration it remained open.

Figure 4 Lake Water Levels, Salinity, Temperature and Rainfall (Yamba Pilot Station) Jul 2010 – Oct 2011

During the months of July, August and September the entrance generally remained closed, corresponding with the period of lowest rainfall over the year. Between October and February the entrance opened and closed most frequently, this correlated with the higher rainfall rates experienced over the spring and summer months. Between July 2010 and November 2011 the entrance was open on 16 occasions, with it being open for more time than it was closed over the period. Over this 16 month period, the duration the entrance remained open varied from 2 to 58 days. In September 2012 the entrance closed and it was reported that it remained closed for more than 70 days. In general, Lake Cakora entrance breakouts occur as a result of high rainfall in the previous 1-2 days.

As shown in *Figure 4*, water levels varied from just under 0.2 m AHD to 1.63 m AHD. Salinity ranged from just over 35 parts per thousand (ppt), which is the average salinity of sea water, to zero during rainfall peaks. Temperature ranged from 10°C in July to just over 35°C in February and showed a general seasonal variation. A temperature spike in November 2010 (about 34°C) corresponded to a period of low water level (i.e. shallow water depths).

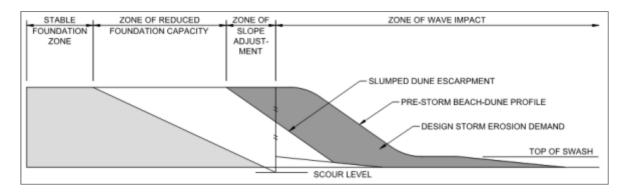
For an unconsolidated (erodible) sandy shoreline, a number of coastline hazard zones can be delineated based on Nielsen *et al* (1992) (refer to *Figure 5*).

Figure 5 Schematic Representation of Coastline Hazard Zones (Nielsen et al 1992)

Taking into account the adopted values for storm demand (40-220 m³/m), estimated width of the zone of reduced foundation capacity (7 to 9 m) and shoreline recession, hazard maps were produced for Brooms Head Beach indicating the immediate hazard line and 2050 and 2100 hazard lines. The hazard lines (i.e. the position of the slumped erosion escarpment due to a major storm event in the vicinity of Brooms Head) take into account shoreline recession due to sand loss from the beach compartment (up to 23.4 m and 53.4 m along the Northern Beach by 2050 and 2100 respectively) and Sea Level Rise (SLR)(up to 20 m and 45 m by 2050 and 2100 respectively).

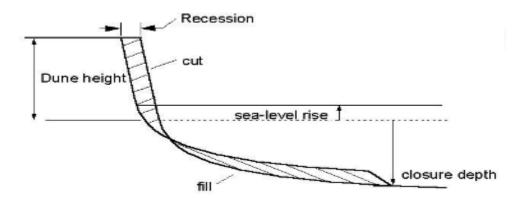
Long term recession due to SLR was based on planning benchmarks of a 0.4 m rise by 2050 and further 0.5 m rise by 2100 relative to the 1990 mean sea level consistent with Councils climate change policy. Recession due to SLR was calculated using the Bruun Rule described further in the *Coastal Processes and Hazard Study* (SMEC 2013b) and can be seen in *Figure 6*.

Figure 6 Schematic Representation of Shoreline Recession (Bruun 1983)

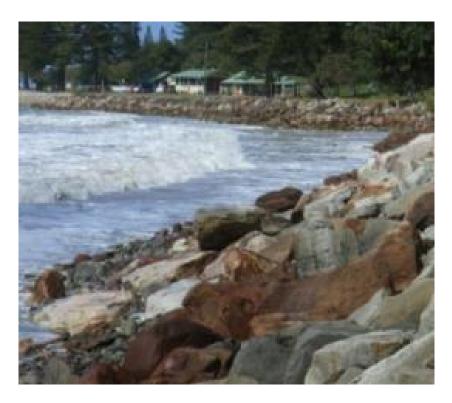
Plate 1 Foreshore Reserve Revetment (22/8/2011)

No design details for the original foreshore reserve revetment are available, however, sections have failed in the past in conditions more benign than would be expected during a major storm event. Dislodged/ loose rocks have also been observed which suggest the rock armour is undersized. Although most of the original revetment has been rebuilt using locally available rock, the rock armour size and quality would not meet design standards for the 1 in 100 ARI storm event and hence the structure would be likely to fail during a major storm event. Failure occurs when sand is scoured out under the toe of the revetment and the rock armour slumps. Slumping of the foreshore reserve revetment would still provide some toe protection during the design storm, which would limit the extent of foreshore erosion. Accordingly, in reality, this would mean that the position of the current hazard line along the protected section of the foreshore reserve would be closer to that shown in *Figure A2*. A further hazard may result from smaller rocks being tossed around by waves in a severe storm event see *Plate 4*. *Plate 1* shows a section of the foreshore reserve revetment north of the northern boatramp which has been subject to repairs.

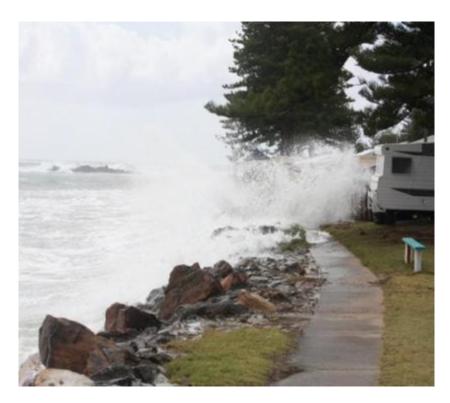
Plate 2 Wave overtopping at southern end of caravan park 25/12/2011 (Mr Mark Cameron)

Plate 2 taken along the foreshore reserve shows a significant wave overtopping event on 25th December, 2011. This event peaked with a significant wave height (H_s) of 3.6 m which coincided with a 'king' tide of 1 m AHD (i.e. extremely high astronomical tide of around 1.8 m). Analysis of data from the closest wave rider buoy (Coffs Harbour), between May 1976 and 31st December, 2011 showed:

Accordingly, the Brooms Head Caravan Park could be affected by more severe overtopping events. Risks associated with 'green water' would include dangerous conditions for pedestrians walking along the footpath at the revetment crest. The stability of caravans and parked vehicles etc at foreshore sites would also be affected and potentially vehicles travelling along the loop road.

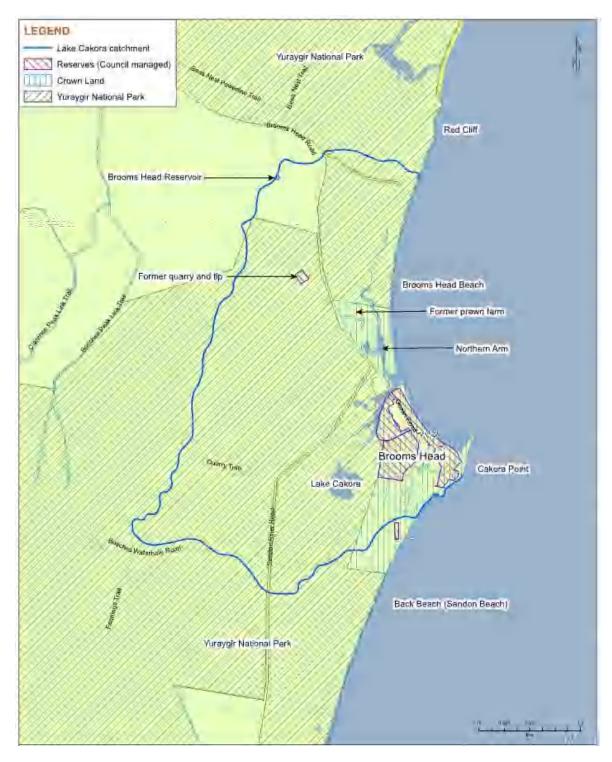
Figure 7 Land Tenure

As indicated in *Figure 7* the Brooms Head Village is surrounded by public lands mainly national park and crown land with a foreshore reserve fronting the lakefront properties along Ocean Road.
