From: Lynne Cairns [<mailto:blcairns@bigpond.com>]
Sent: Friday, 12 March 2021 2:54 PM
To: Ashley Lindsay; Council Email
Cc: Jim Simmons; Debrah Novak; 'spowelly POWELL'
Subject: Request for a Meeting with General Manager, Mayor, Cr Novak, Mr Powell and Mr and Mrs Cairns

From: Lynne Cairns
Sent: Thu, 25 Mar 2021 13:46:58 +1100
To: Council Email
Cc: 'spowelly POWELL'
Subject: First Email: Submission MOD2021/0016 and DA2021/0153
Attachments: Attachment 1 Front page_Summary.pdf, Attachment 2 Detailed information.pdf, Attachment 3 Photos.pdf, Attachment 4 Issues and breaches DA2019_0439 Conditions of Consent.pdf, Attachment 5 Details and signatures of those making Submission.pdf, Attachment 6 DA2019-0439 Notification Plan 19 Gumnut Road Yamba.pdf, Attachment 7 DA 2019-0439 Application DA assessment.pdf, Attachment 8 ECM_1996721_v1_DAP memo 19 Gumnut Rd Yamba DA2019 0439.pdf, Attachment 9 DA2019 0439 - Notice of Determination of Application - 19 Gumnut Road YAMBA NSW 2464 (1).pdf

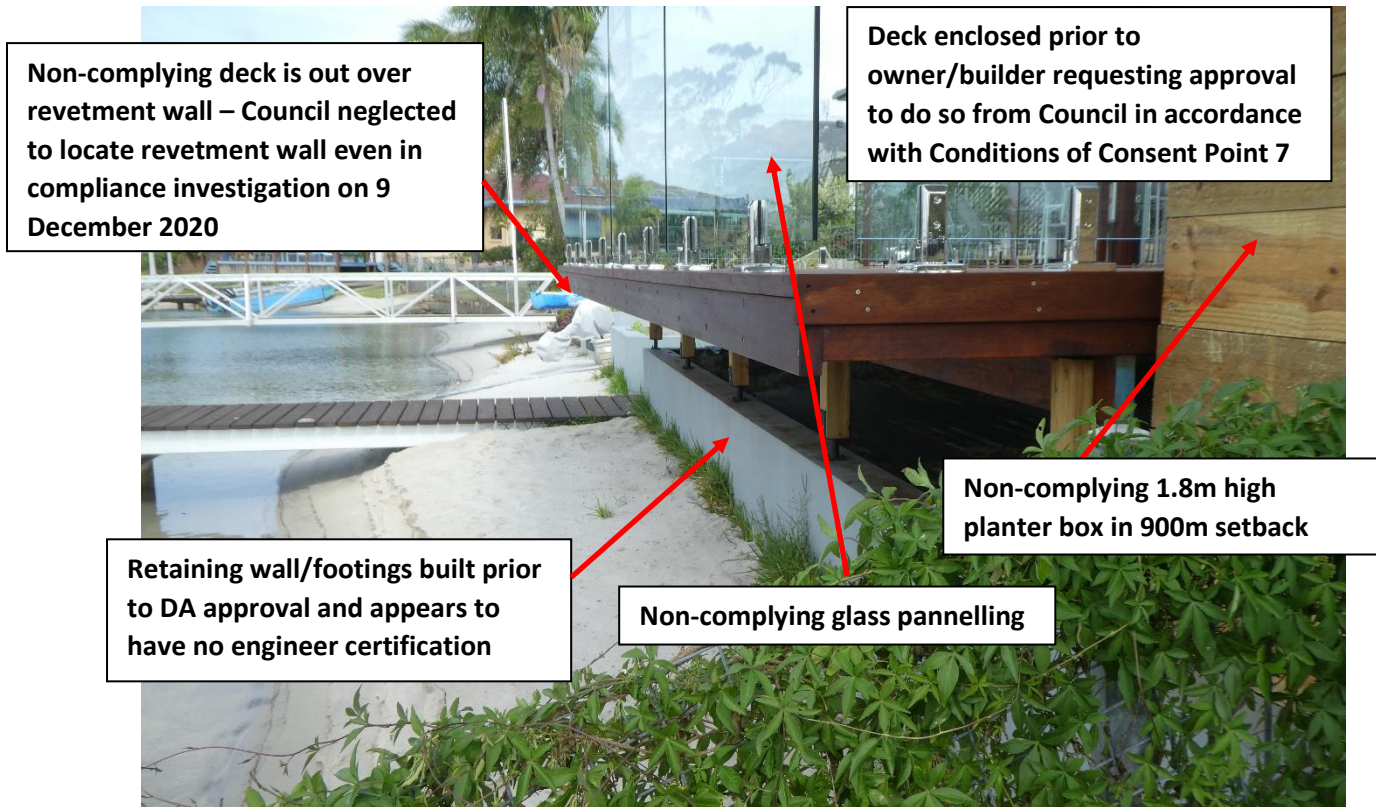
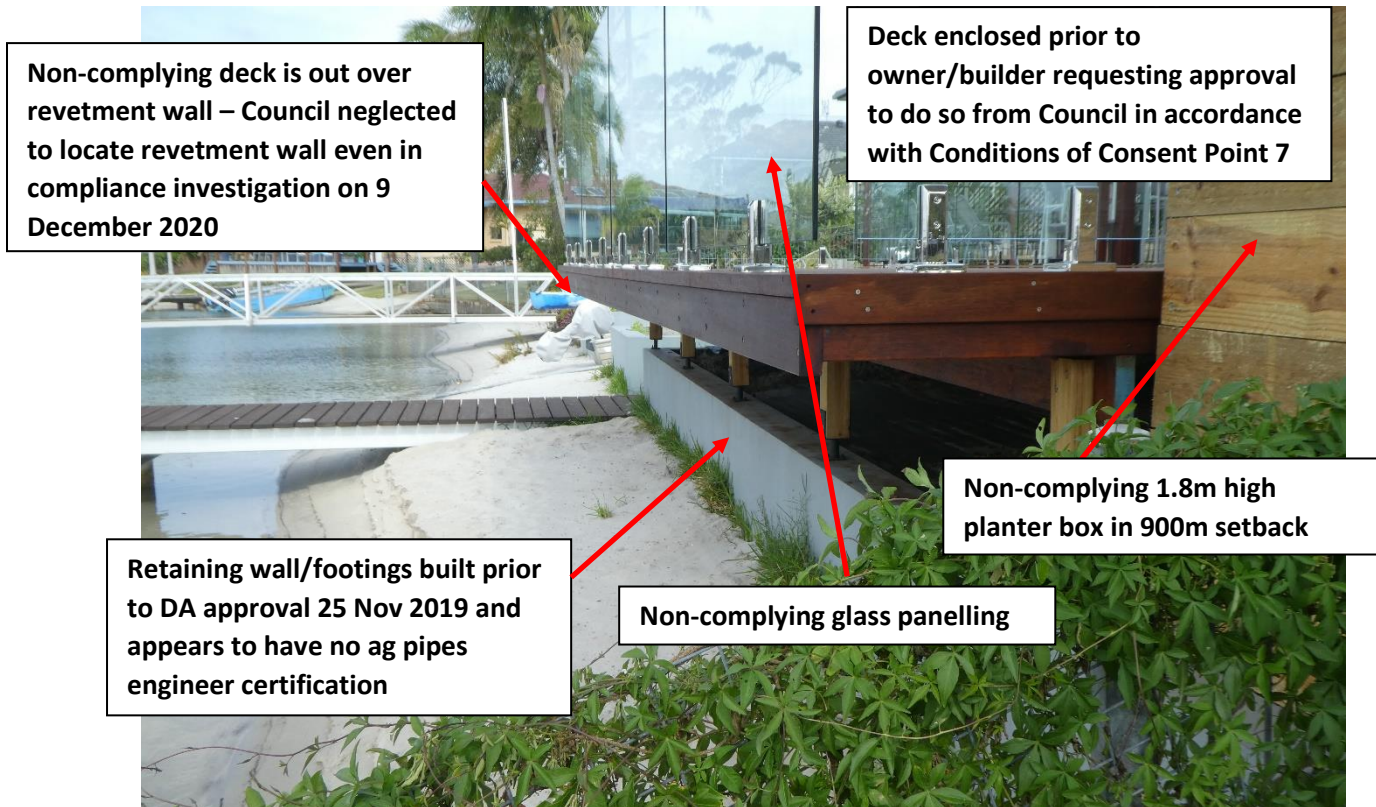
1. Photo taken 24 November 2020 of deck at 19 Gumnut Road Yamba sitting on non-complying foundations (the retaining wall) and non-complying deck is out over the revetment wall – Council neglected to locate revetment wall in accordance with Councils DCP Schedule C2 page 47, points 4 and 5.

1. Photo taken 24 November 2020 of deck at 19 Gumnut Road Yamba sitting on non-complying footings (the retaining wall) and non-complying deck is out over the revetment wall – Council neglected to locate revetment wall in accordance with Councils DCP Schedule C2 page 47, points 4 and 5.

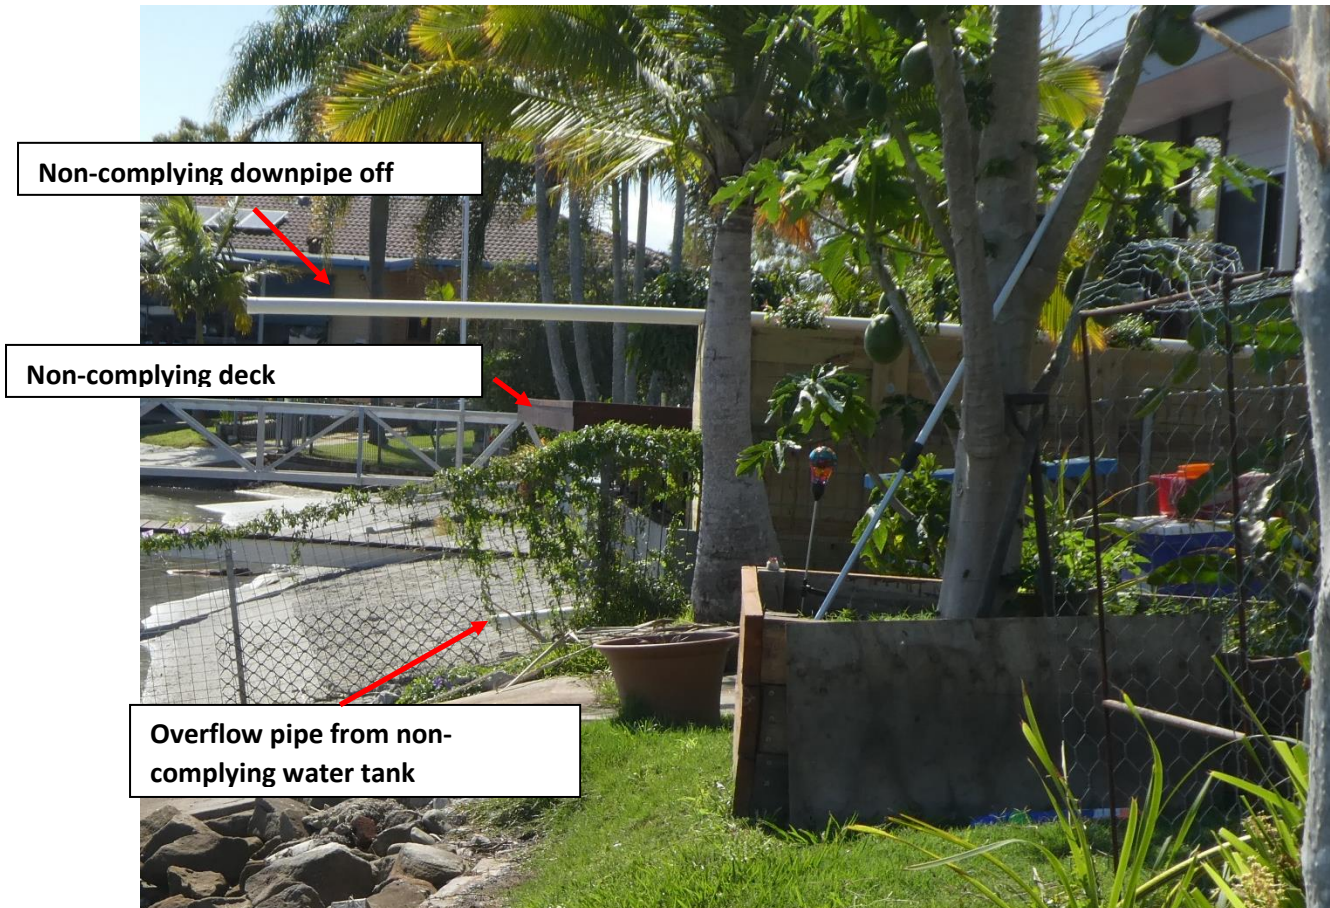
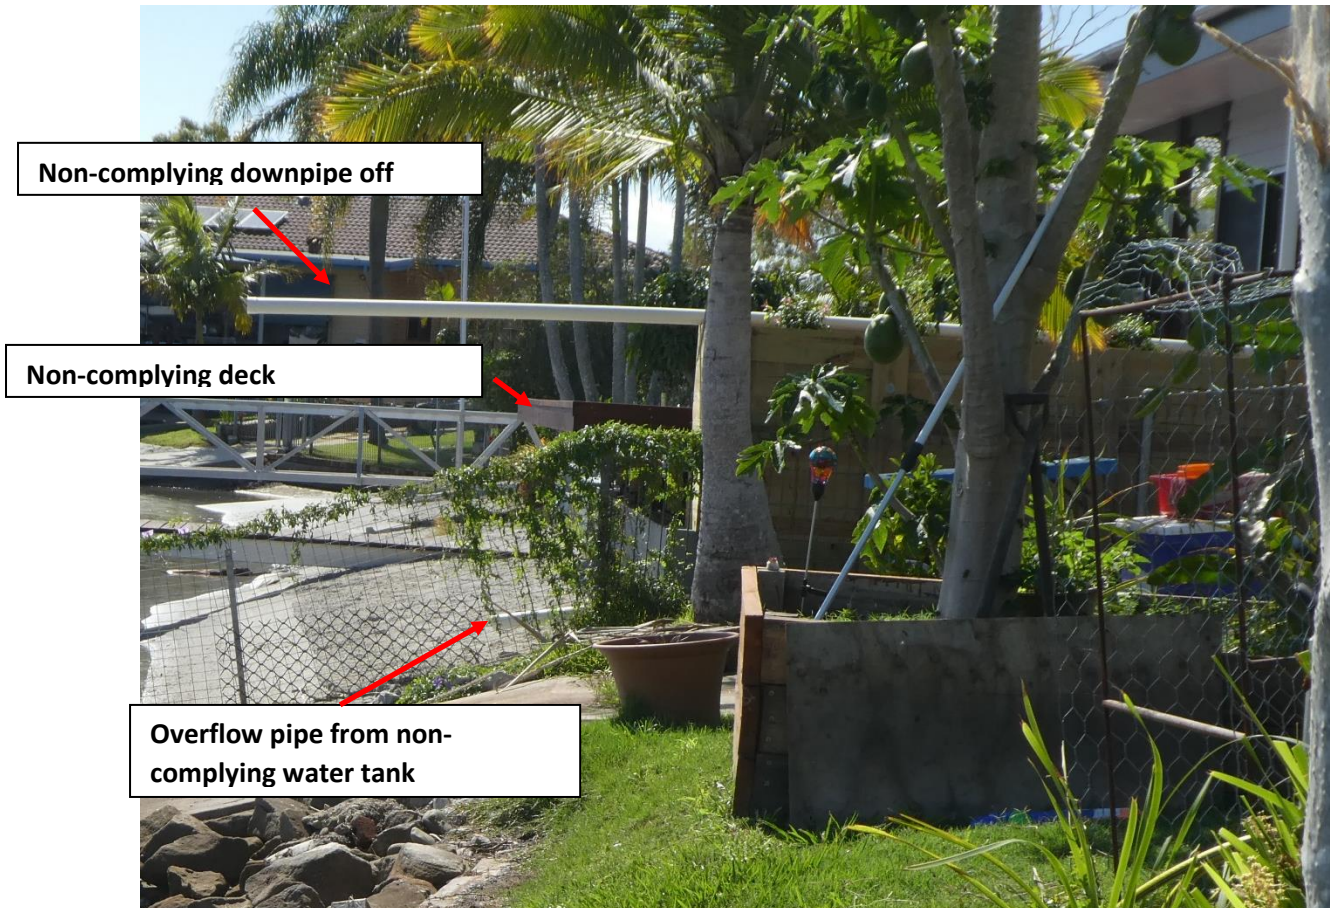
2. Photo of deck at 19 Gumnut Road Yamba sitting on footings (the retaining wall) taken 24 November 2020 – non complying downpipe, deck, footings, and overflow pipe

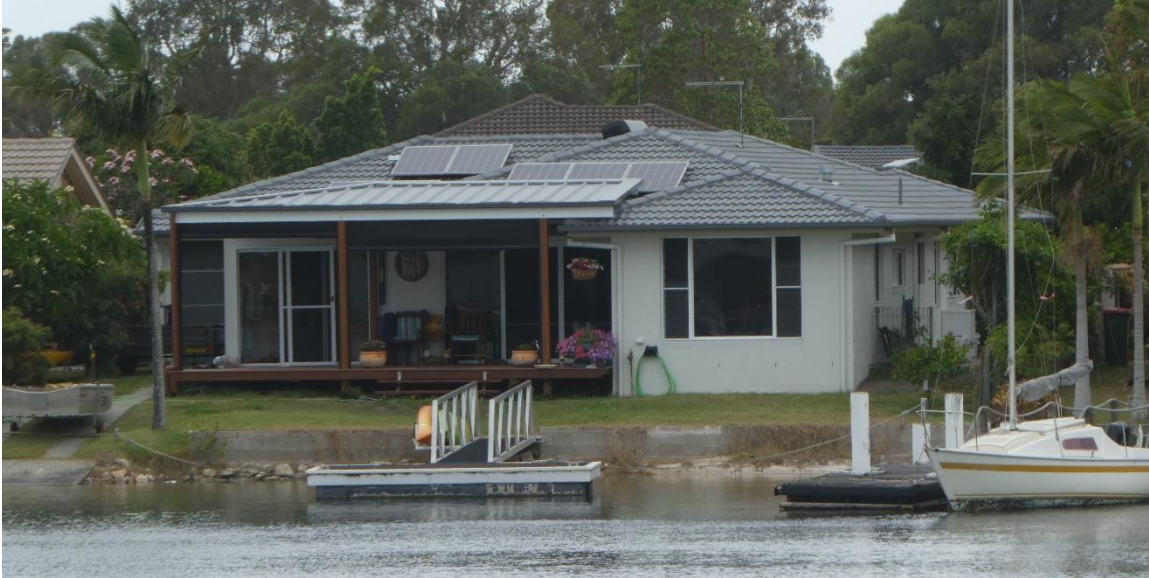
3. Photo taken 30 November 2020 of 3 Melaleuca Drive Yamba – extension adding room on the right and back verandah – same style as rest of home

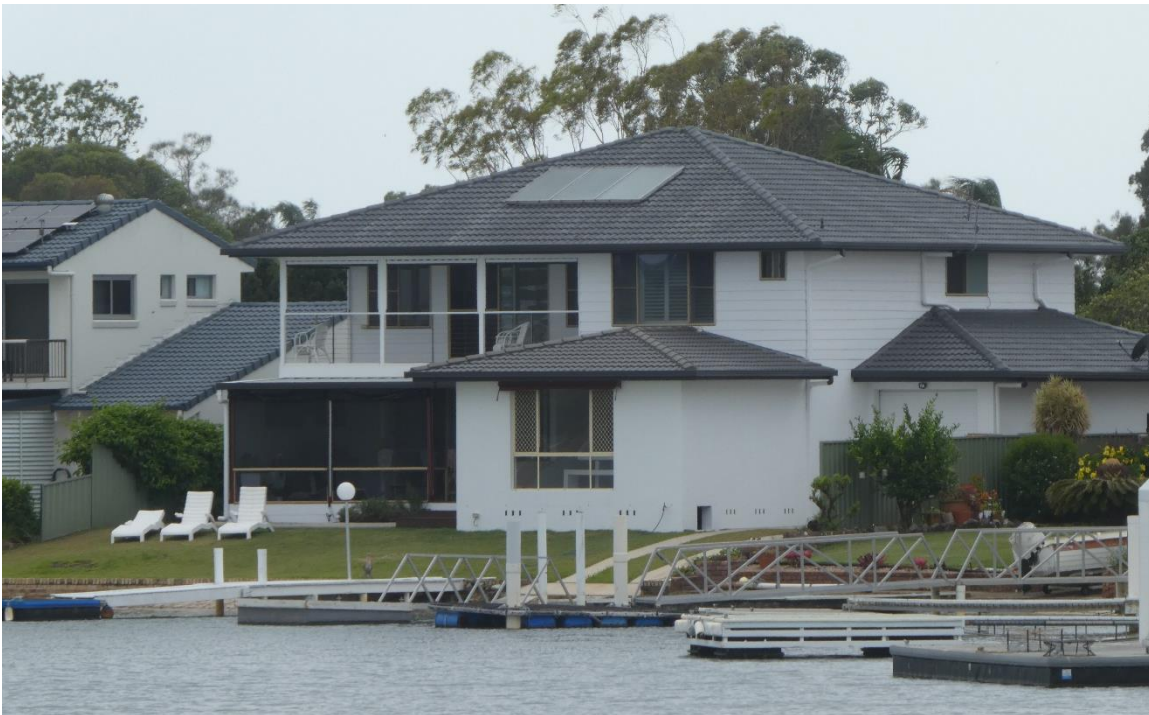
4. Photo taken 30 November 2020 of 25 Melaleuca Drive Yamba – extension adding a room on the right – same style as rest of home

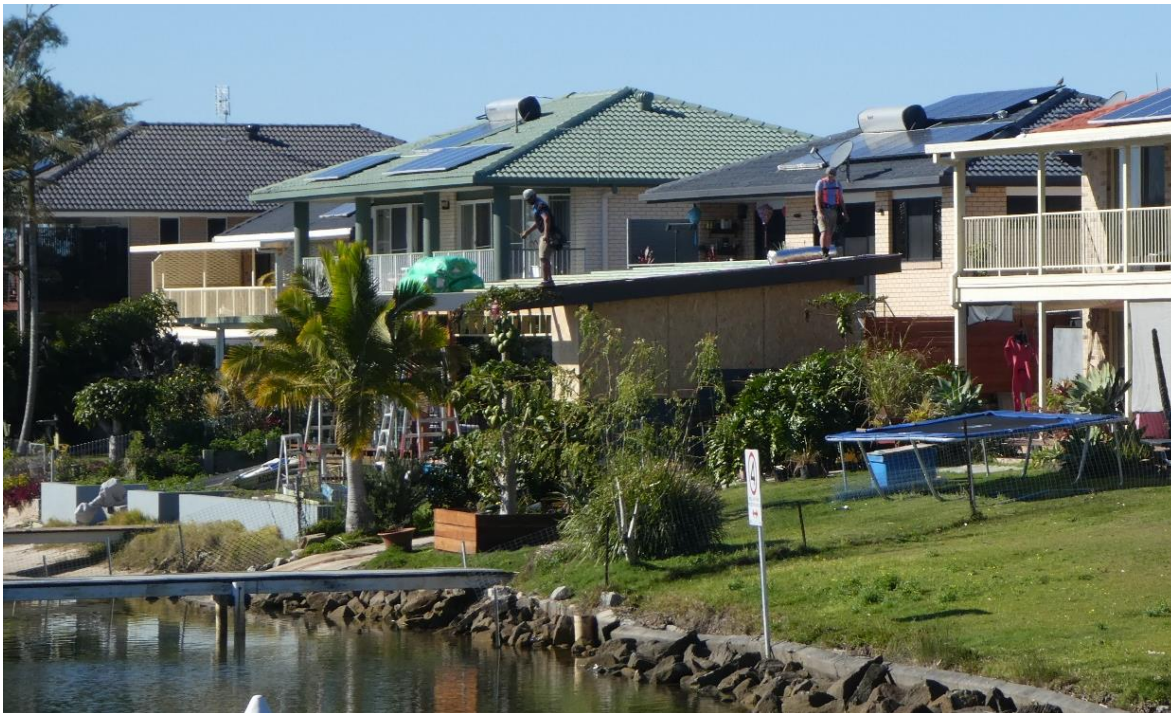
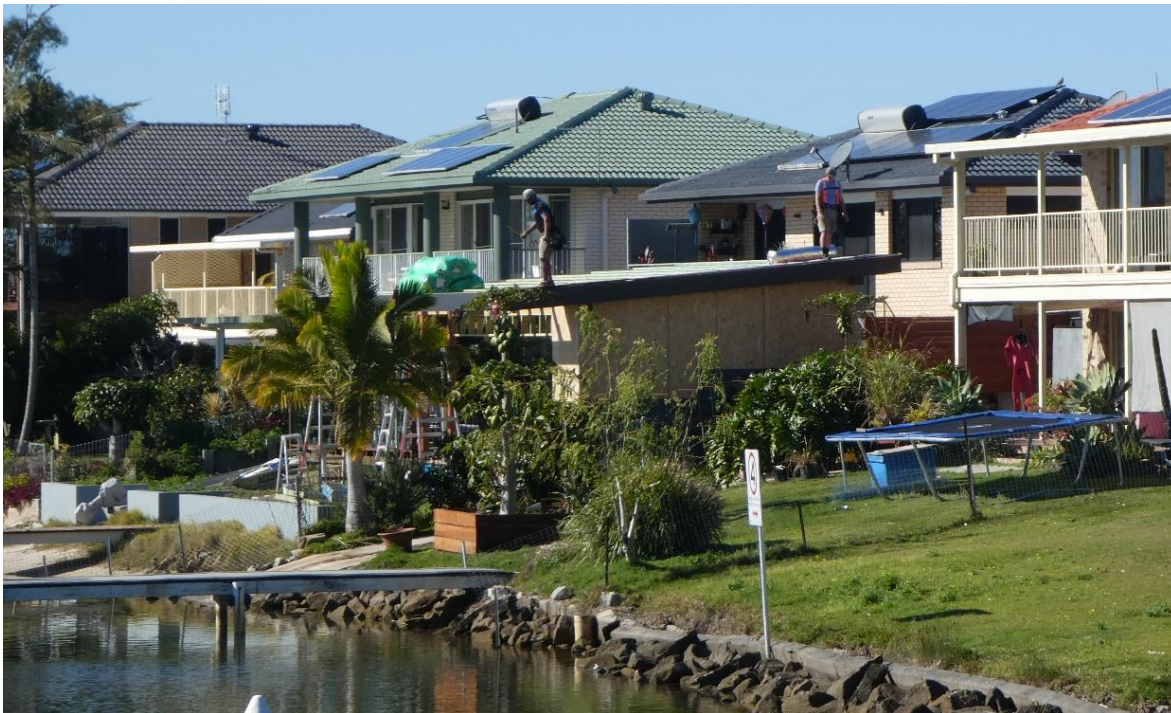
5. Photo taken 6 August 2020 19 Gumnut Road – installing extended roof on studio – non complying retaining wall/foundations visible for deck constructed prior to DA approval

5. Photo taken 6 August 2020 19 Gumnut Road – installing extended roof on studio – non complying retaining wall/footings visible for deck constructed prior to DA approval

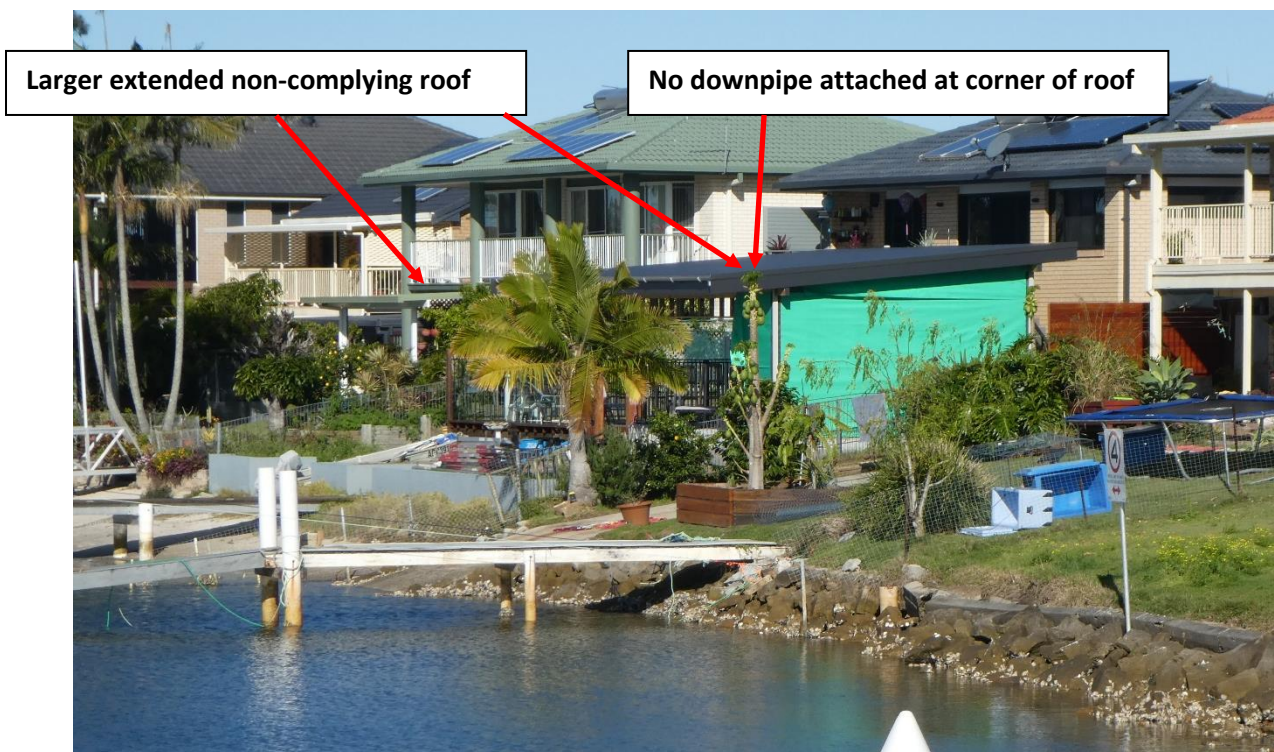
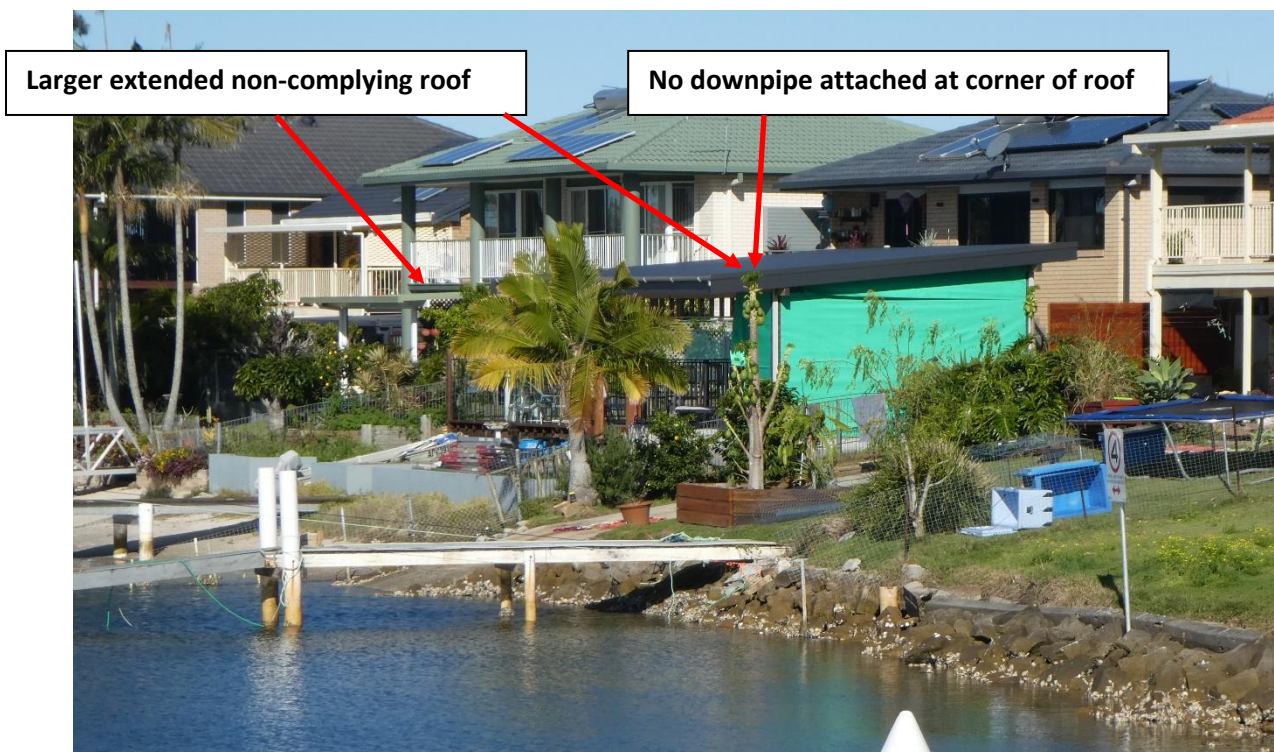
6. Photo taken 16 August 2020 19 Gumnut Road – extended non-complying roof complete on studio - no downpipe visible

Larger extended non-complying roof

No downpipe attached at corner of roof

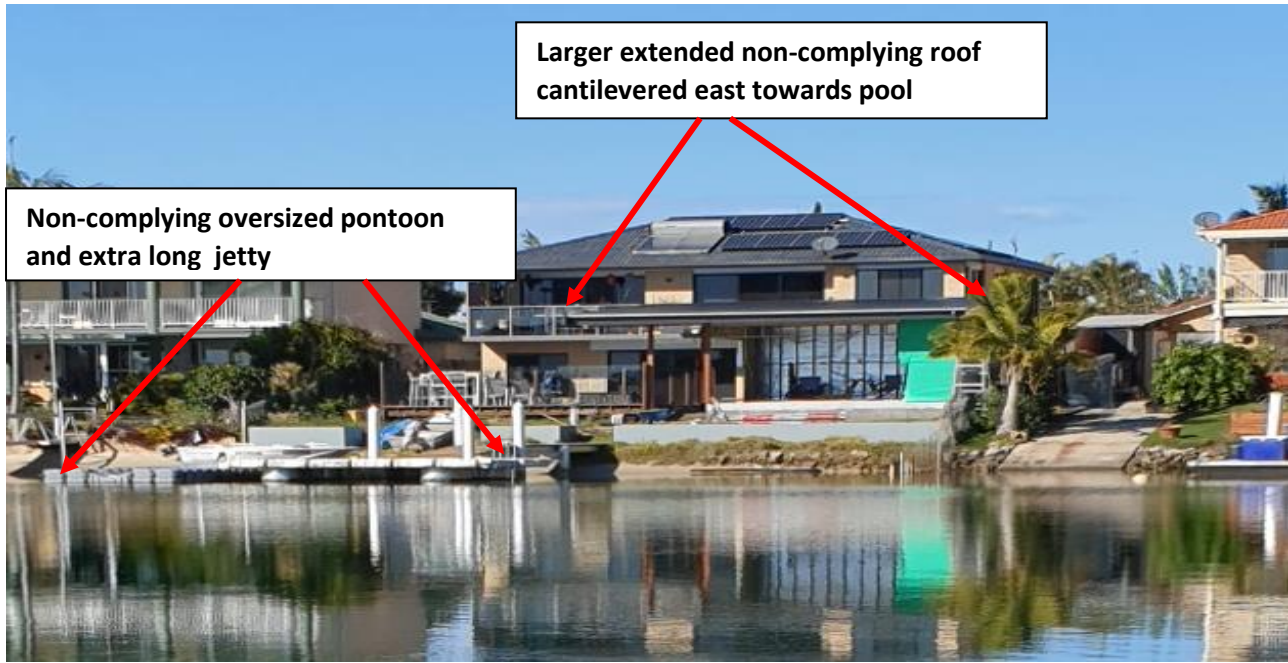
7. Photo taken 18 August 2020 19 Gumnut Road – larger extended non-complying roof completed on studio

7. Photo taken 18 August 2020 19 Gumnut Road – larger extended non-complying roof completed on studio and large non-complying pontoon and extra long jetty

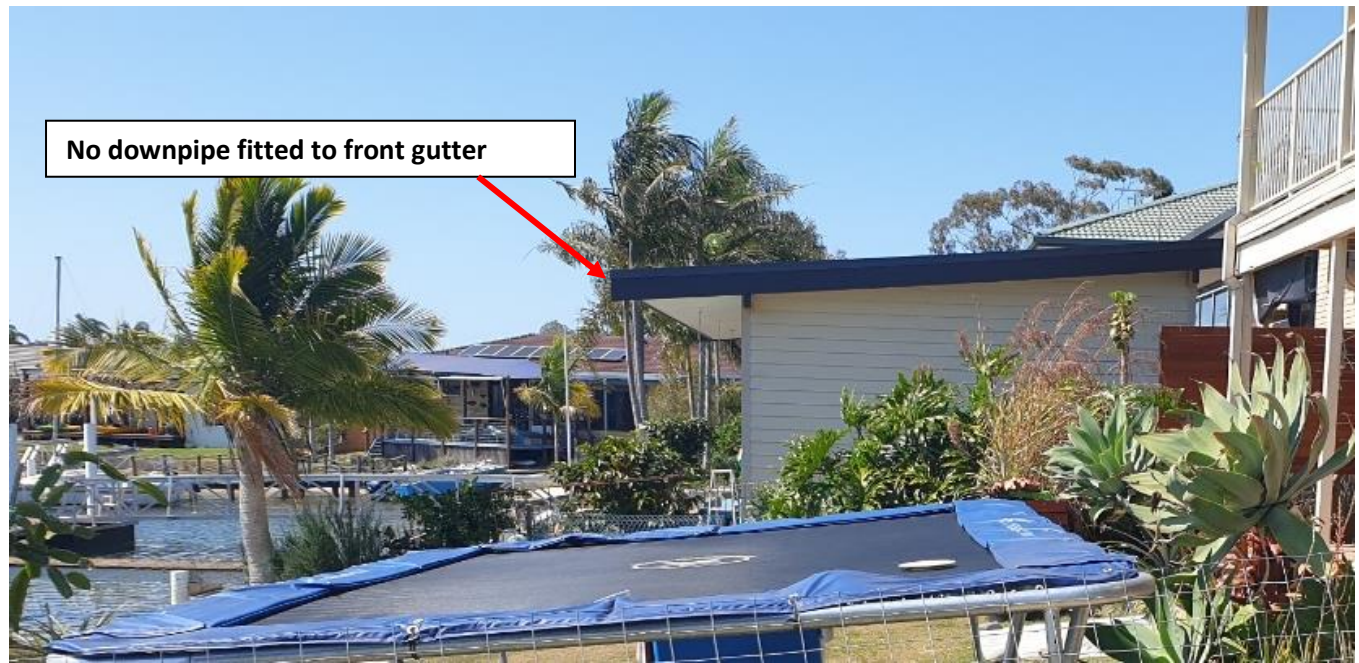
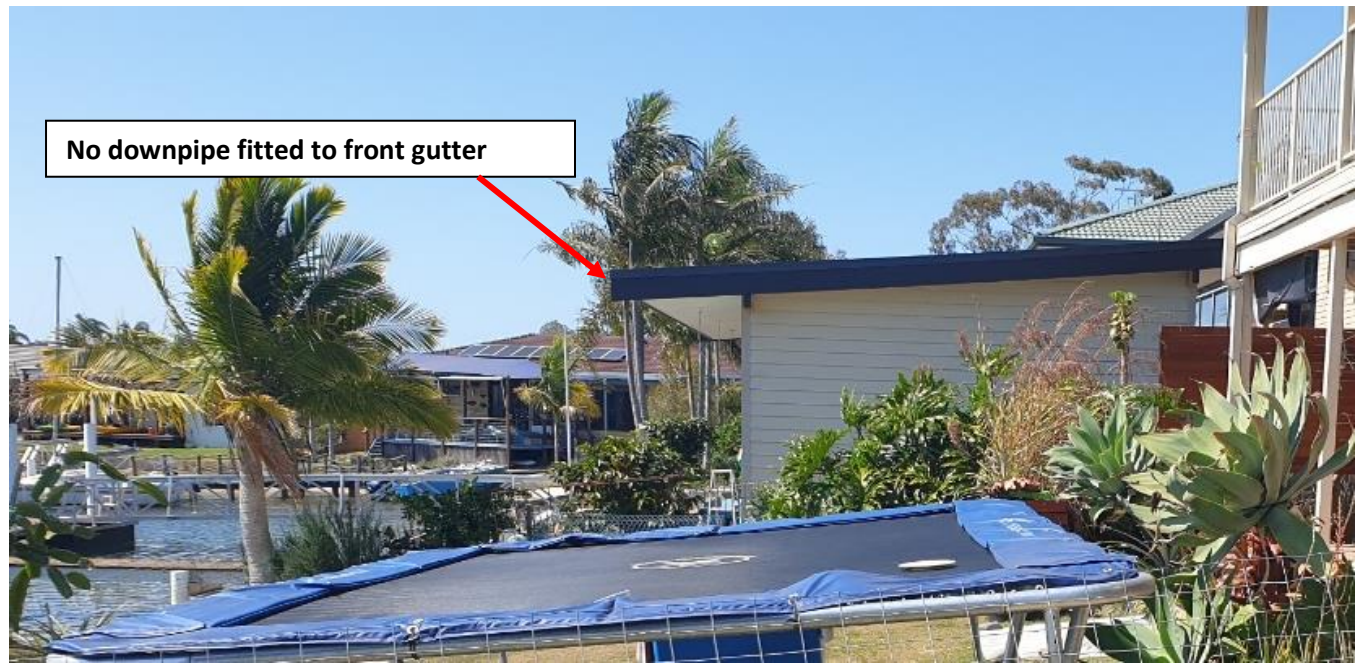
8. Photo taken 4 September 2020 19 Gumnut Road – roof complete and walls clad, no downpipe

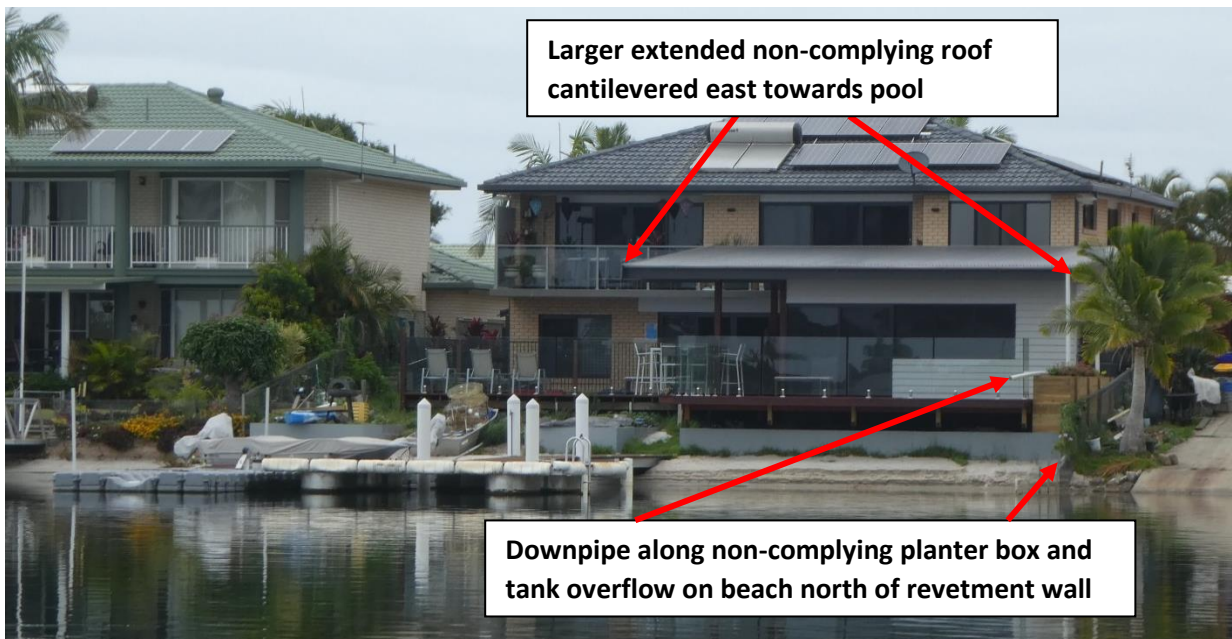
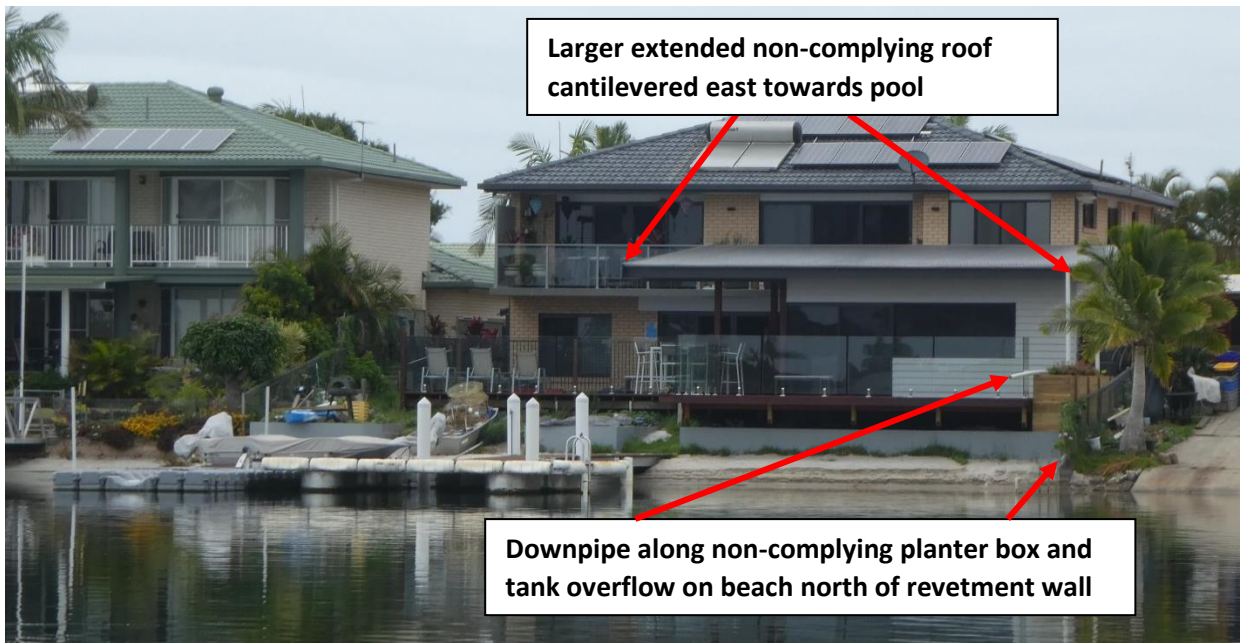
10. Photo taken 1 December 2020 19 Gumnut Road – downpipe and tank overflow still in place, non-complying glass panelling installed to deck. Non-complying roof larger than in Consent Plans and cantilevered to east, and Structural Plans show roof as a hip roof not flat

Larger extended non-complying roof cantilevered east towards pool

Downpipe along non-complying planter box and tank overflow on beach north of revetment wall

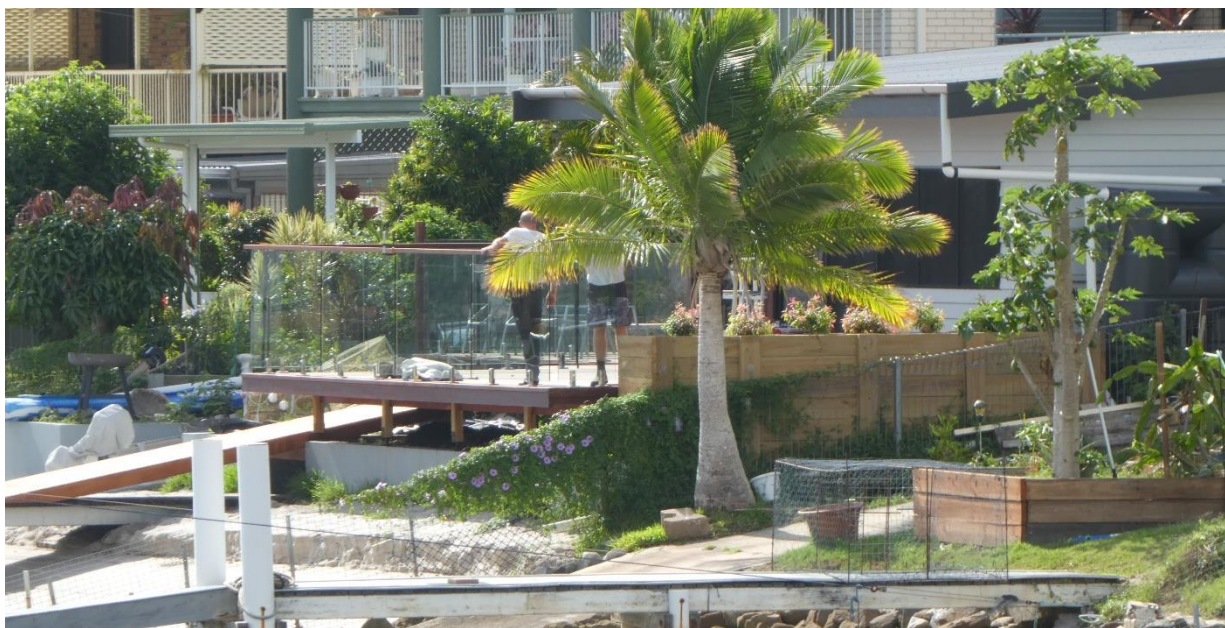
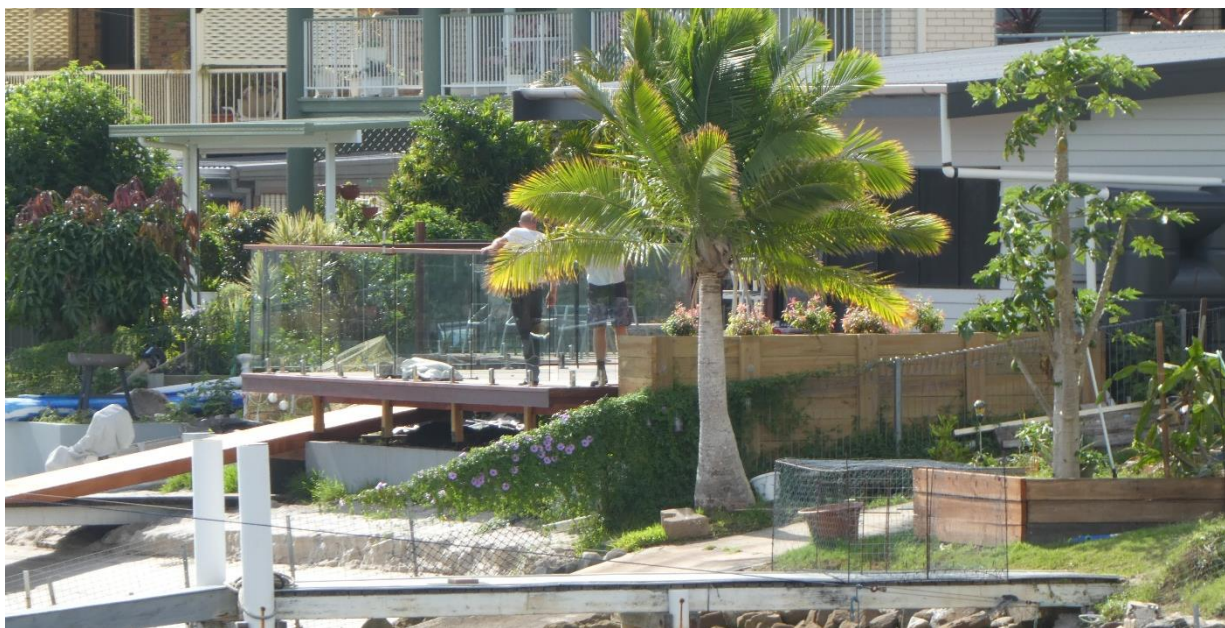
11. Photo taken 10 December 2020 19 Gumnut Road – downpipe now redirected to top of water tank overflow still in place out over beachfront, non-complying wood bench now installed on top of non-complying glass panelling and non-complying ramp extending from up near the pool to nearly first piers on the non-complying jetty

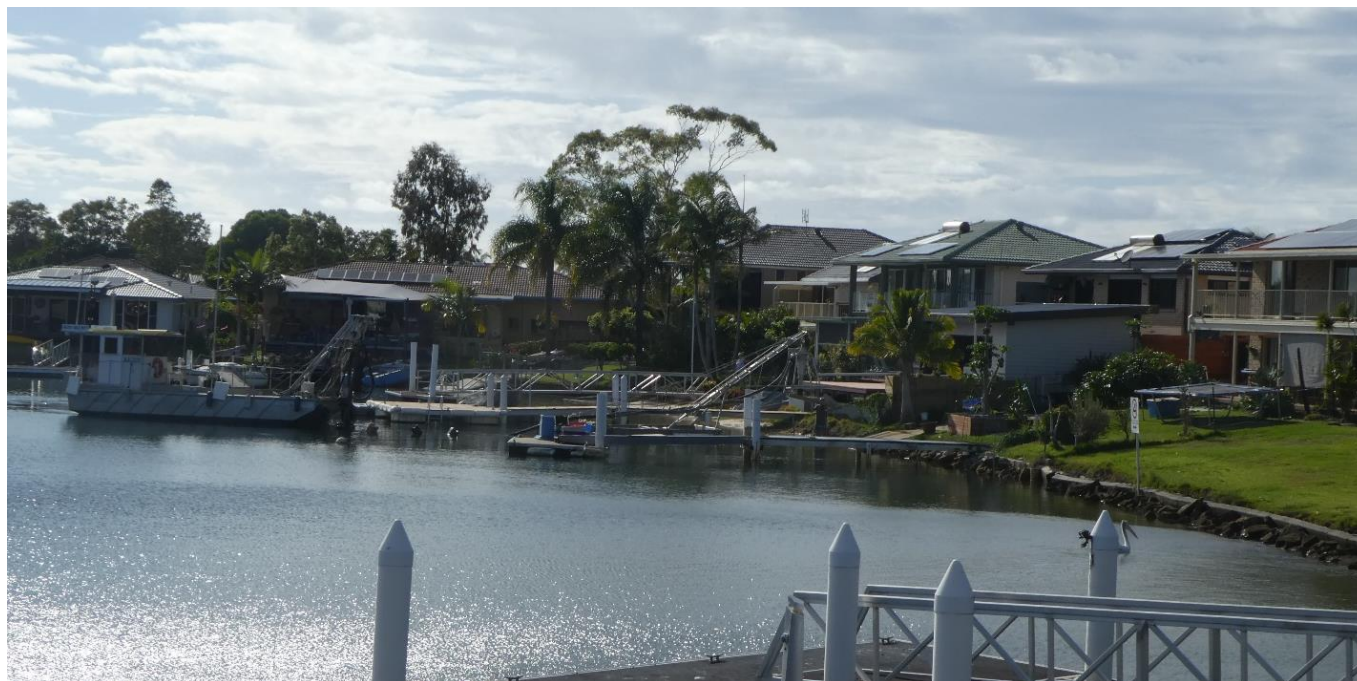
12. Photo taken at 7.34am 2 November 2020 – commercial dredge setting up to pump

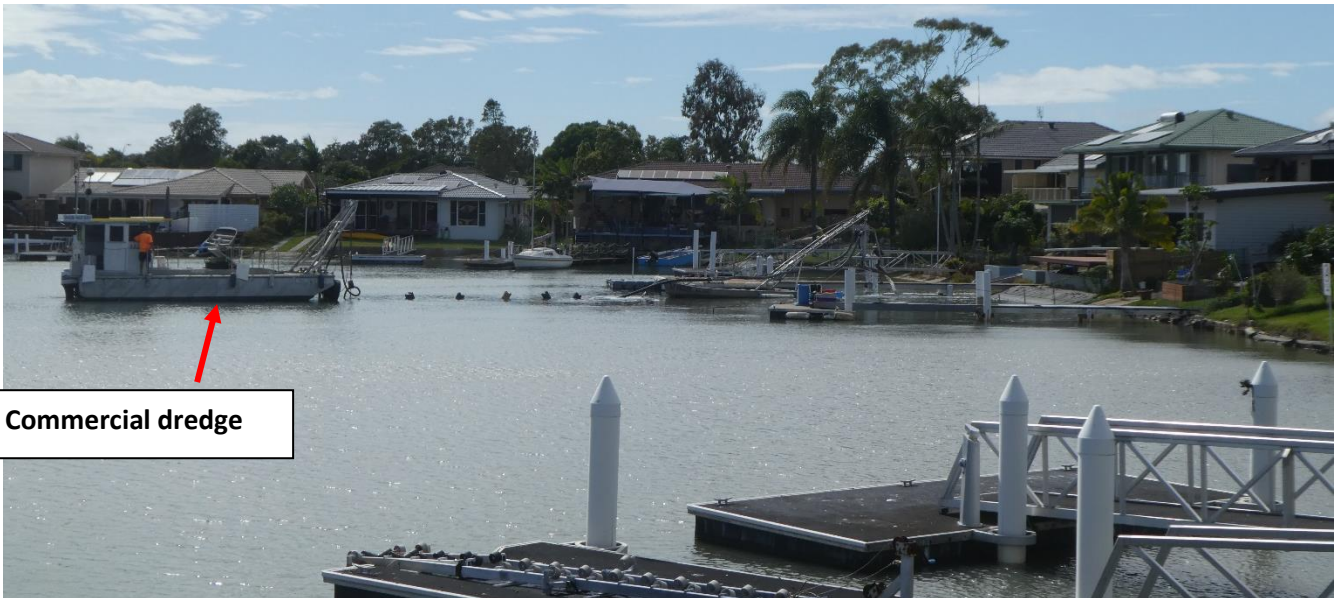
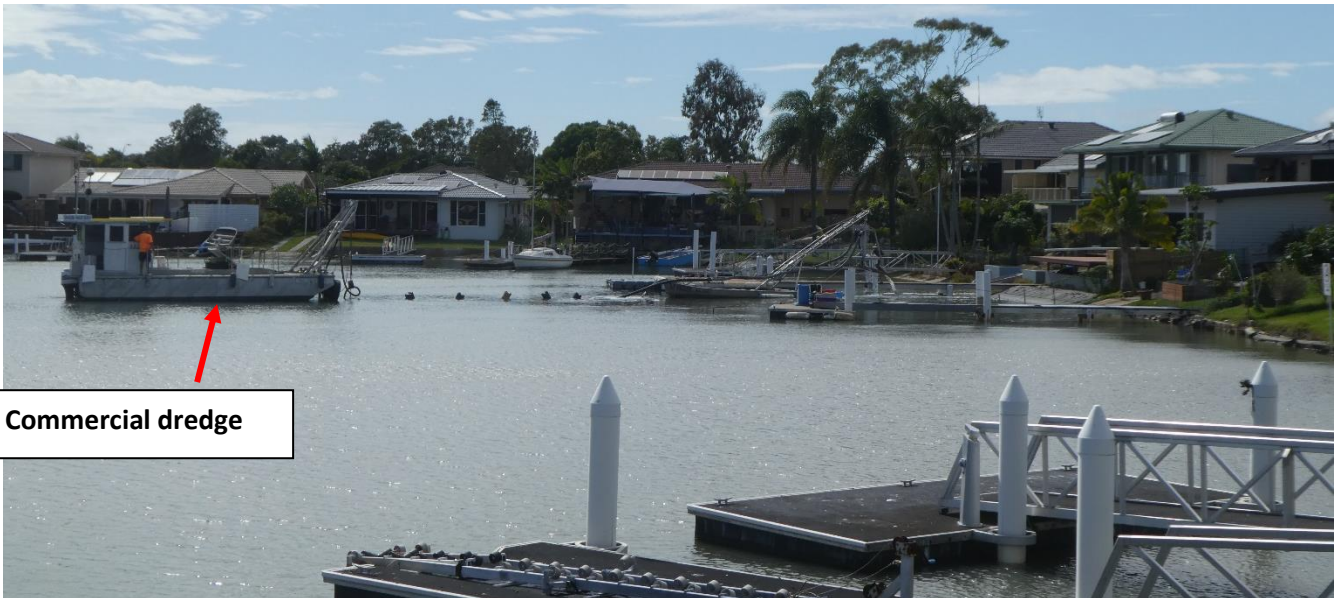
13. Photo taken at 8.57am 2 November 2020 – sand pumped from dredge covering the grass and the revetment wall

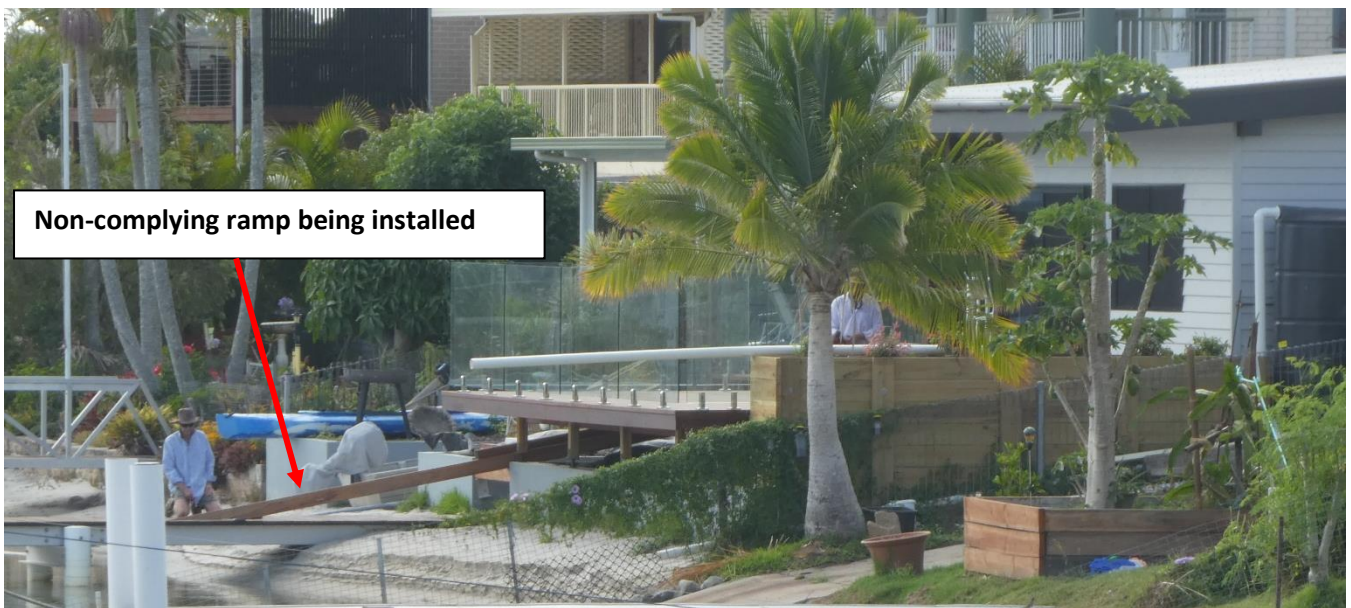
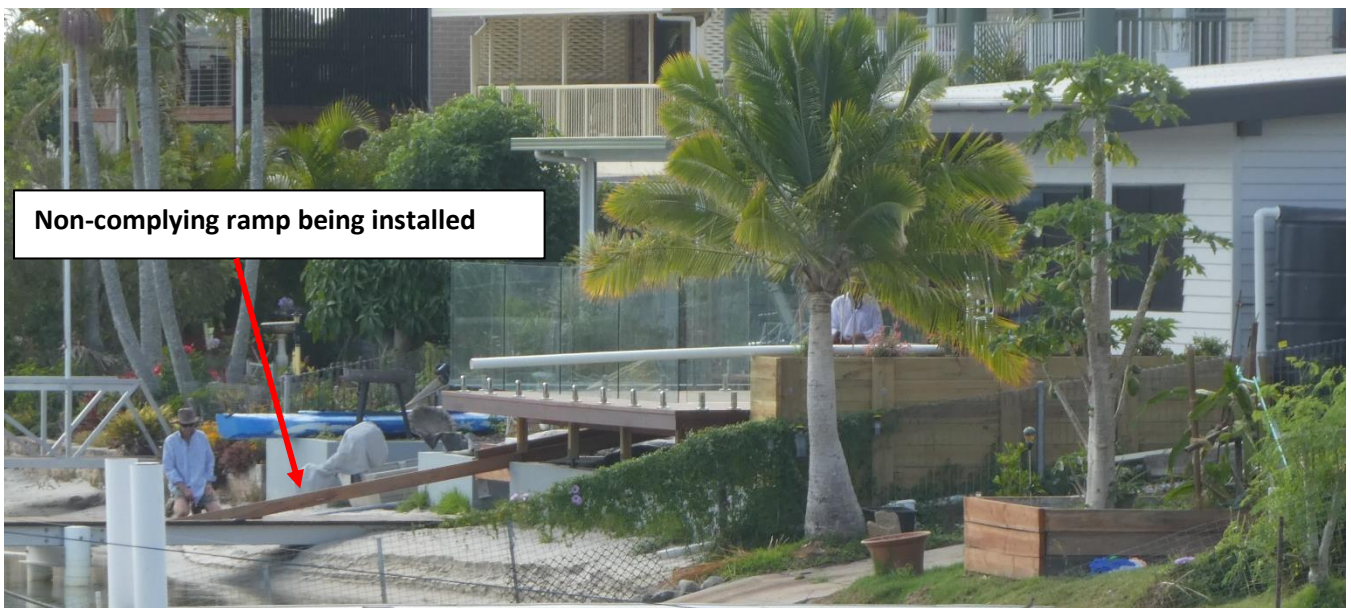
14 a). Photo taken 2 December 2020 19 Gumnut Road – downpipe still along top of non-complying planter box. Non-complying ramp being installed from up near pool to nearly first piers on non-complying jetty.

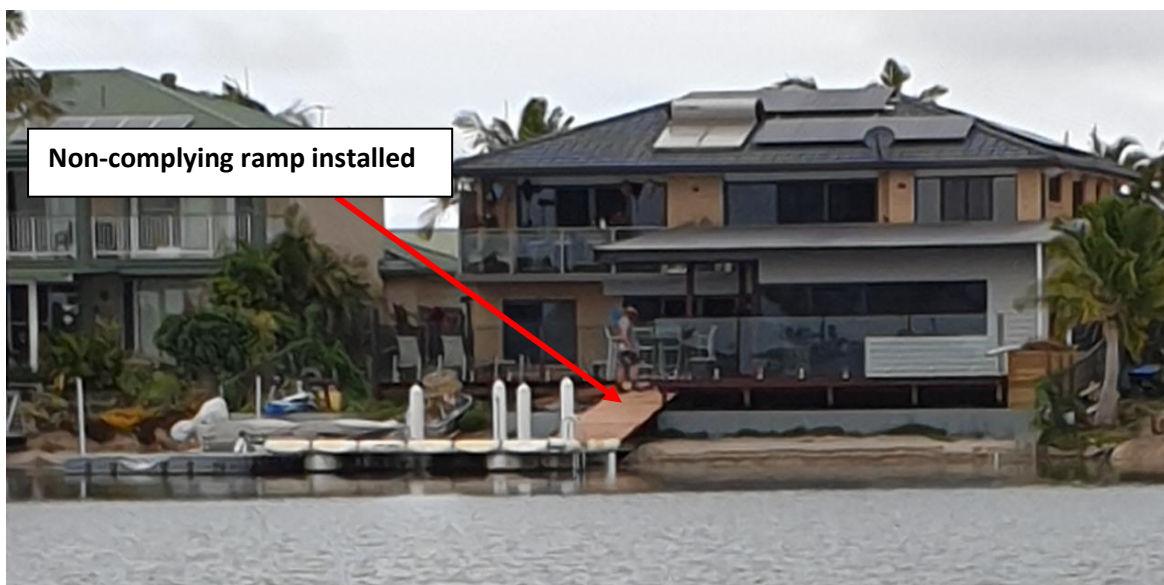
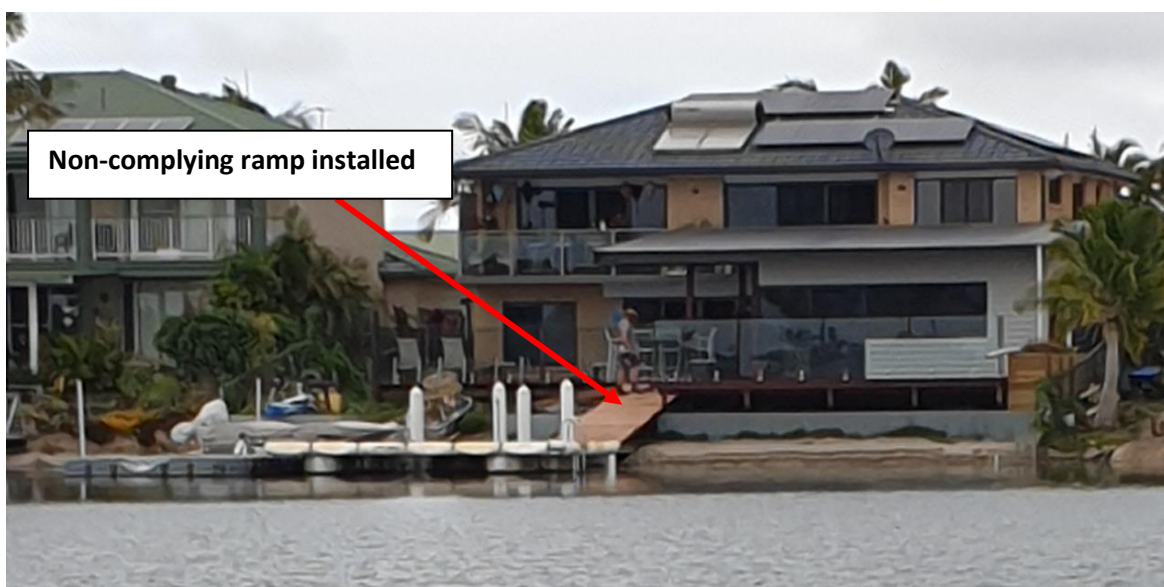
14 b) Taken 3 December 2020 - the new non-complying ramp from jetty towards the pool
