From: Lynne Cairns [<mailto:blcairns@bigpond.com>]
Sent: Friday, 12 March 2021 2:54 PM
To: Ashley Lindsay; Council Email
Cc: Jim Simmons; Debrah Novak; 'spowelly POWELL'
Subject: Request for a Meeting with General Manager, Mayor, Cr Novak, Mr Powell and Mr and Mrs Cairns

From: Lynne Cairns
Sent: Thu, 25 Mar 2021 13:46:58 +1100
To: Council Email
Cc: 'spowelly POWELL'
Subject: First Email: Submission MOD2021/0016 and DA2021/0153
Attachments: Attachment 1 Front page_Summary.pdf, Attachment 2 Detailed information.pdf, Attachment 3 Photos.pdf, Attachment 4 Issues and breaches DA2019_0439 Conditions of Consent.pdf, Attachment 5 Details and signatures of those making Submission.pdf, Attachment 6 DA2019-0439 Notification Plan 19 Gumnut Road Yamba.pdf, Attachment 7 DA 2019-0439 Application DA assessment.pdf, Attachment 8 ECM_1996721_v1_DAP memo 19 Gumnut Rd Yamba DA2019 0439.pdf, Attachment 9 DA2019 0439 - Notice of Determination of Application - 19 Gumnut Road YAMBA NSW 2464 (1).pdf

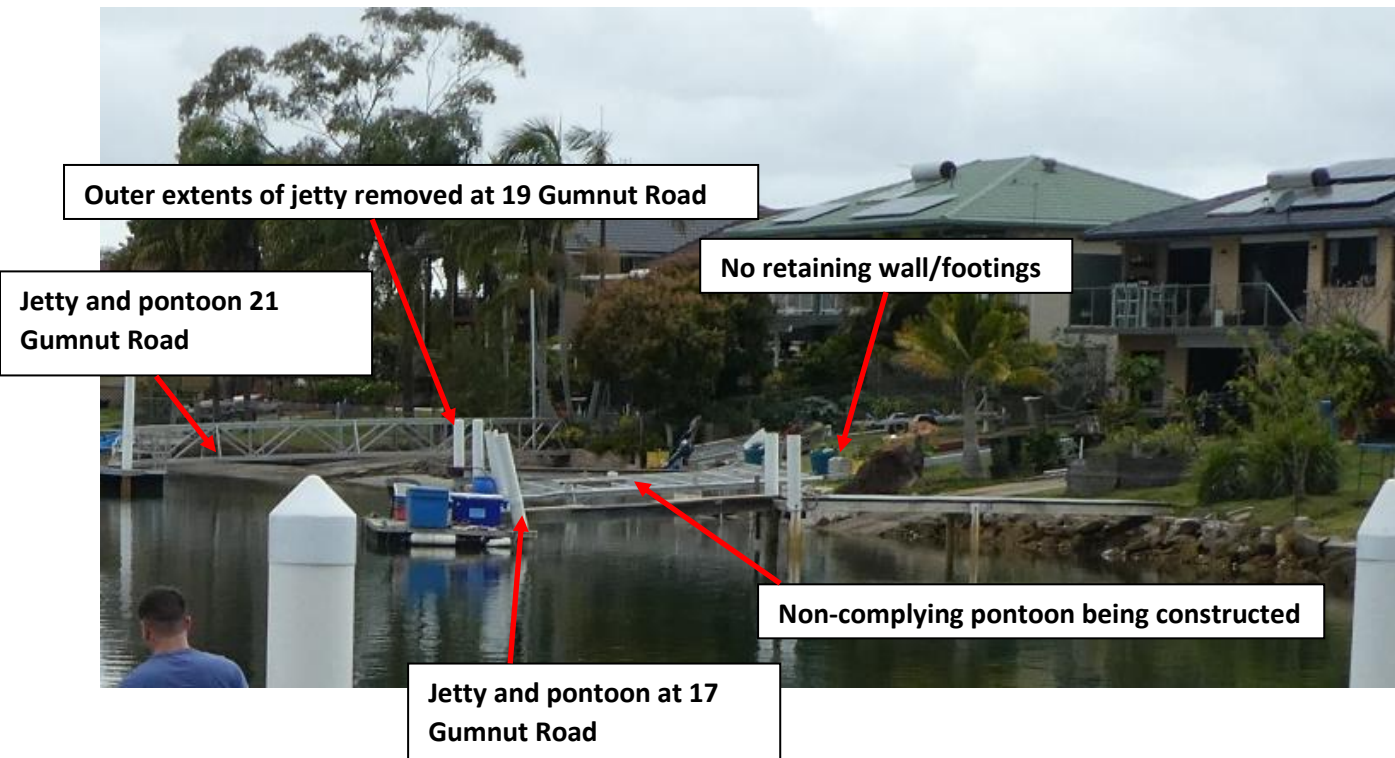
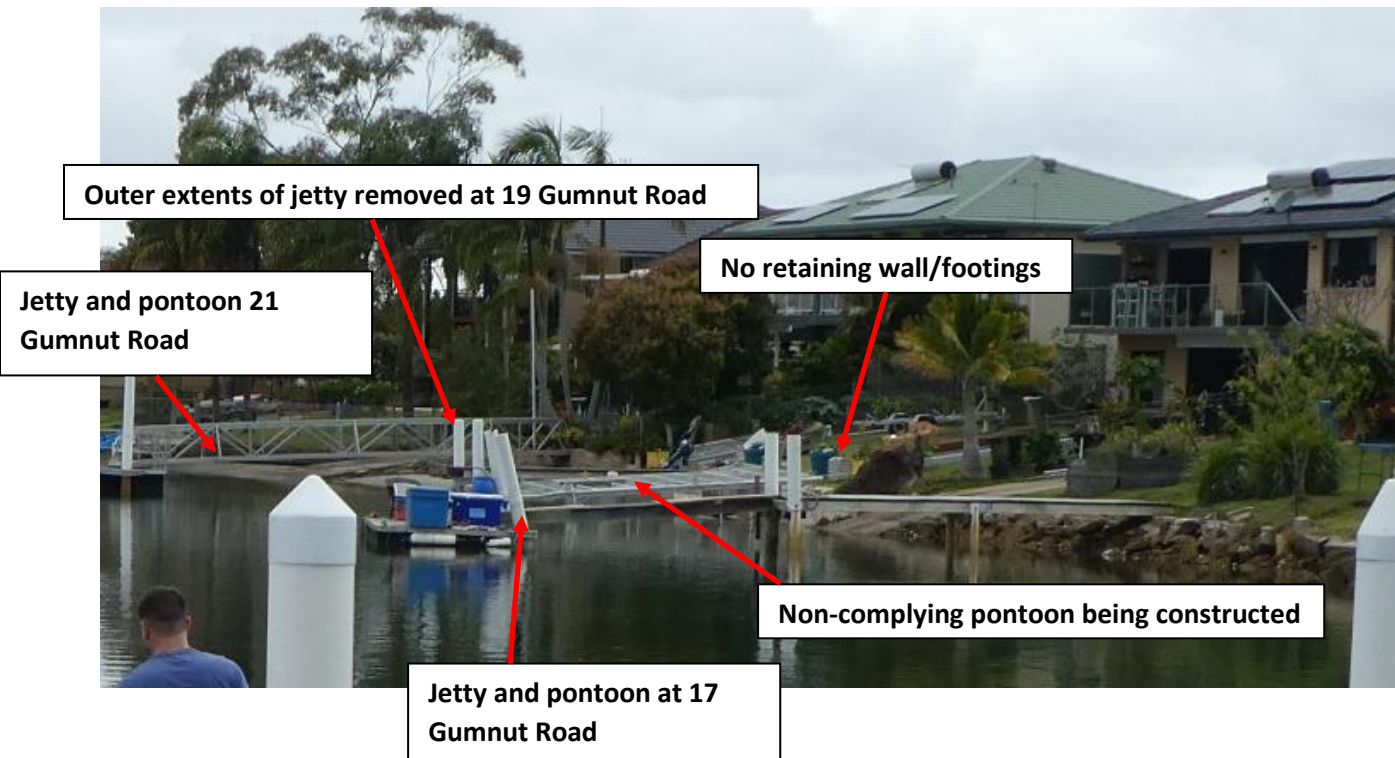
15. Photo taken 30 September 2018 of 19 Gumnut Road – outer extents of jetty demolished and removed back to first tall piers from the beachfront and pontoon being constructed on beachfront of 19 Gumnut Road. No retaining wall/footings constructed.

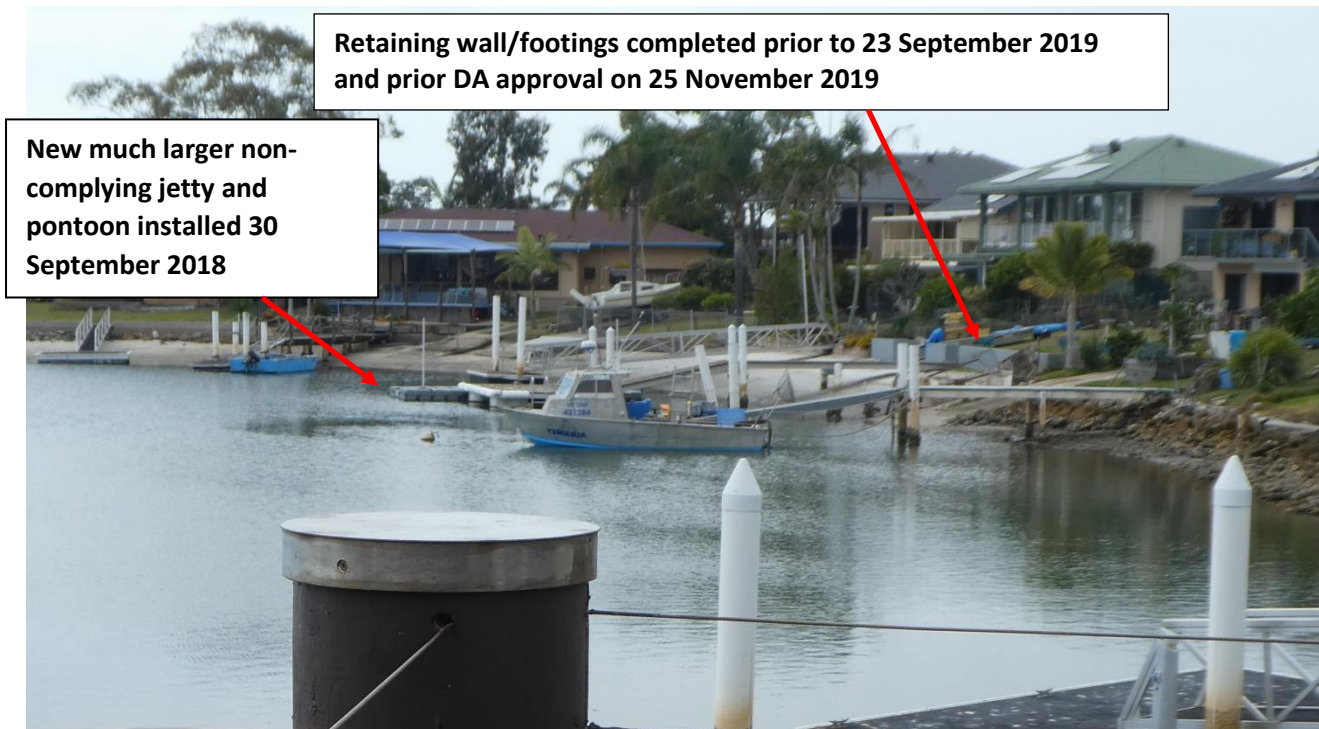
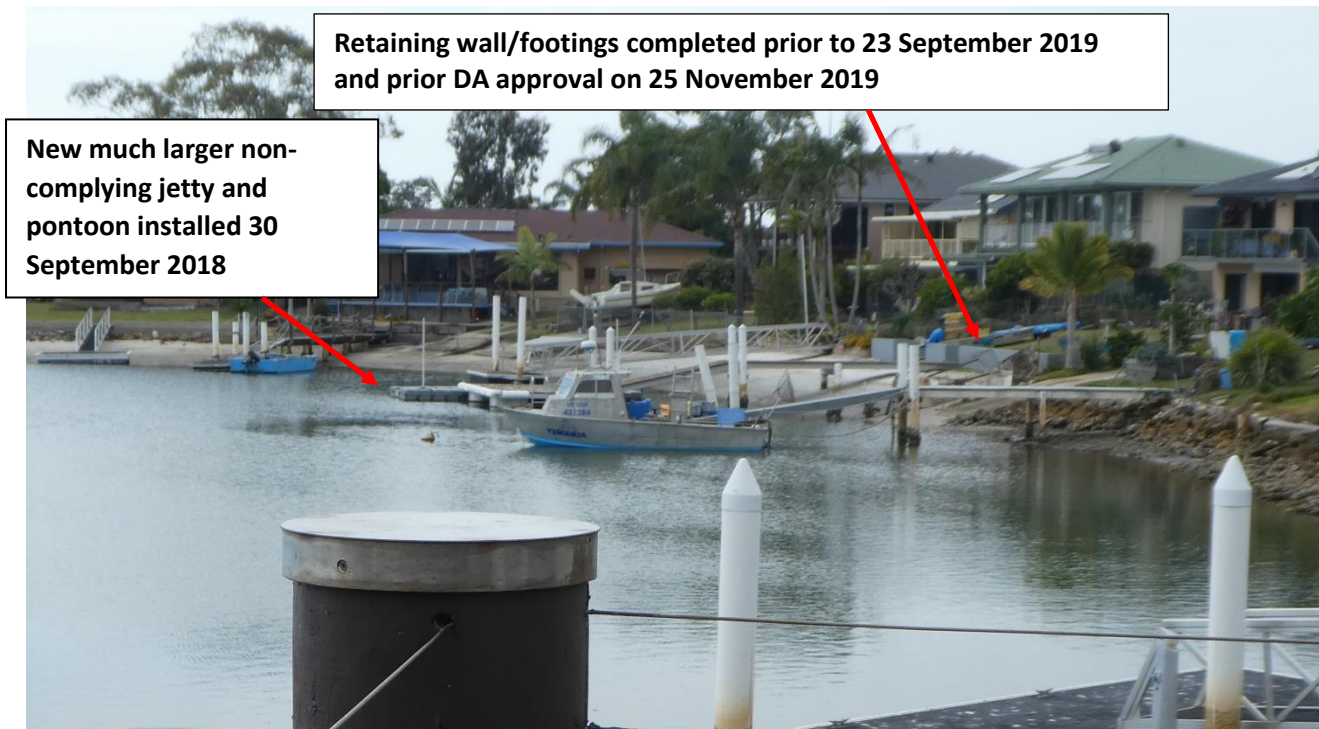
16. Photo taken 23 September 2019 showing retaining wall/footings already built prior to DA approval on 25 November 2019

16. Photo taken 23 September 2019 showing retaining wall/footings already built prior to DA approval on 25 November 2019 (provided separately to Council)

8. It appears Council has failed to see and address the fact that the retaining wall (now the footings for the large non-complying extended deck possibly out over the revetment wall) was already completely constructed prior to DA approval on 25 November 2019. Council has overlooked the fact that photos of the finished, constructed wall were provided in Mr and Mrs Cairns submission dated 20 September 2019 and 15 November 2019 (asking whether Council approval was required to raise/construct the revetment/retaining wall and fill behind it and a photo dated 29 October 2019 showing an excavator filling behind the wall). Councils Building Surveyor undertook and onsite inspection on 13 November 2019 and appears to have failed to sight the constructed retaining wall prior to DA approval. It also appears Council has failed to ensure the wall has been certified by an appropriate engineer. (see attachment photos showing non-complying works – photos 1, 16, 22a) and 22 b)).

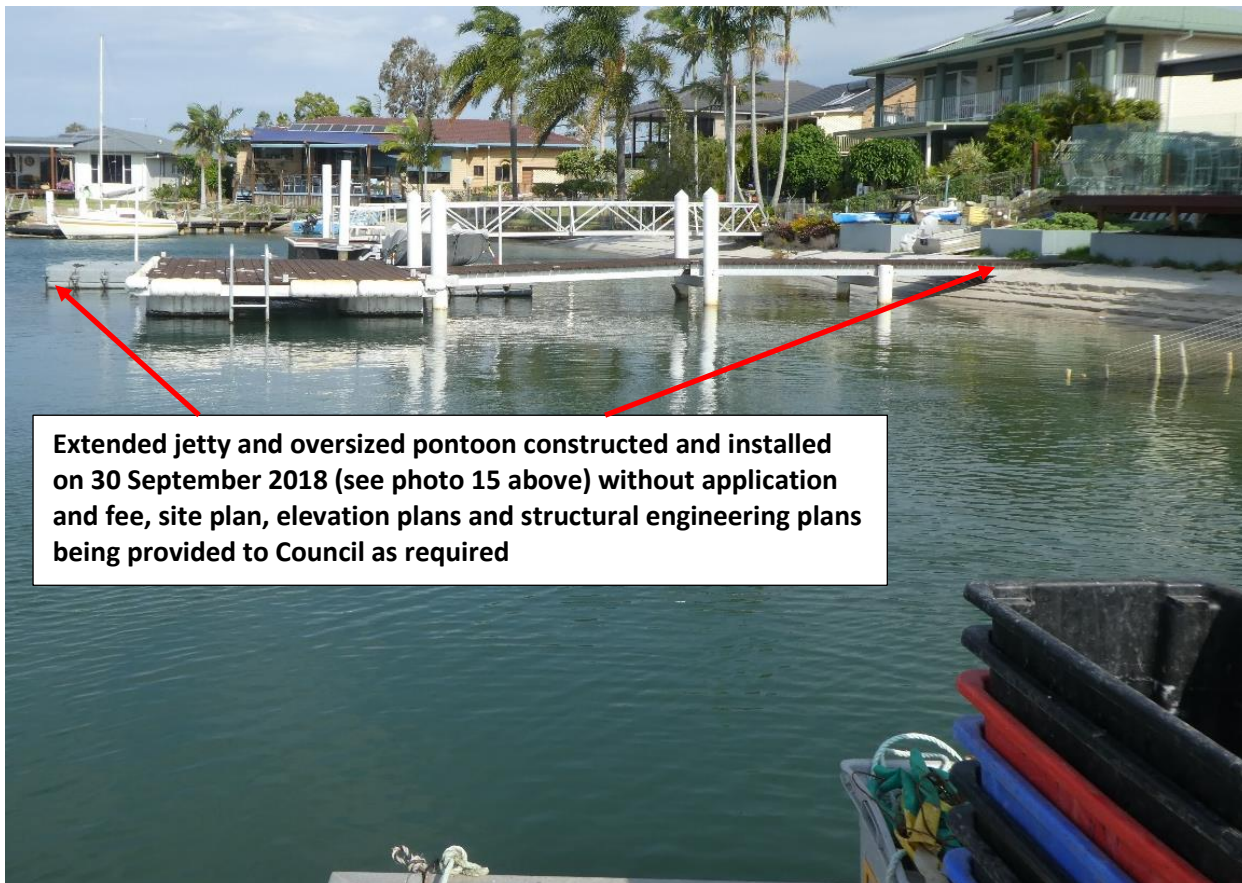
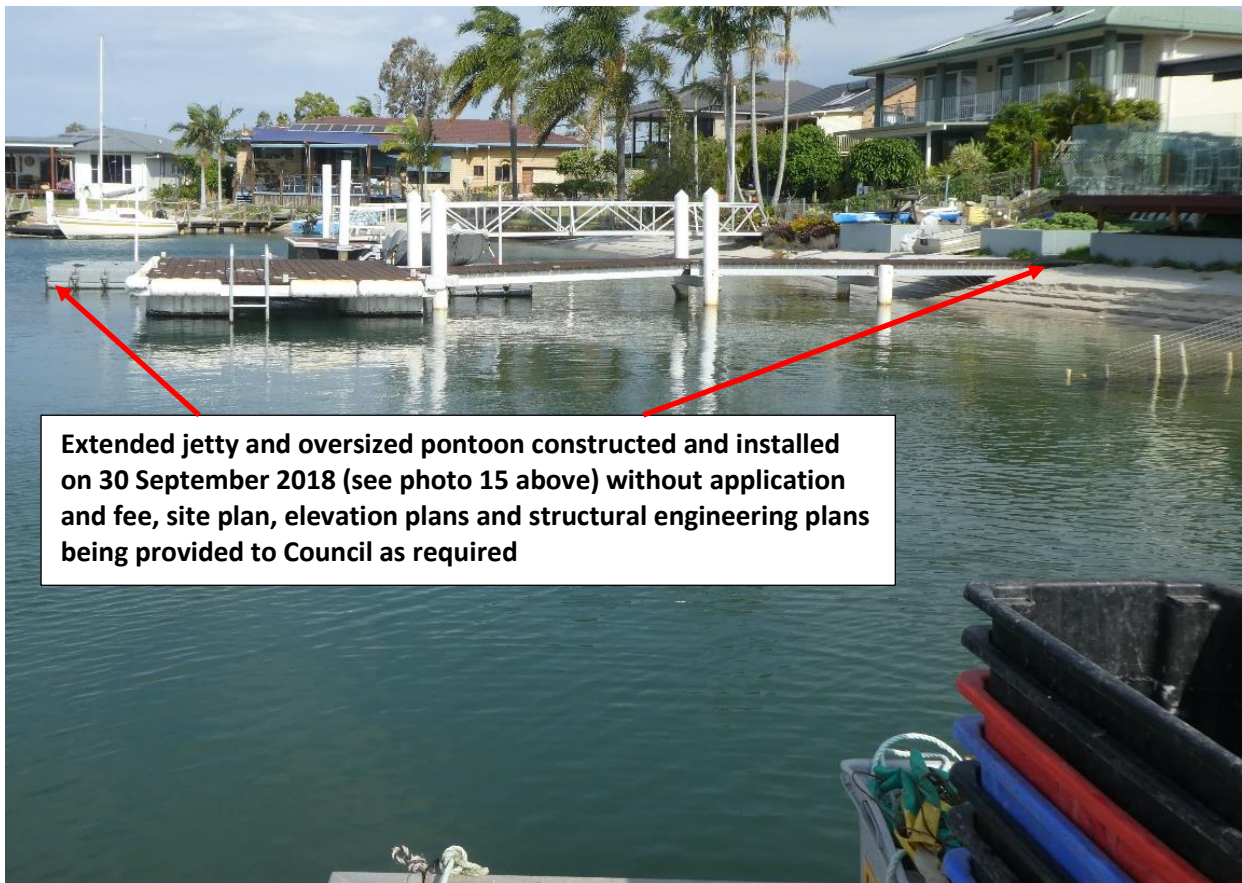
17. Photo taken 24 November 2020 at 19 Gumnut Road showing new extended jetty and oversized pontoon with boat storage attached to the eastern side of the pontoon (impeding access to pontoon at 21 Gumnut Road) – much larger and further out than previous jetty (photo taken from the outer edge of pontoon at 17 Gumnut Road).

Extended jetty and oversized pontoon constructed and installed on 30 September 2018 (see photo 15 above) without application and fee, site plan, elevation plans and structural engineering plans being provided to Council as required

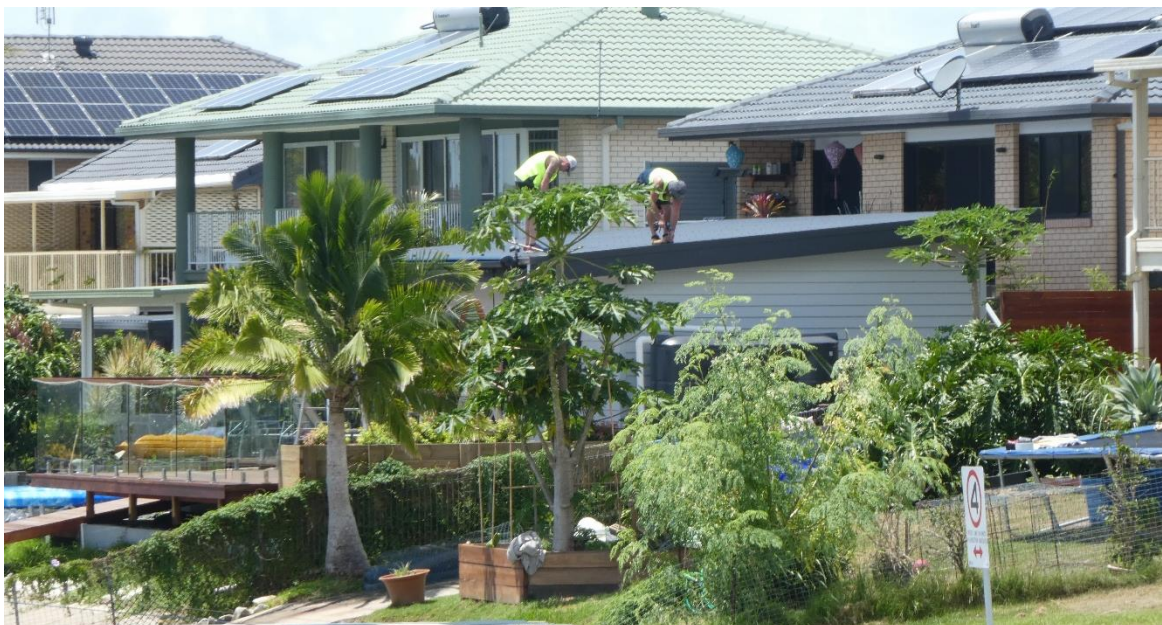
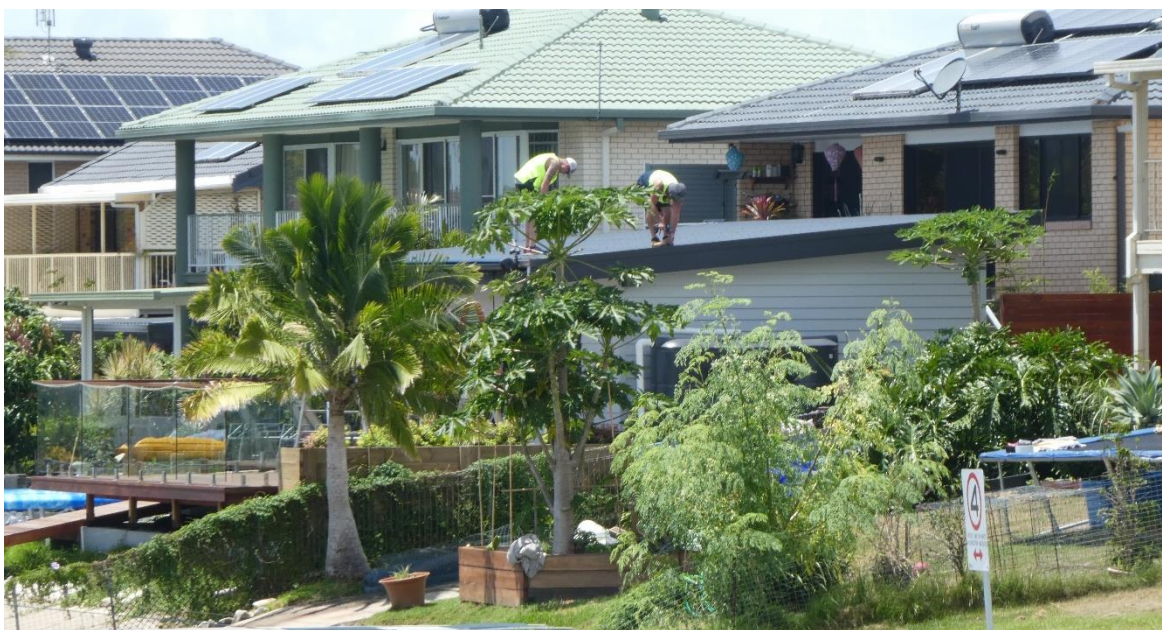
20. Photo taken 28 January 2021 – installing large non-complying extendable awning

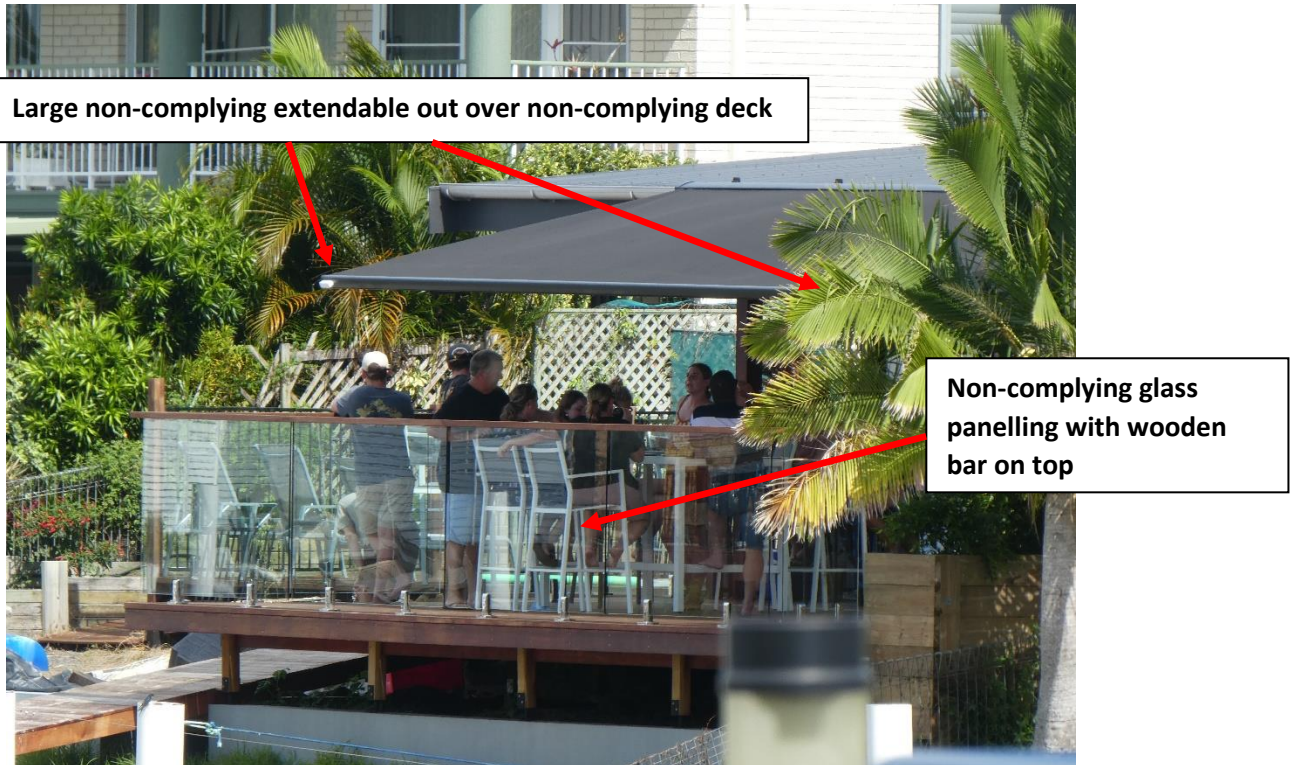
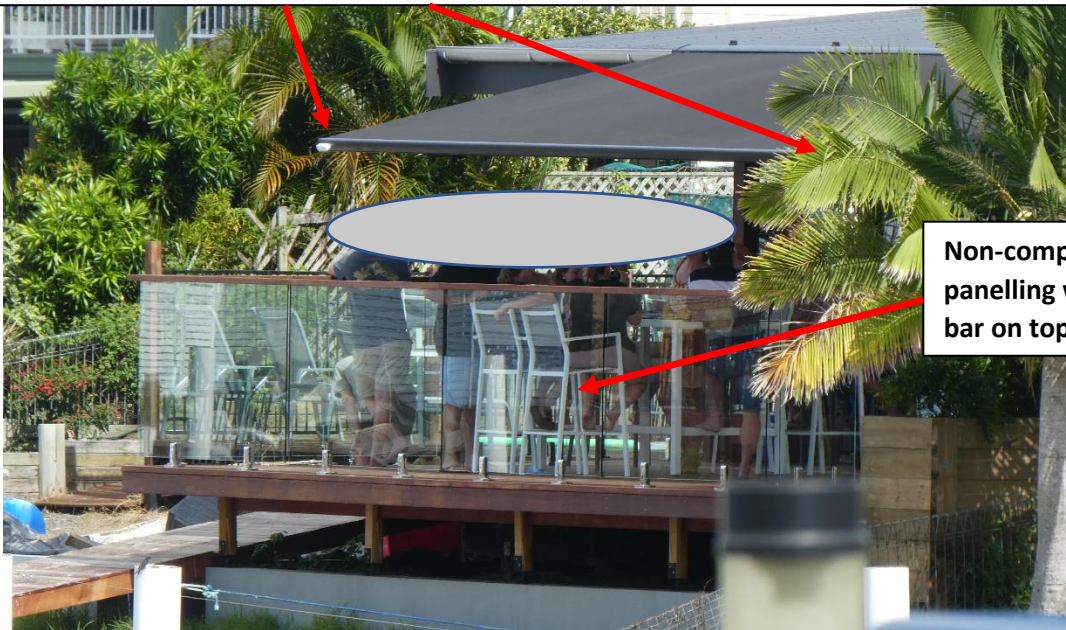
21. Photo taken 20 February 2021 of large non-complying extendable awning attached to non-complying studio roof, over a non-complying deck (resting on non-complying footings) with non-complying glass panelling on deck with wooden bar on top with a non-complying 1.8m high planter box on western boundary fence inside the 900mm setback. Studio and deck being used prior to Occupational Certificate – Council has been notified of this use.

Structural Certification would be rendered invalid as certification was for the design of the studio and the studio was not built in accordance with the Consent and Structural Plans and also the Structural Plans show it as having hip roof yet the Consent Plans and built form is a flat roof.

21. Photo taken 20 February 2021 of large non-complying extendable awning attached to non-complying studio roof, over a non-complying deck (resting on non-complying footings) with non-complying glass panelling on deck with wooden bar on top with a non-complying 1.8m high planter box on western boundary fence inside the 900mm setback. Studio and deck being used prior to Occupational Certificate – Council has been notified at least 5 times of this use since Dec 2020.

Large non-complying extendable awning (installed 28 Jan 2021 – Council emailed 31 January 2021) - out over non-complying deck awning

Non-complying glass panelling with wooden bar on top

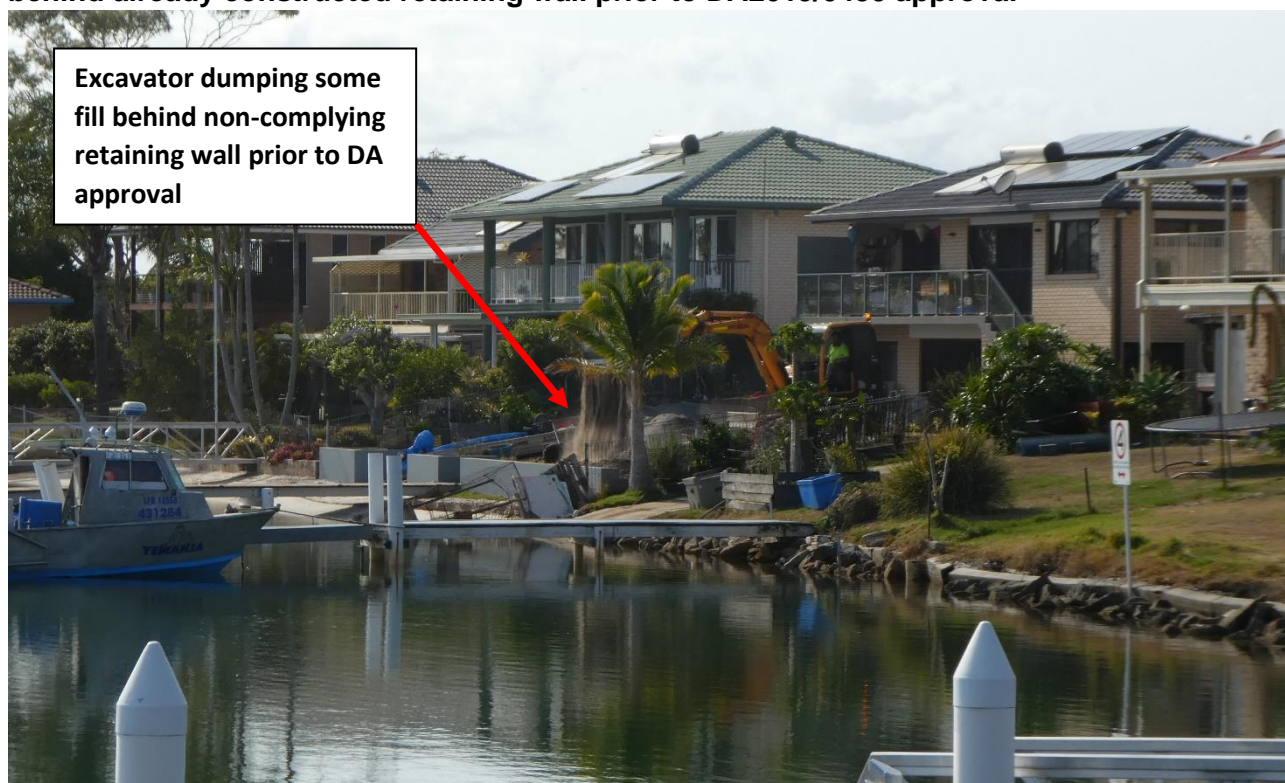
22 a). Photo taken 29 October 2019 – backyard of 19 Gumnut Road Yamba – excavator filling behind already constructed retaining wall prior to DA2019/0439 approval

Excavator dumping some fill behind non-complying retaining wall/footings prior to DA approval

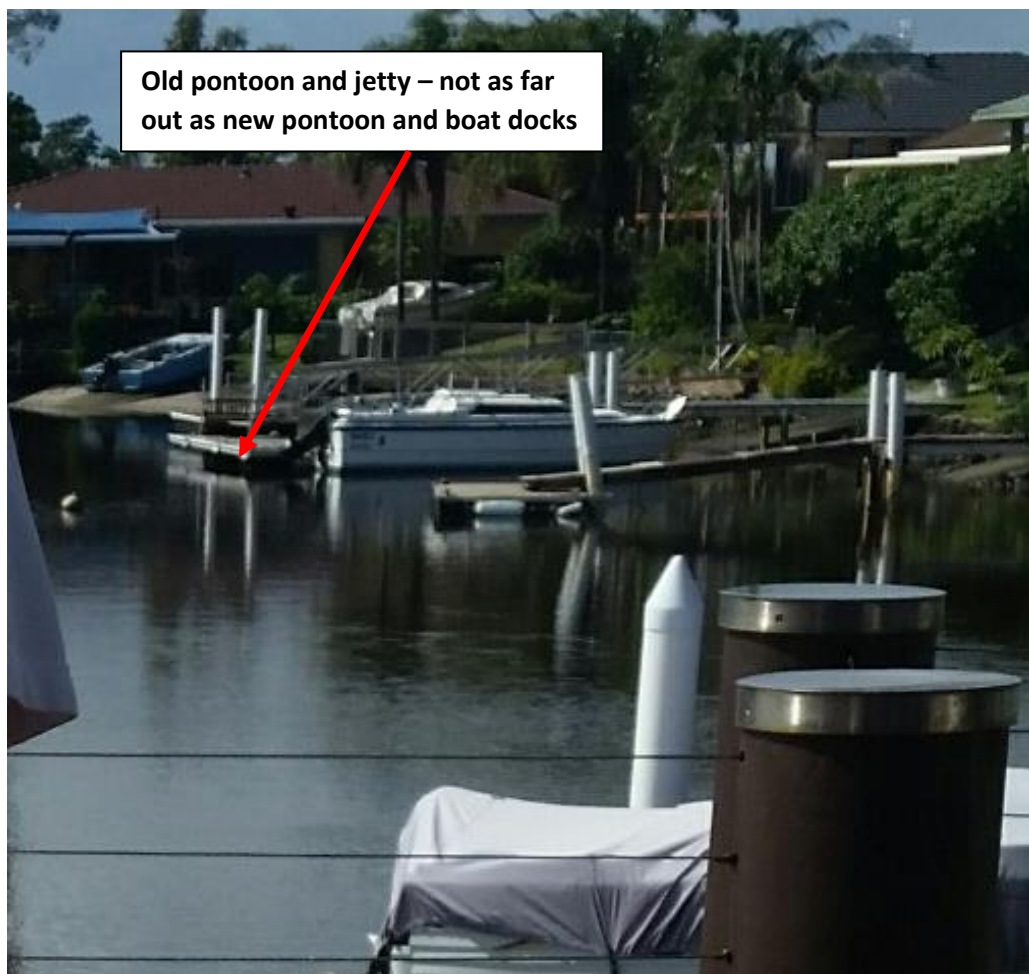
23. Photo taken 19 January 2018 – previous pontoon and jetty at 19 Gumnut Road Yamba – very different structure to new pontoon and jetty installed 30 September 2018.

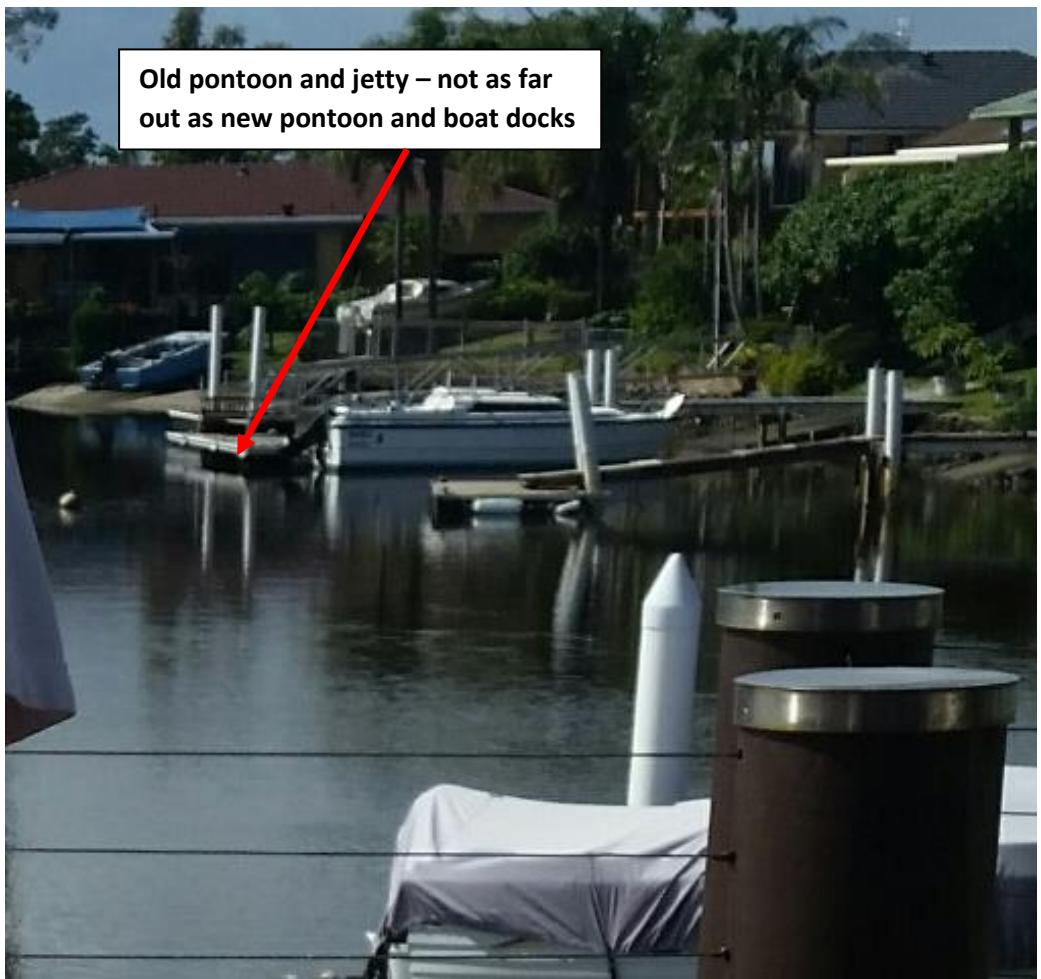
23. Photo taken 19 January 2018 – previous pontoon and jetty at 19 Gumnut Road Yamba – very different structure to new pontoon and jetty installed 30 September 2018.

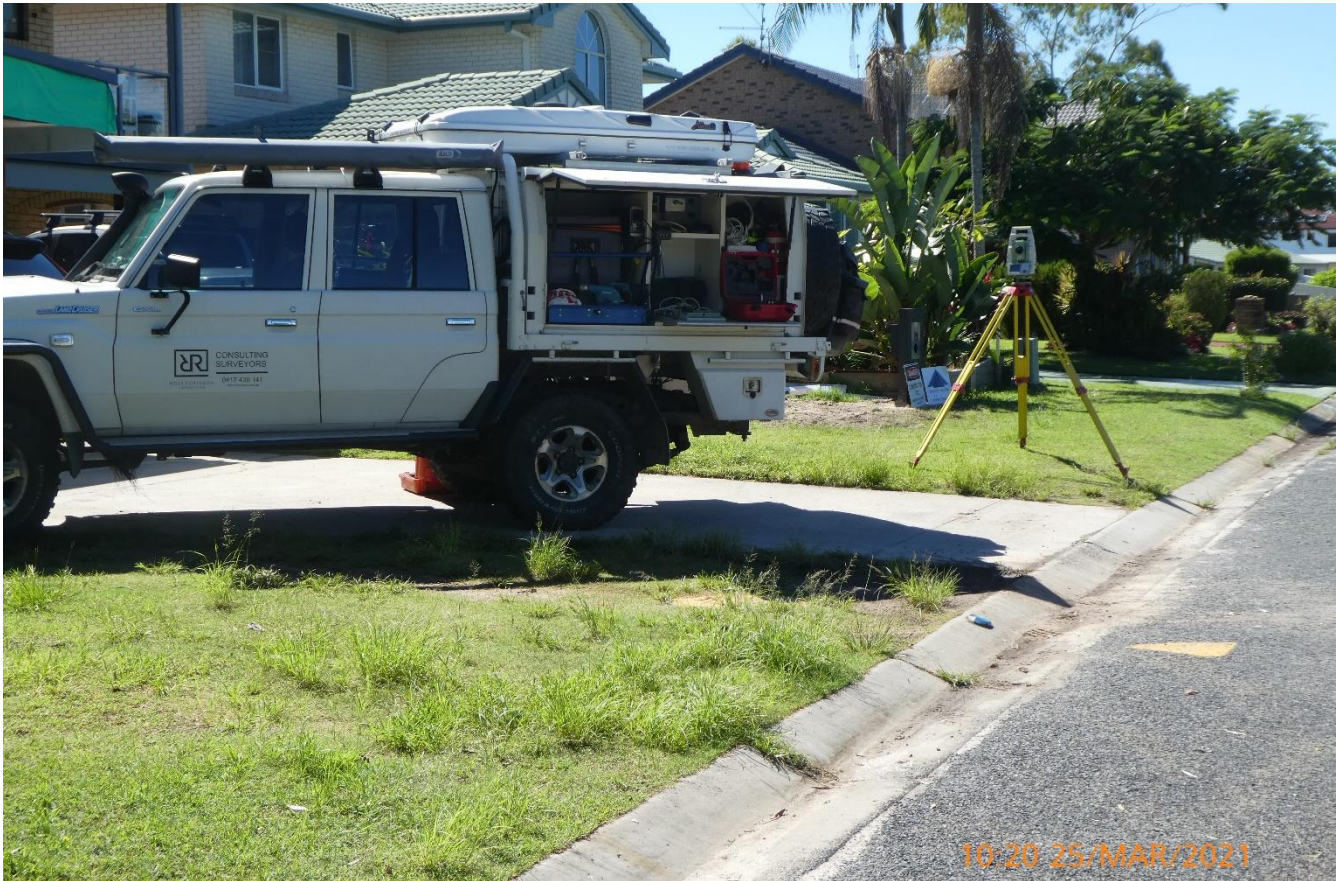
26. Photo taken at 10.20am 25 March 2021 at the front of 19 Gumnut Road Yamba – a surveyor on the property surveying it for the first time.

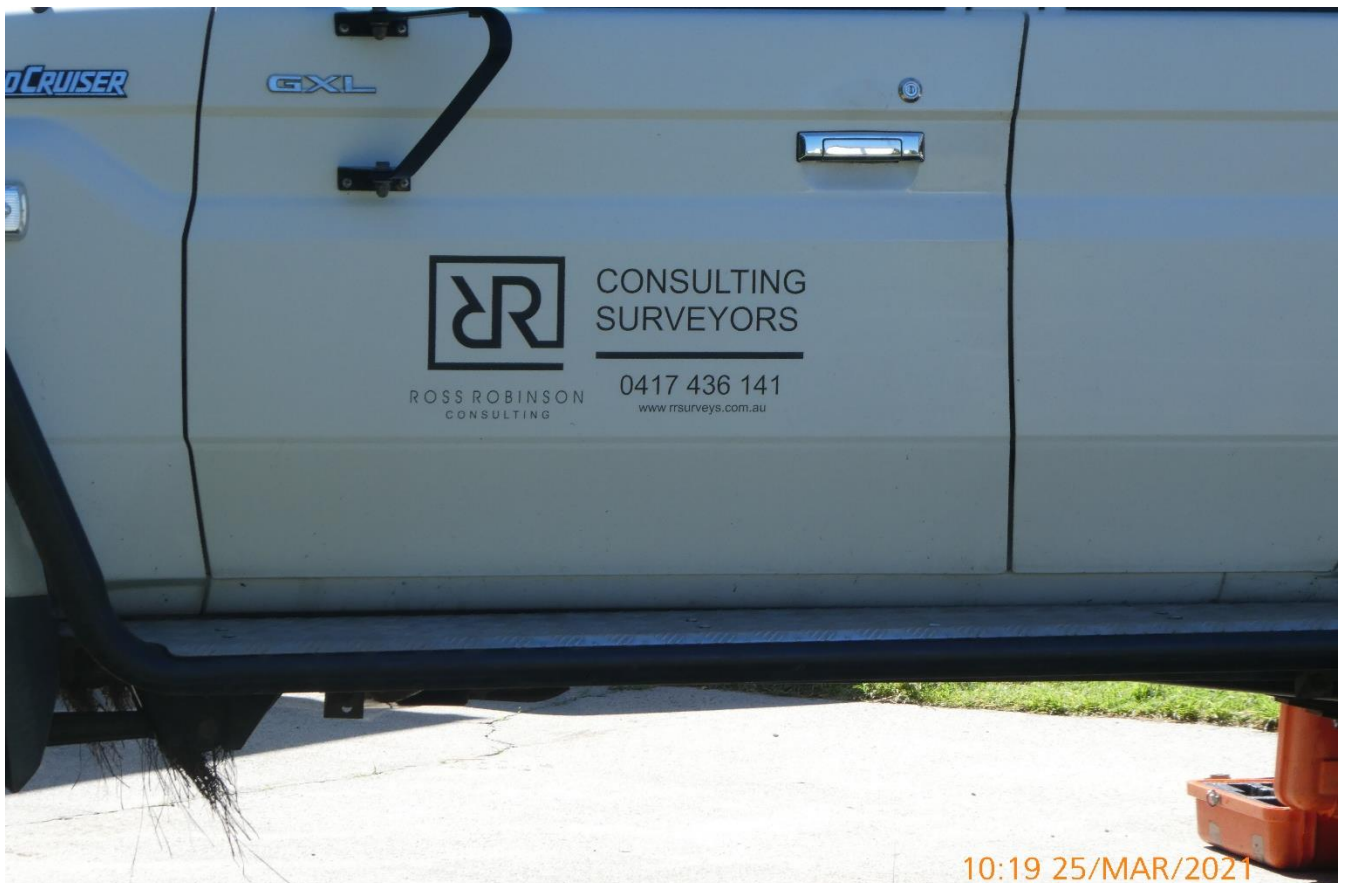
27. Photo taken at 10.19am 25 March 2021 at the front of 19 Gumnut Road Yamba – surveyor surveying the property for the first time

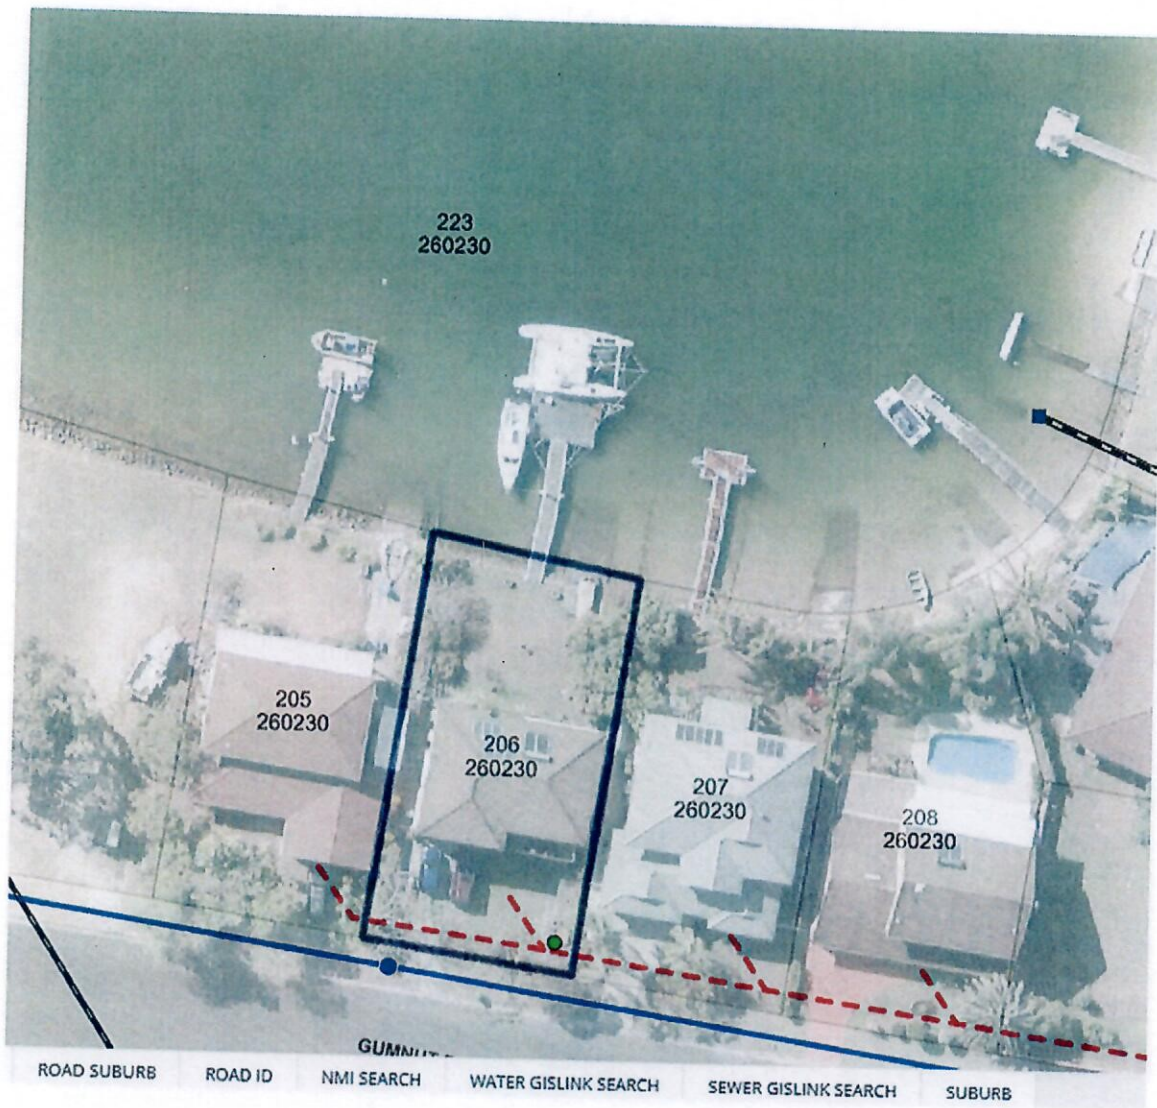
The adjoining (no17) living room has a setback of 4.5 metres from the eastern boundary (garage has a 1.5m side setback) and one window with dimensions of 1.8 x 0.9 however has multiple windows on the northern elevation as detailed below.

The views from No 17 are predominately to the north as the property is located at the end of the canal.
