Title
Erosion and recession hazard zones - Present Day: Brooms Head

Project
2021s1471 - Hydrosphere - CVC CMP Stage 2 - 4

Client
Hydrosphere Consulting

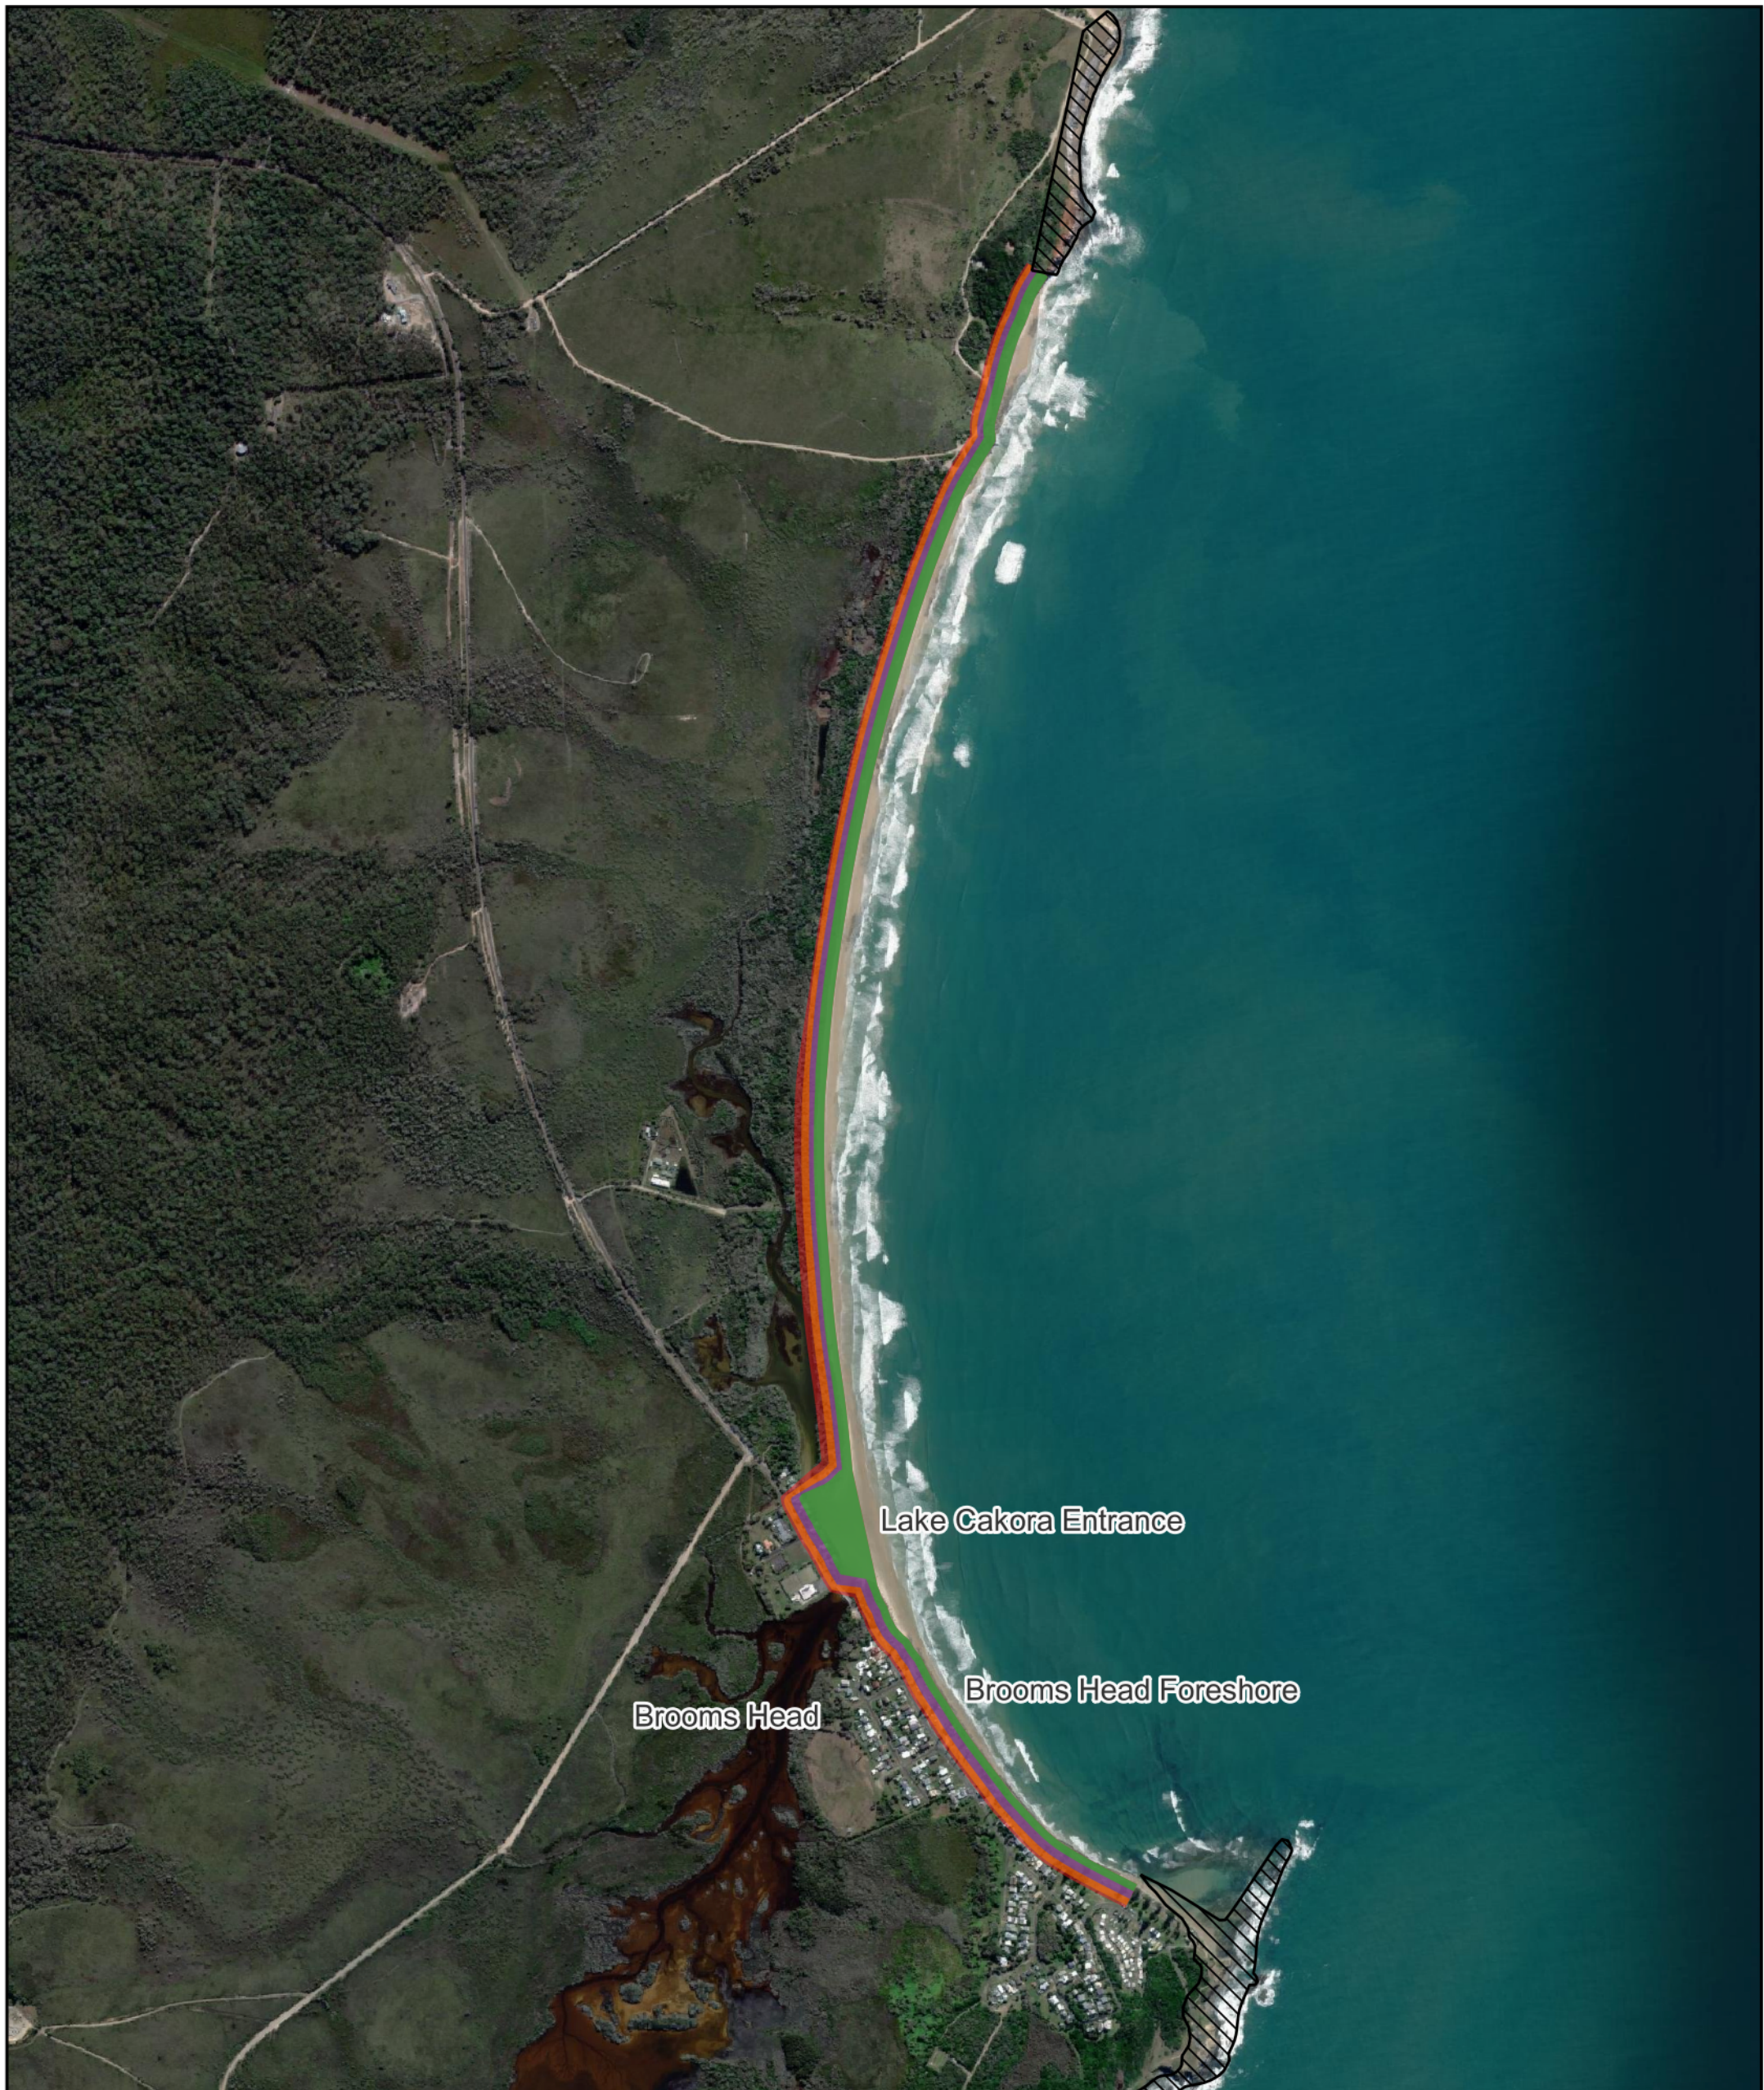
Erosion and recession hazard zones (without protection)

50% exceedance probability

10% exceedance probability

2% exceedance probability

1% exceedance probability

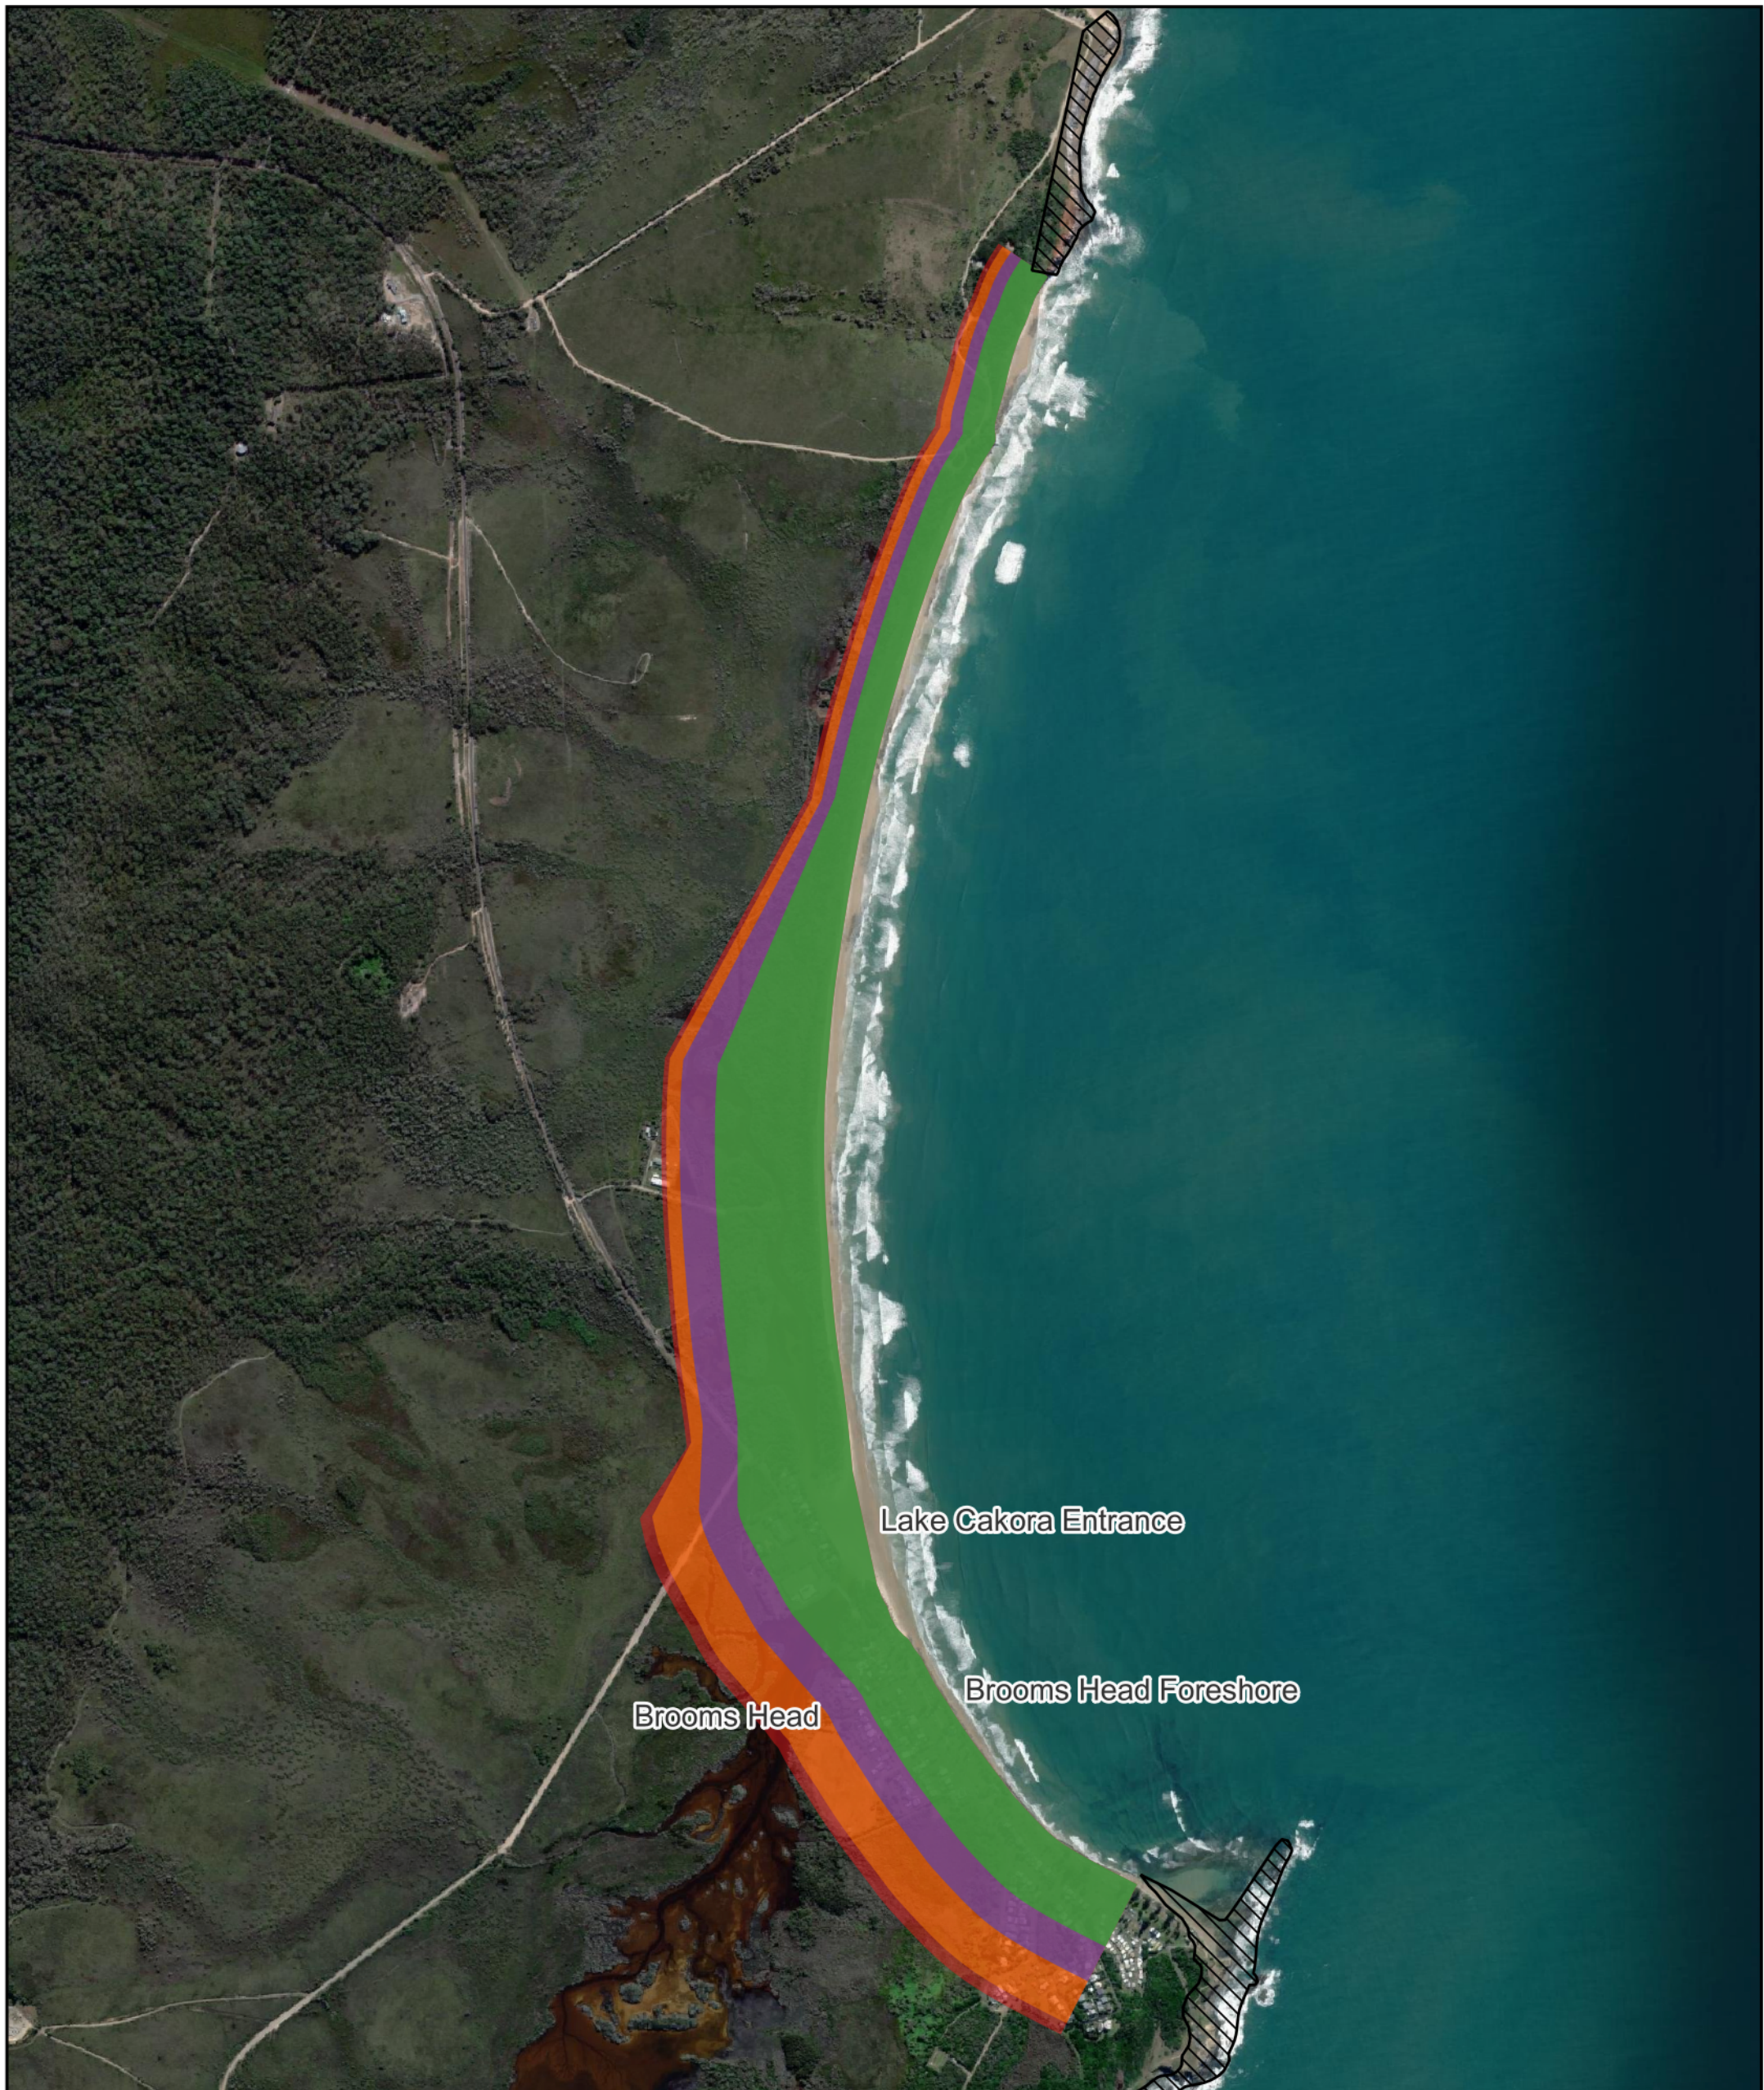
Title
 Erosion and recession hazard zones -SSP5 2123: Brooms Head

- Erosion and recession hazard zones (without protection)
- 50% exceedance probability
 - 10% exceedance probability
 - 2% exceedance probability
 - 1% exceedance probability
 - Bedrock
