**Title**  
Erosion and recession hazard zones - Present Day: Diggers Camp

**Project**  
2021s1471 - Hydrosphere - CVC CMP Stage 2 - 4

**Client**  
Hydrosphere Consulting

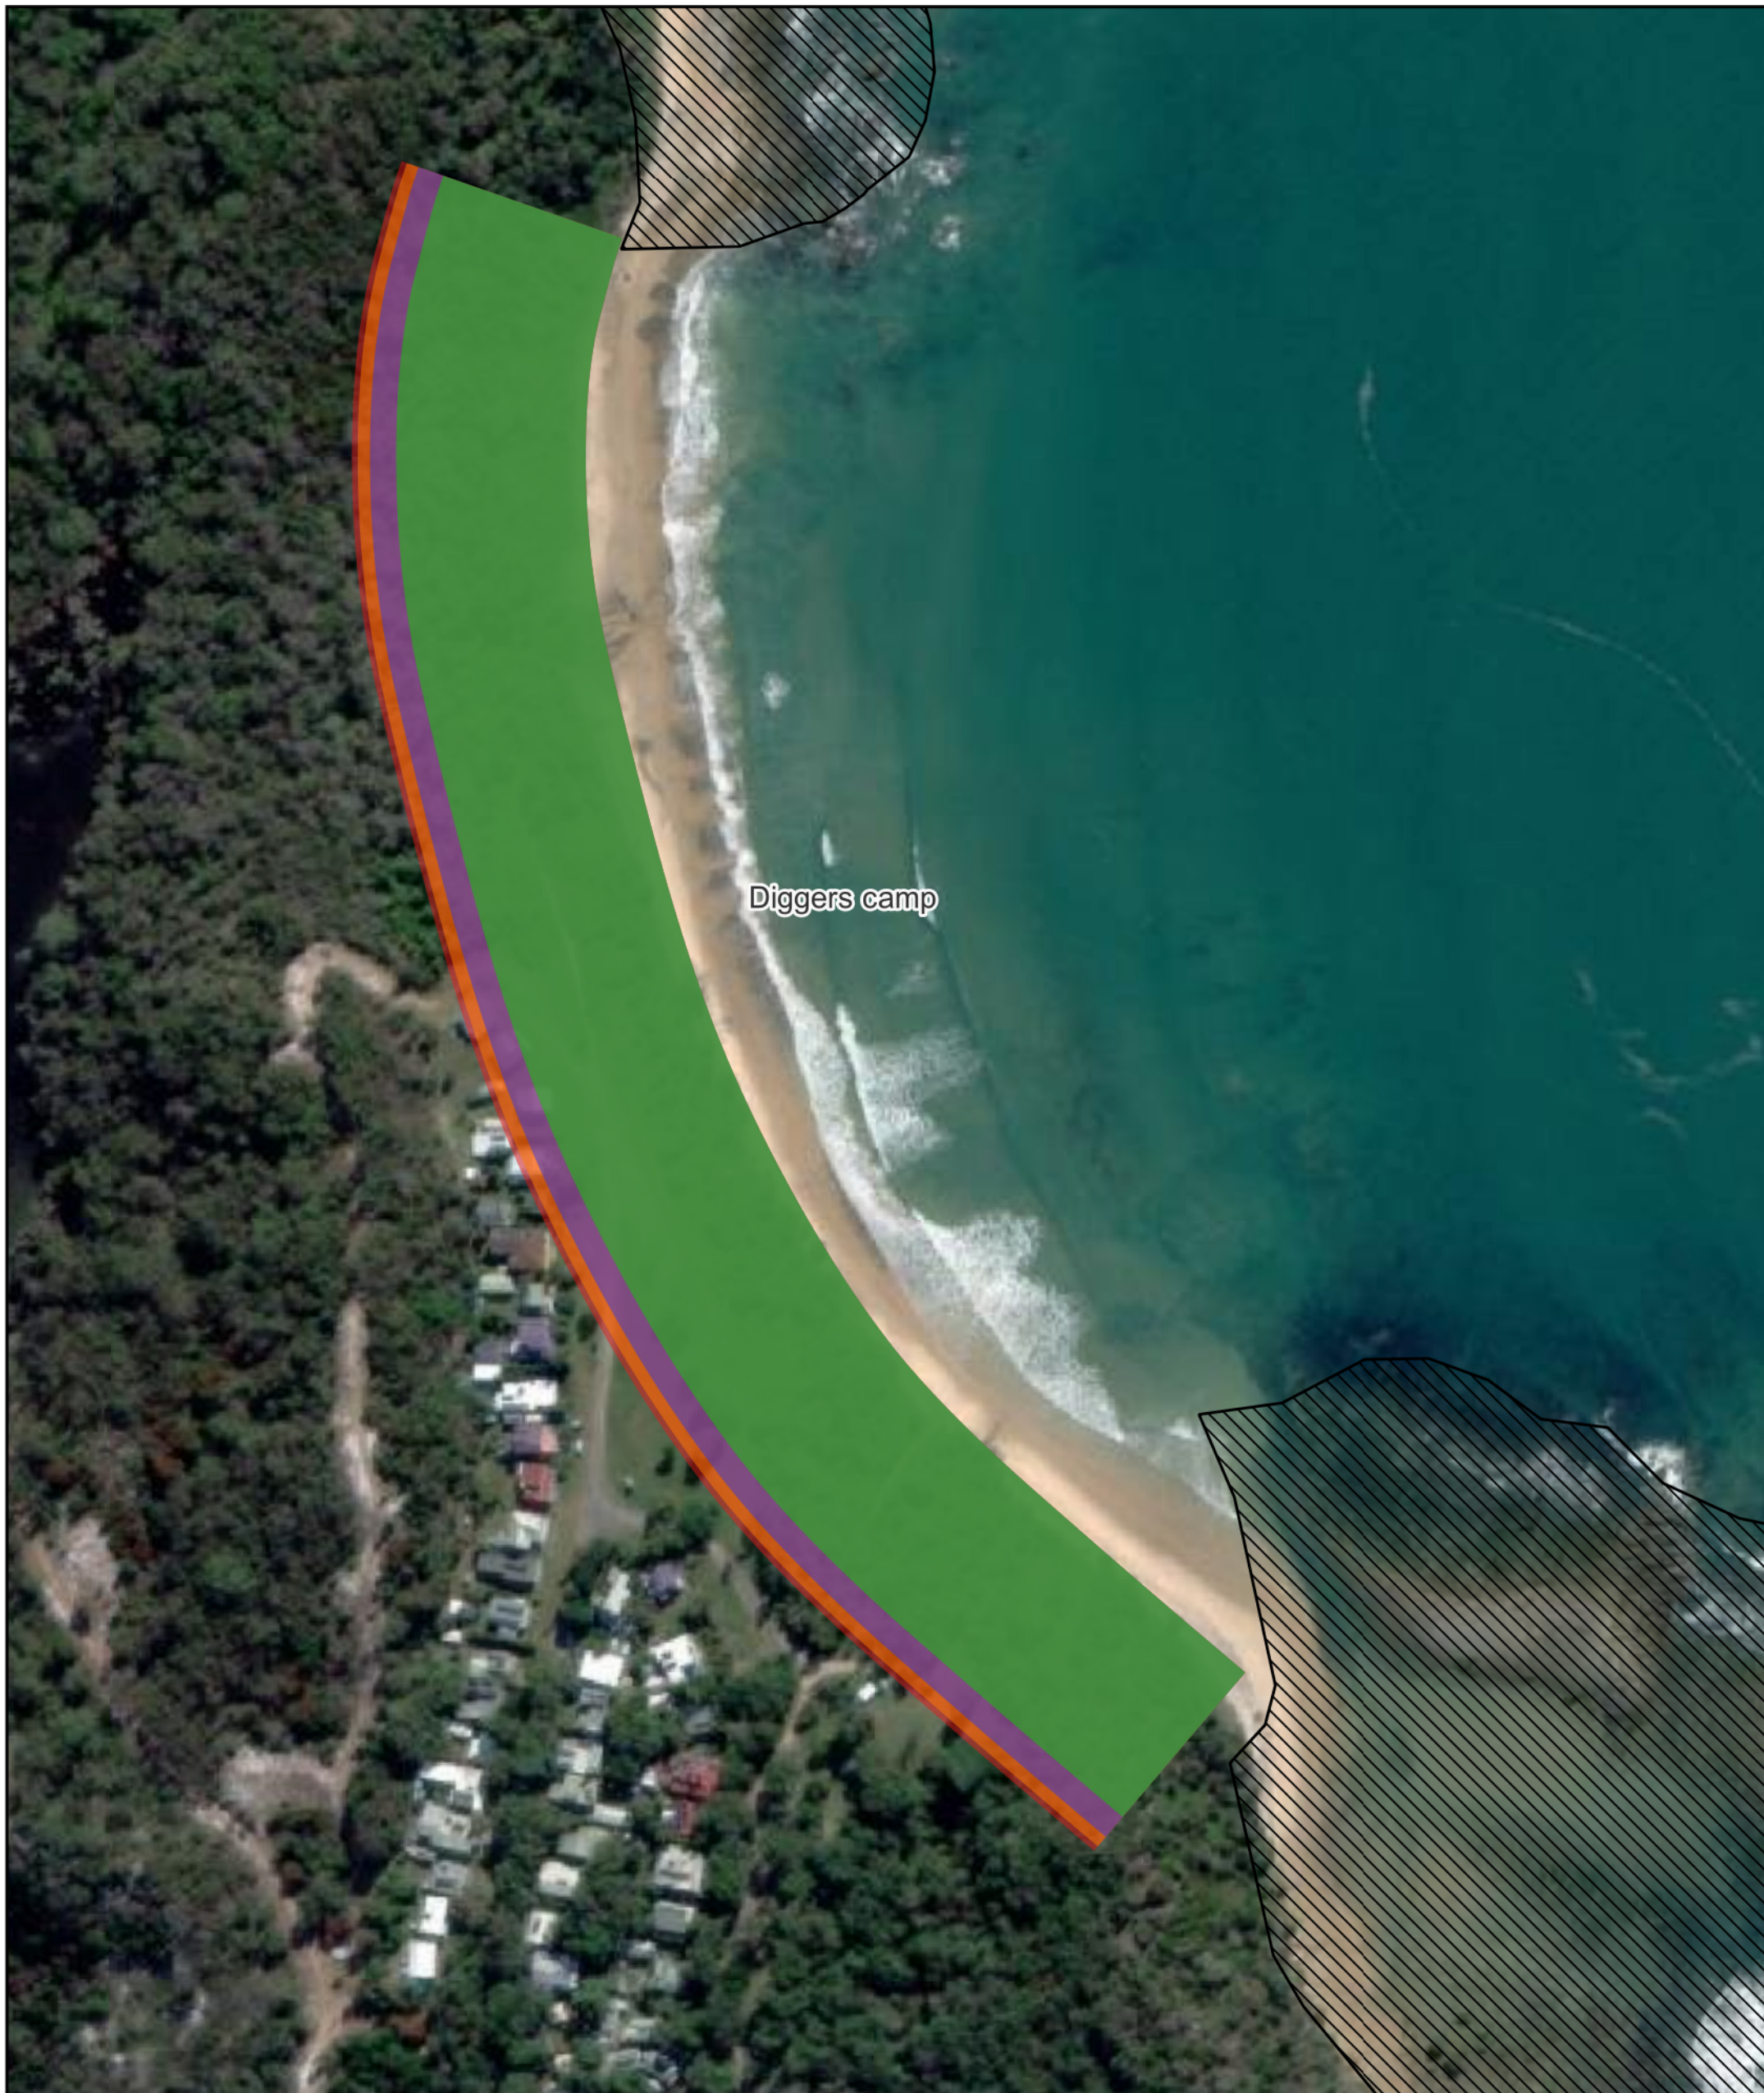
**Title**  
Erosion and recession hazard zones -SSP2 2043: Diggers Camp

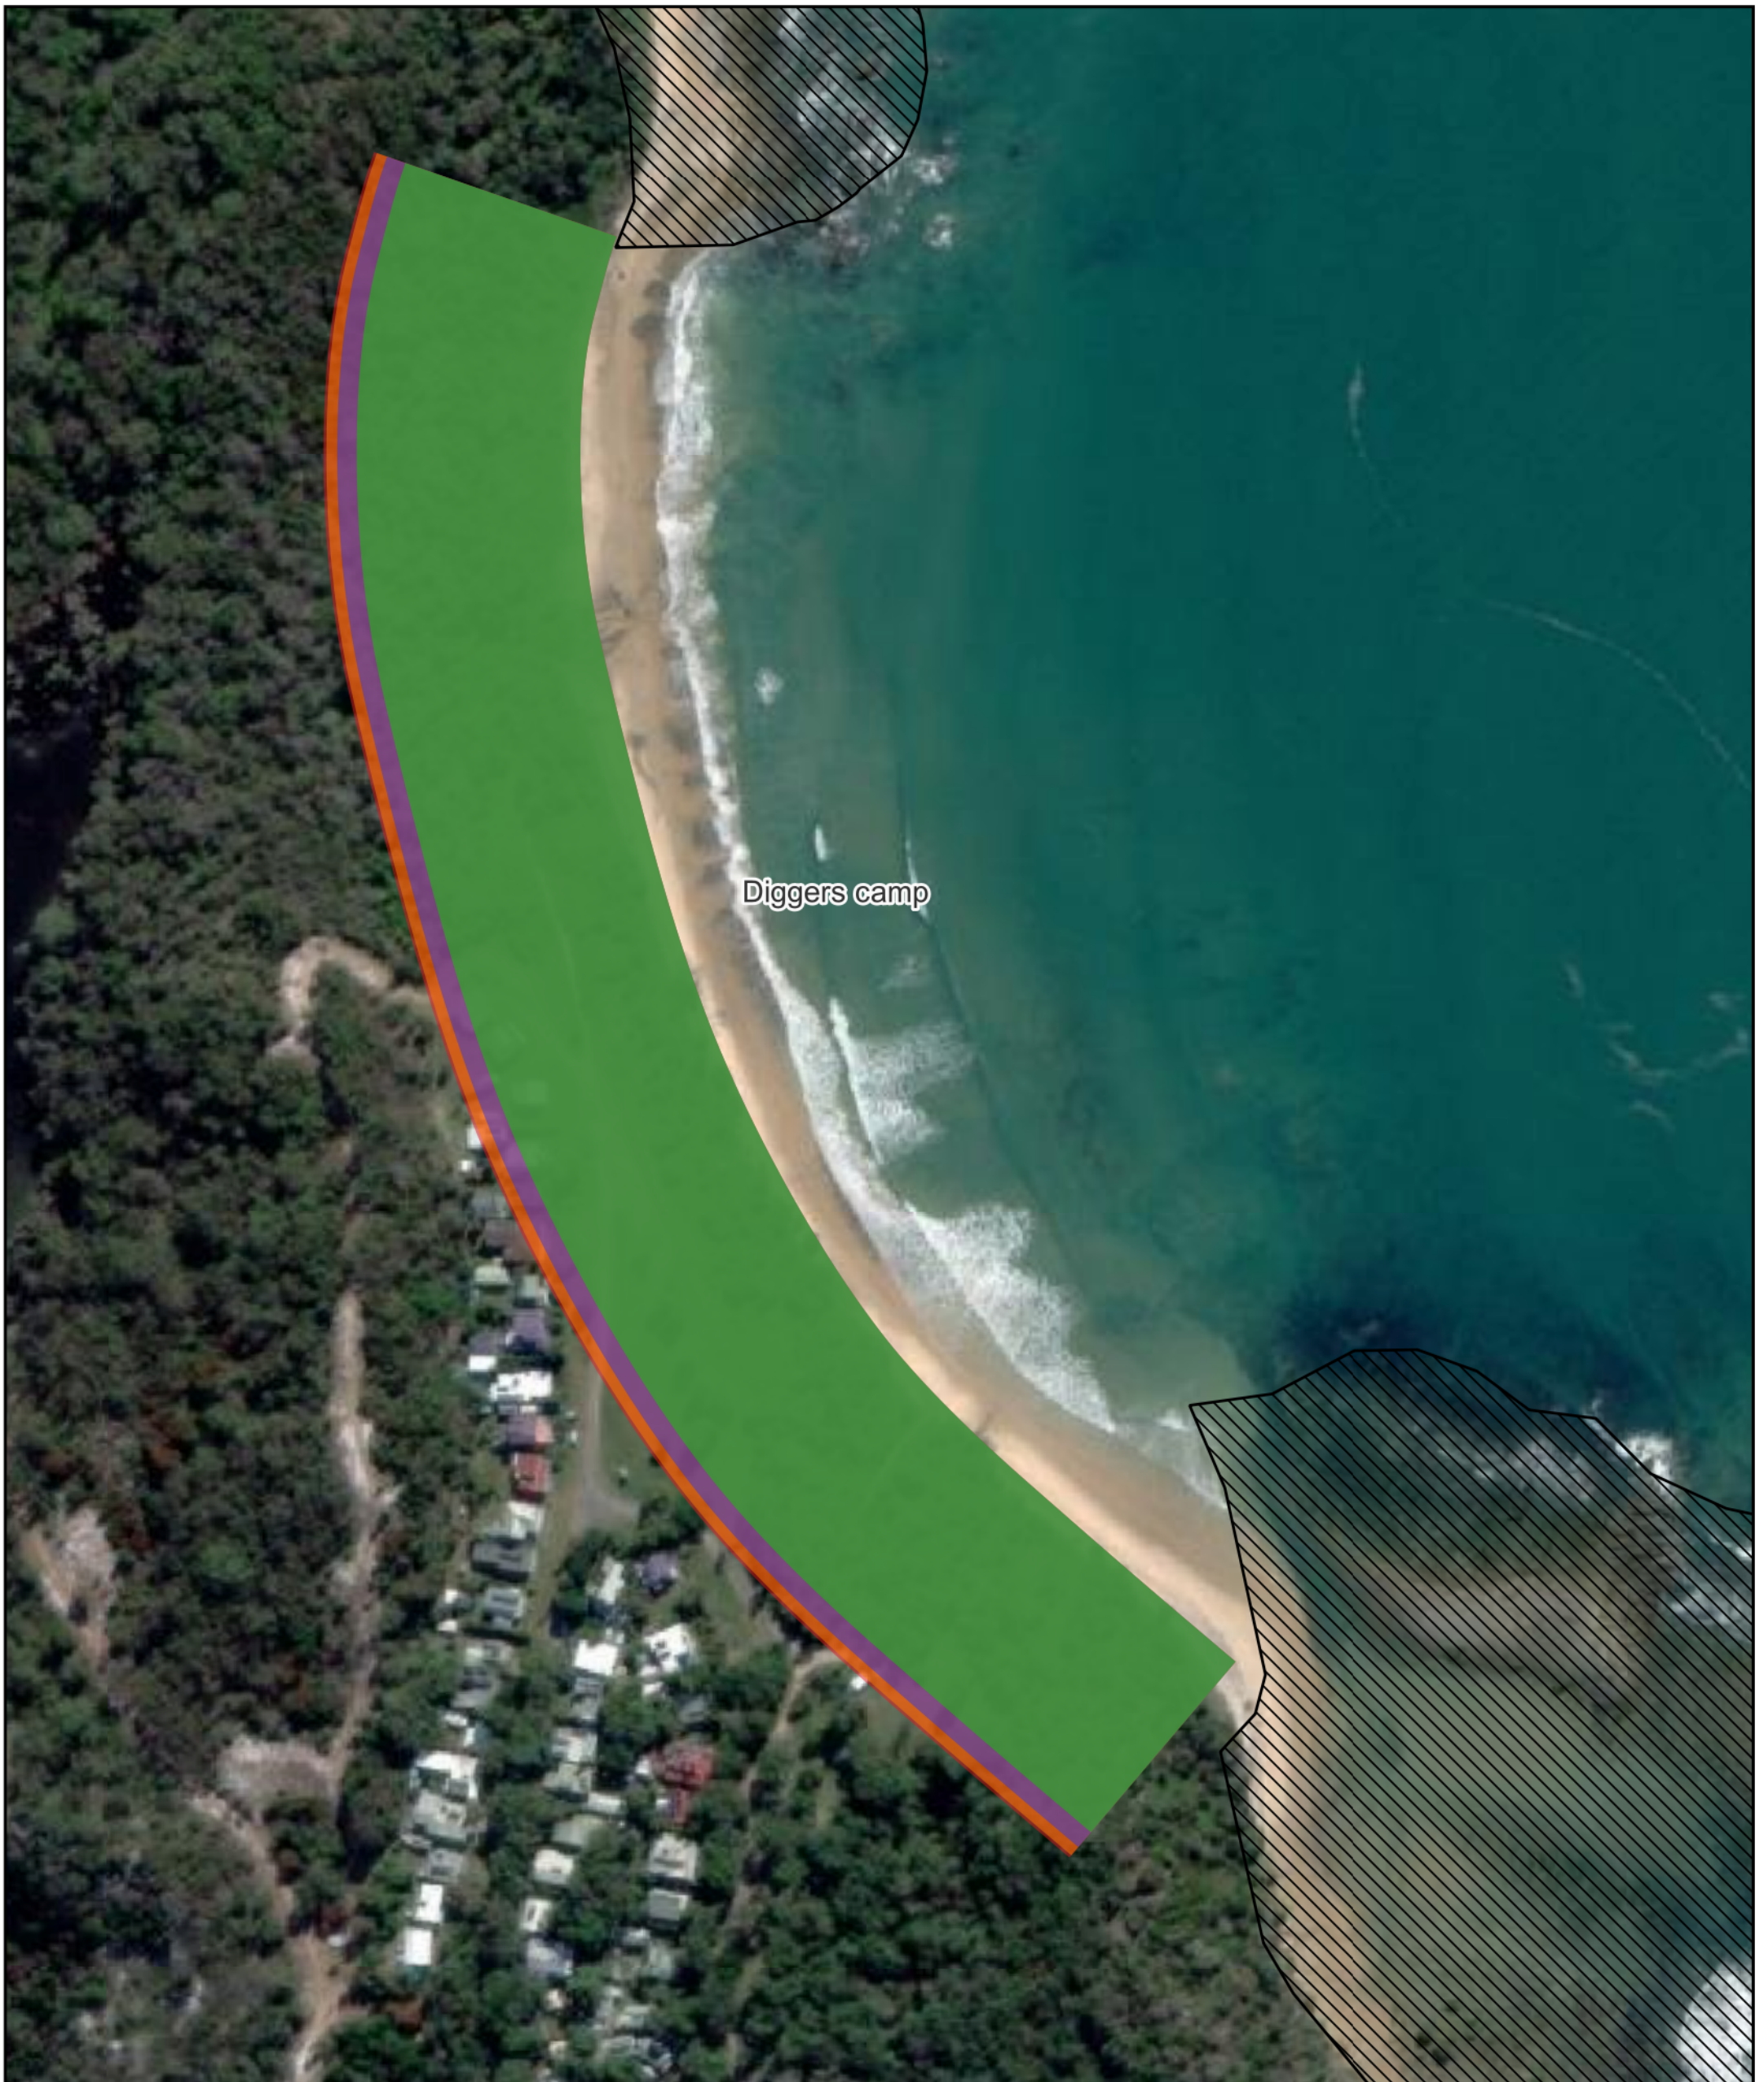
**Title**  
Erosion and recession hazard zones -SSP2 2073: Diggers Camp

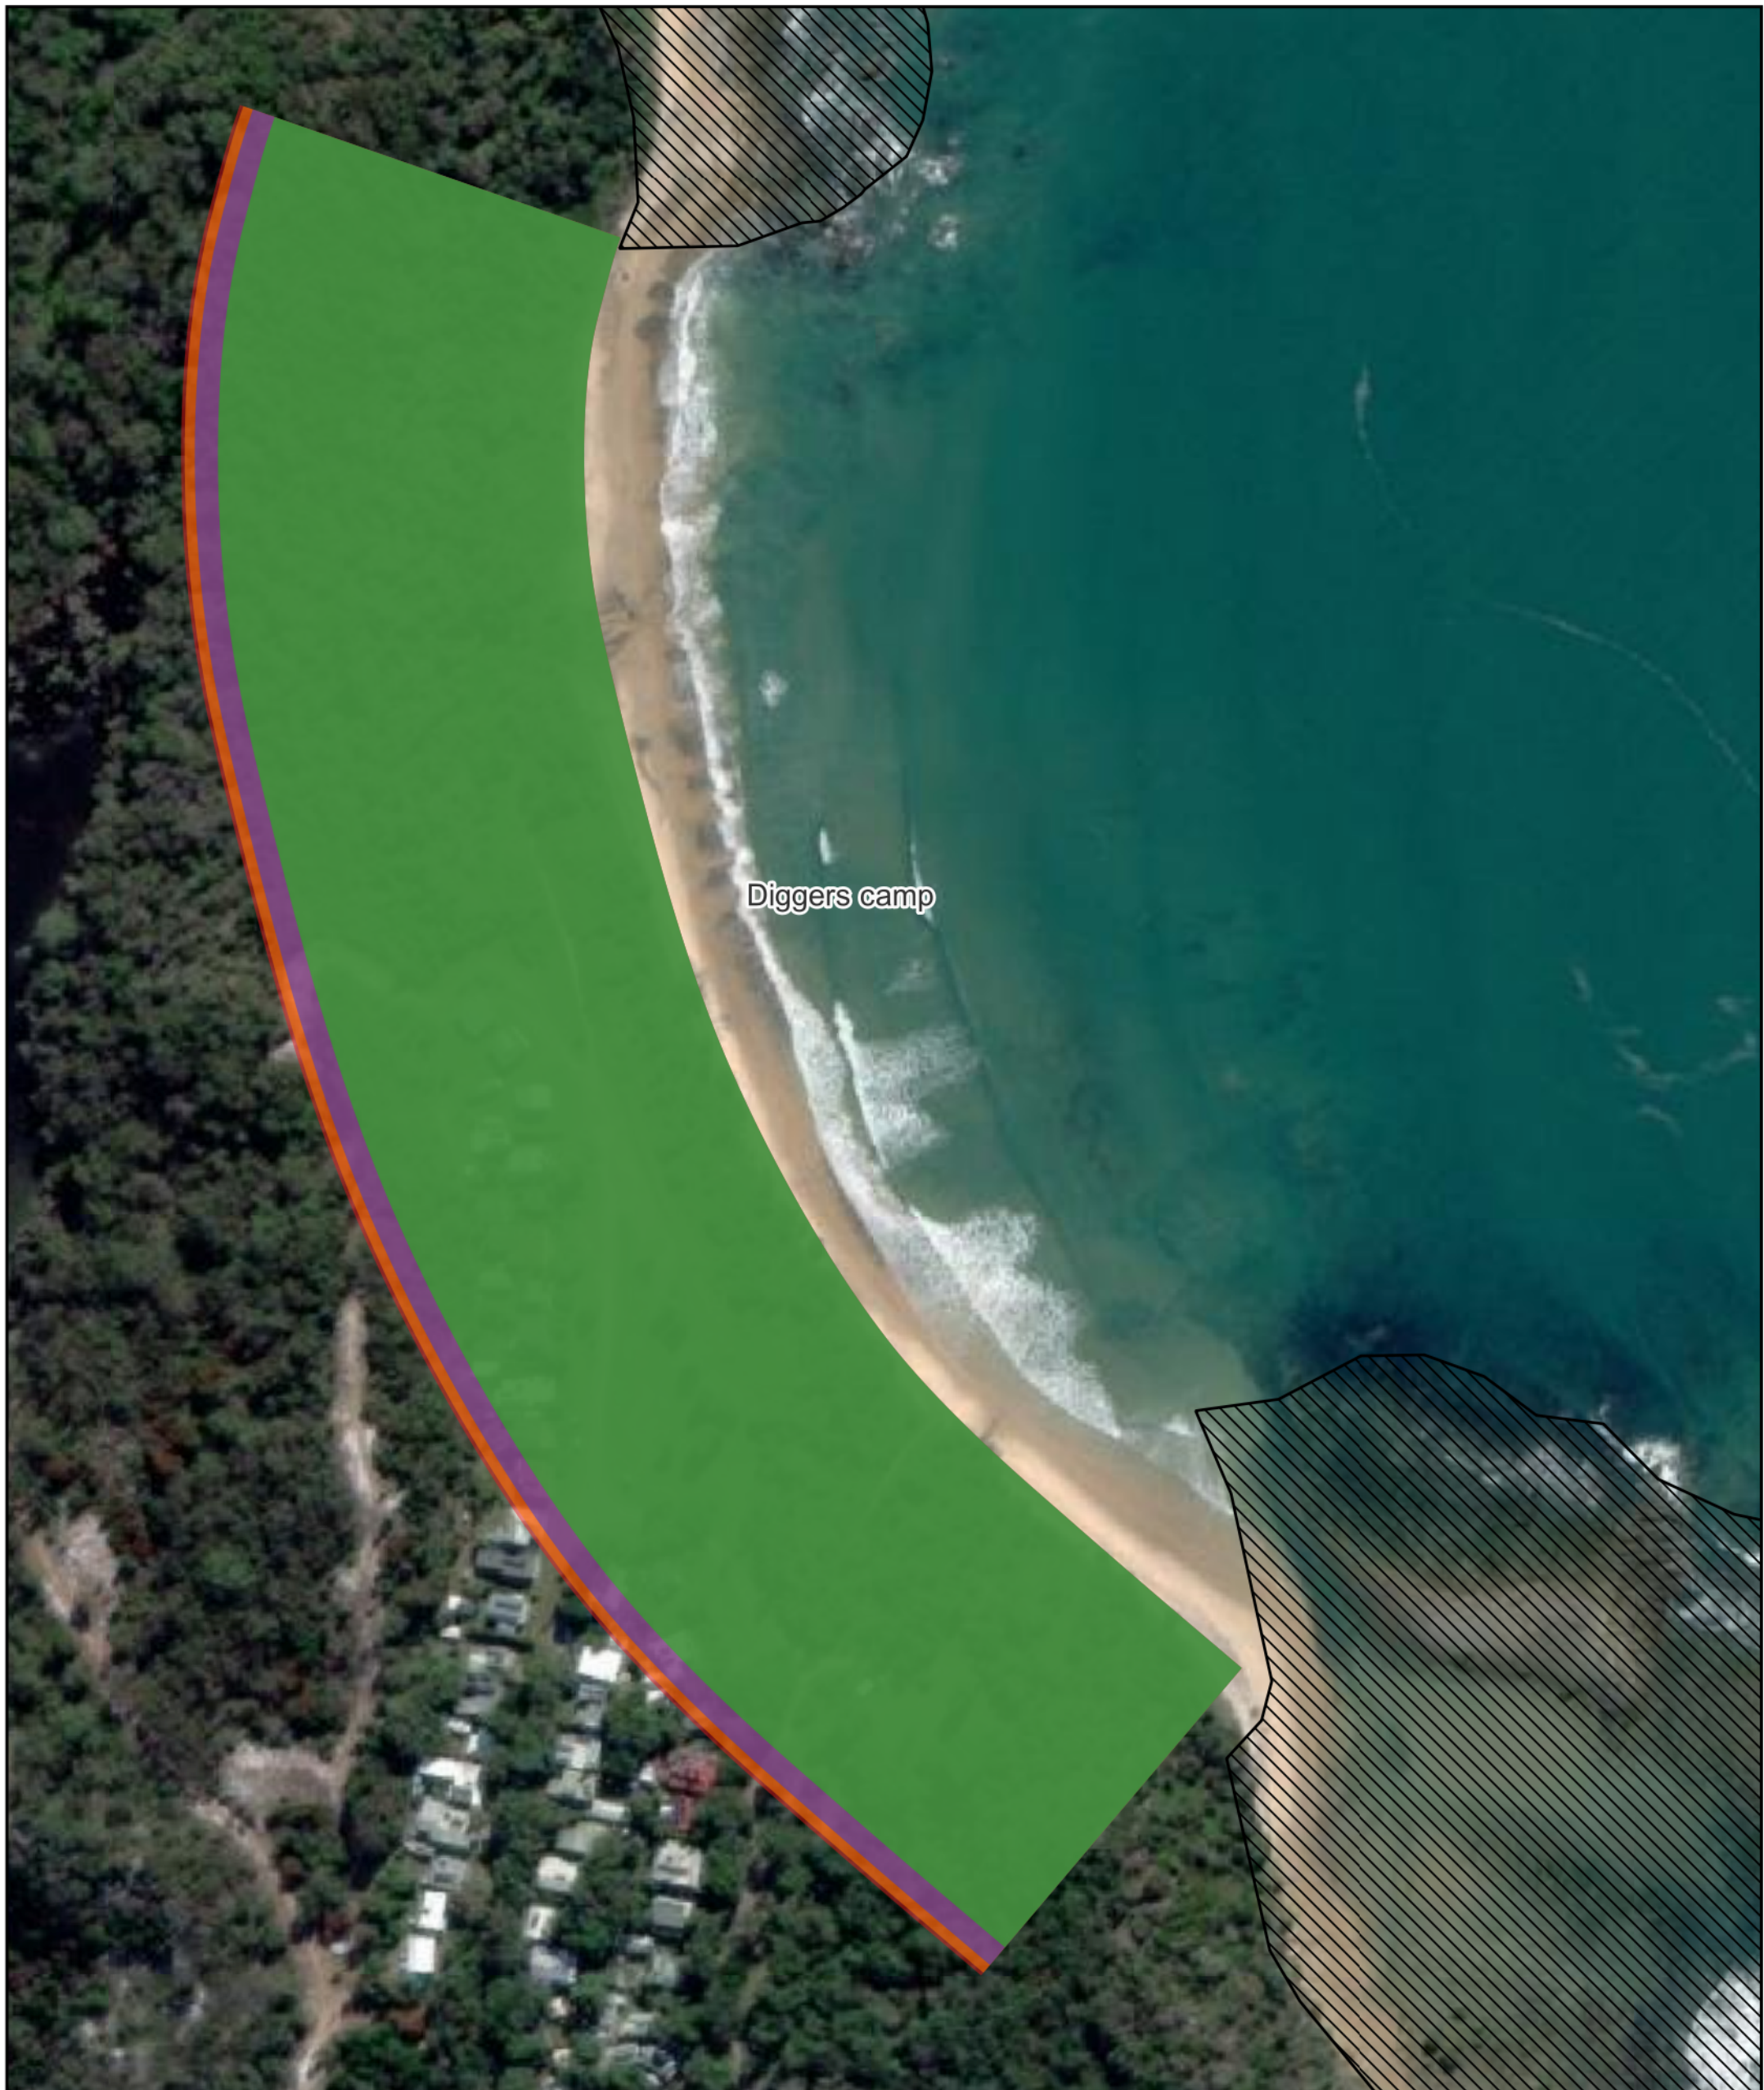
**Title**  
Erosion and recession hazard zones -SSP2 2123: Diggers Camp

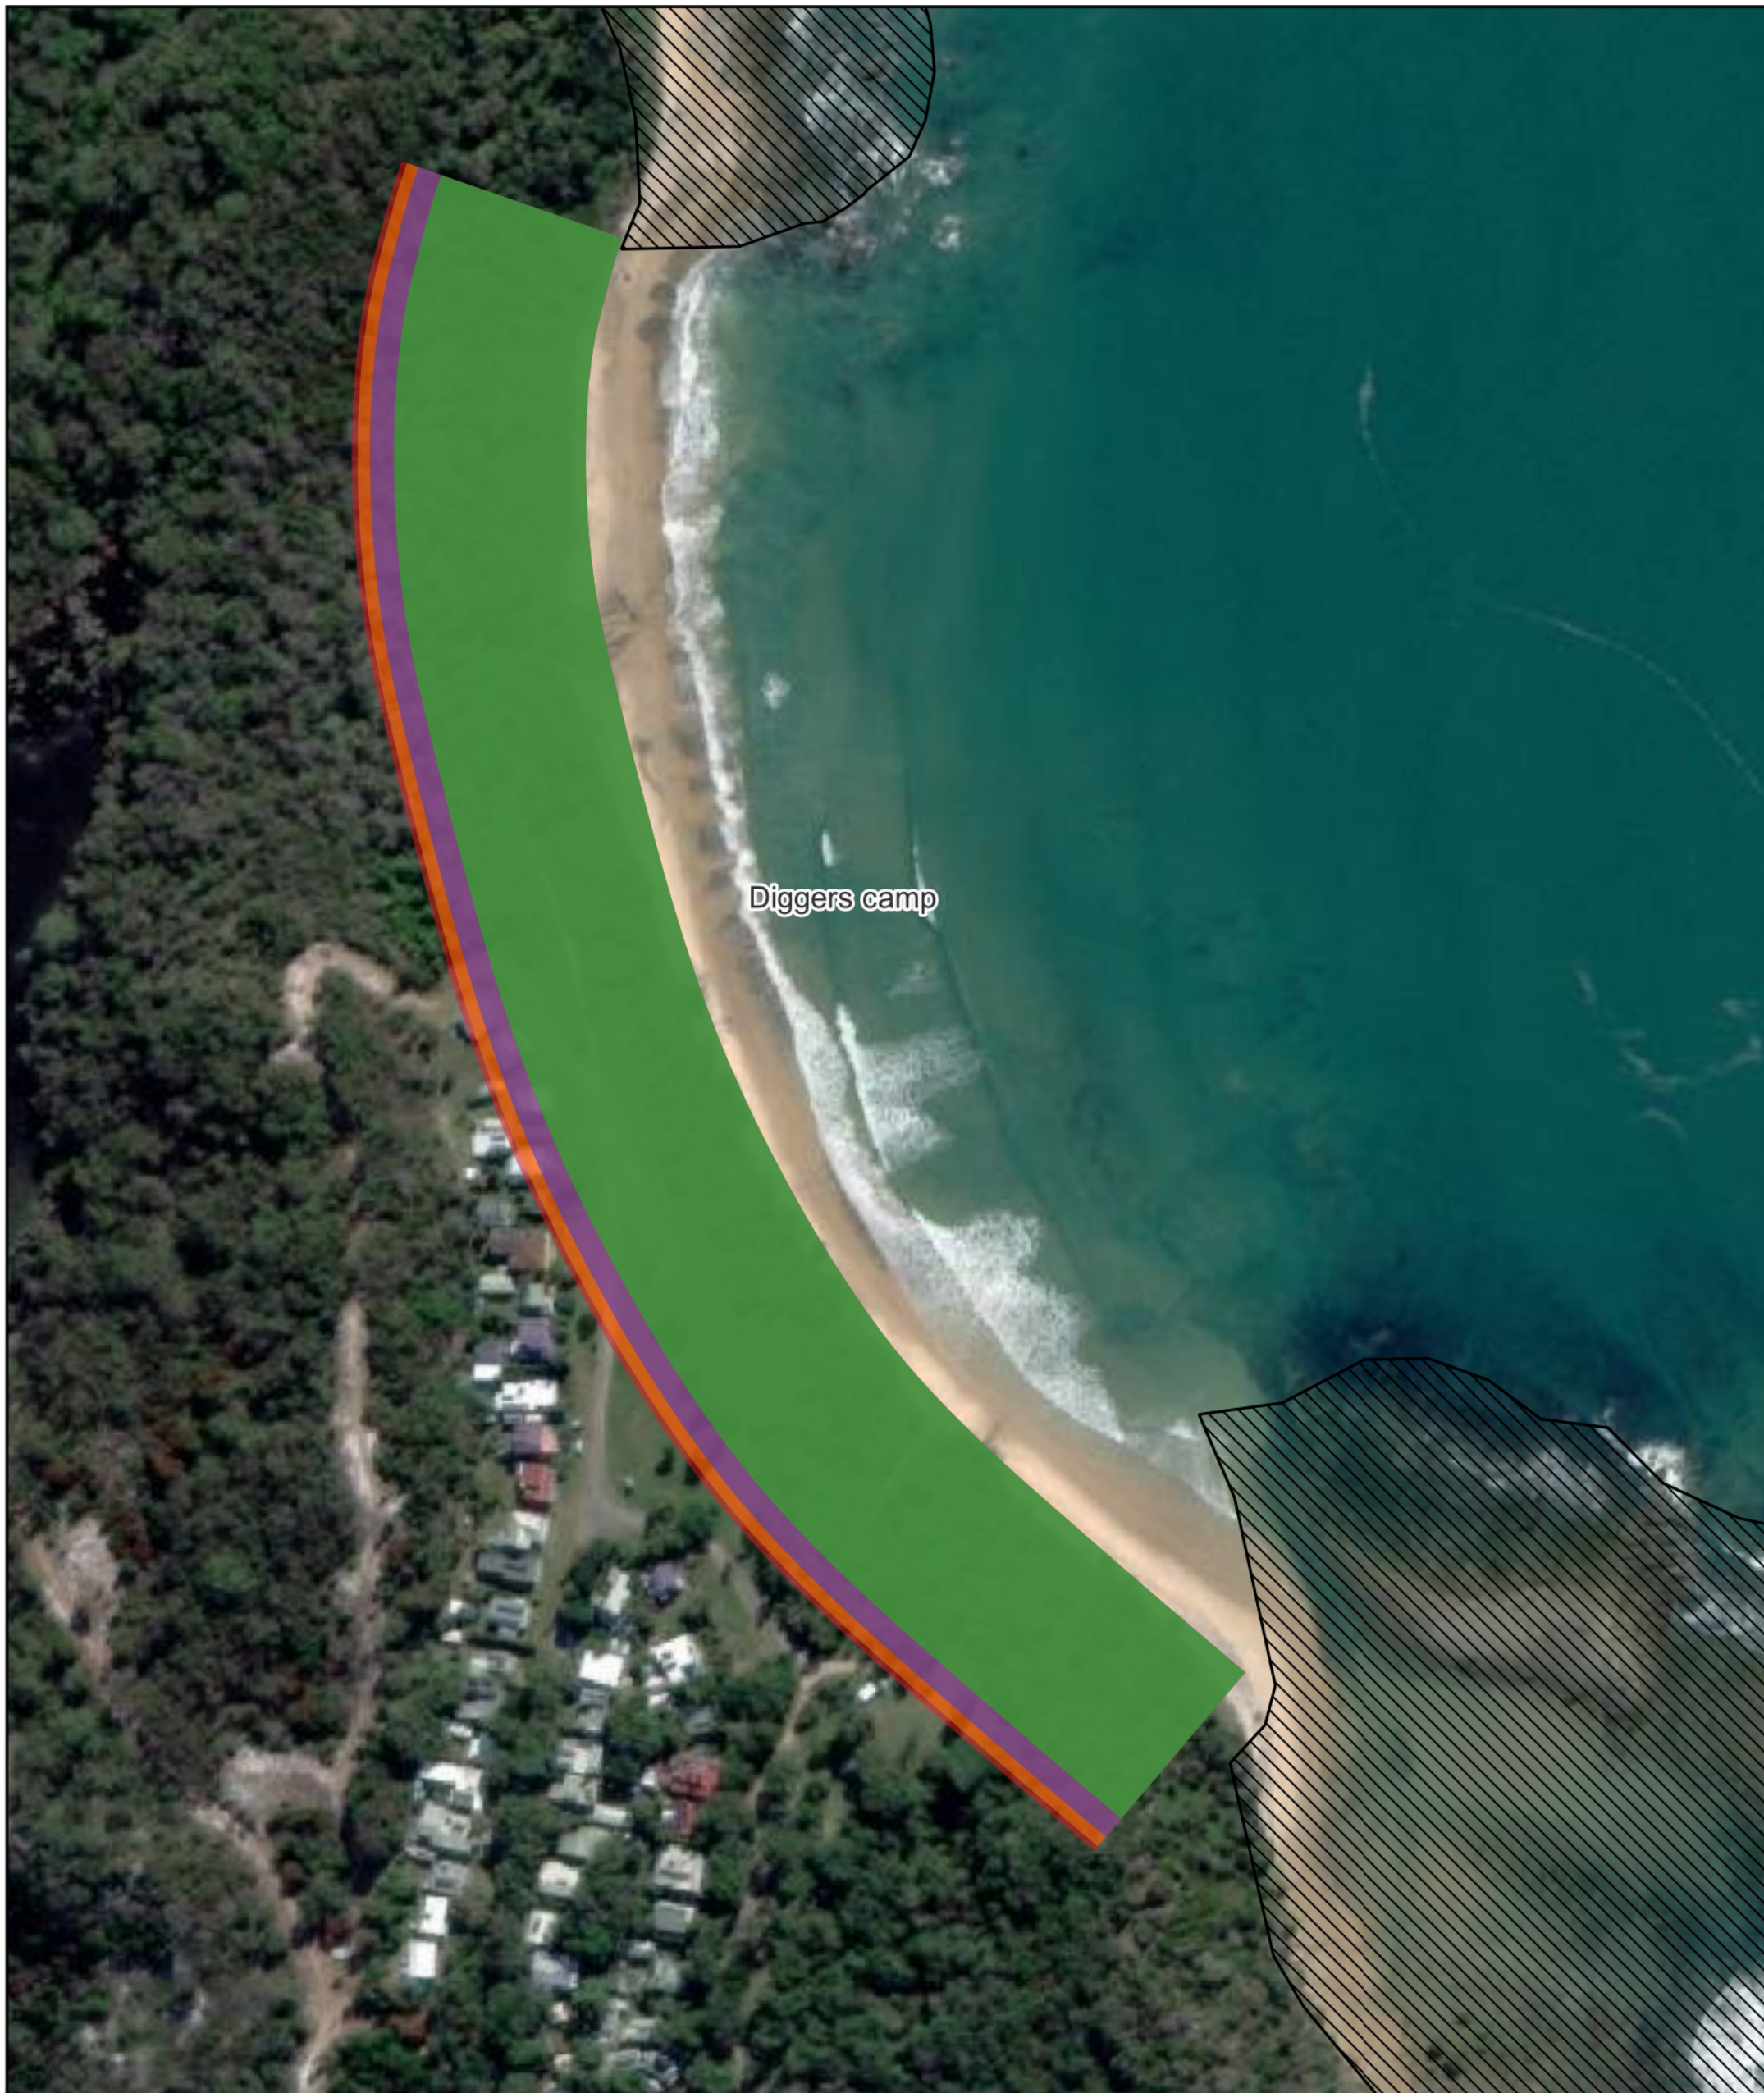
**Title**  
Erosion and recession hazard zones -SSP5 2043: Diggers Camp

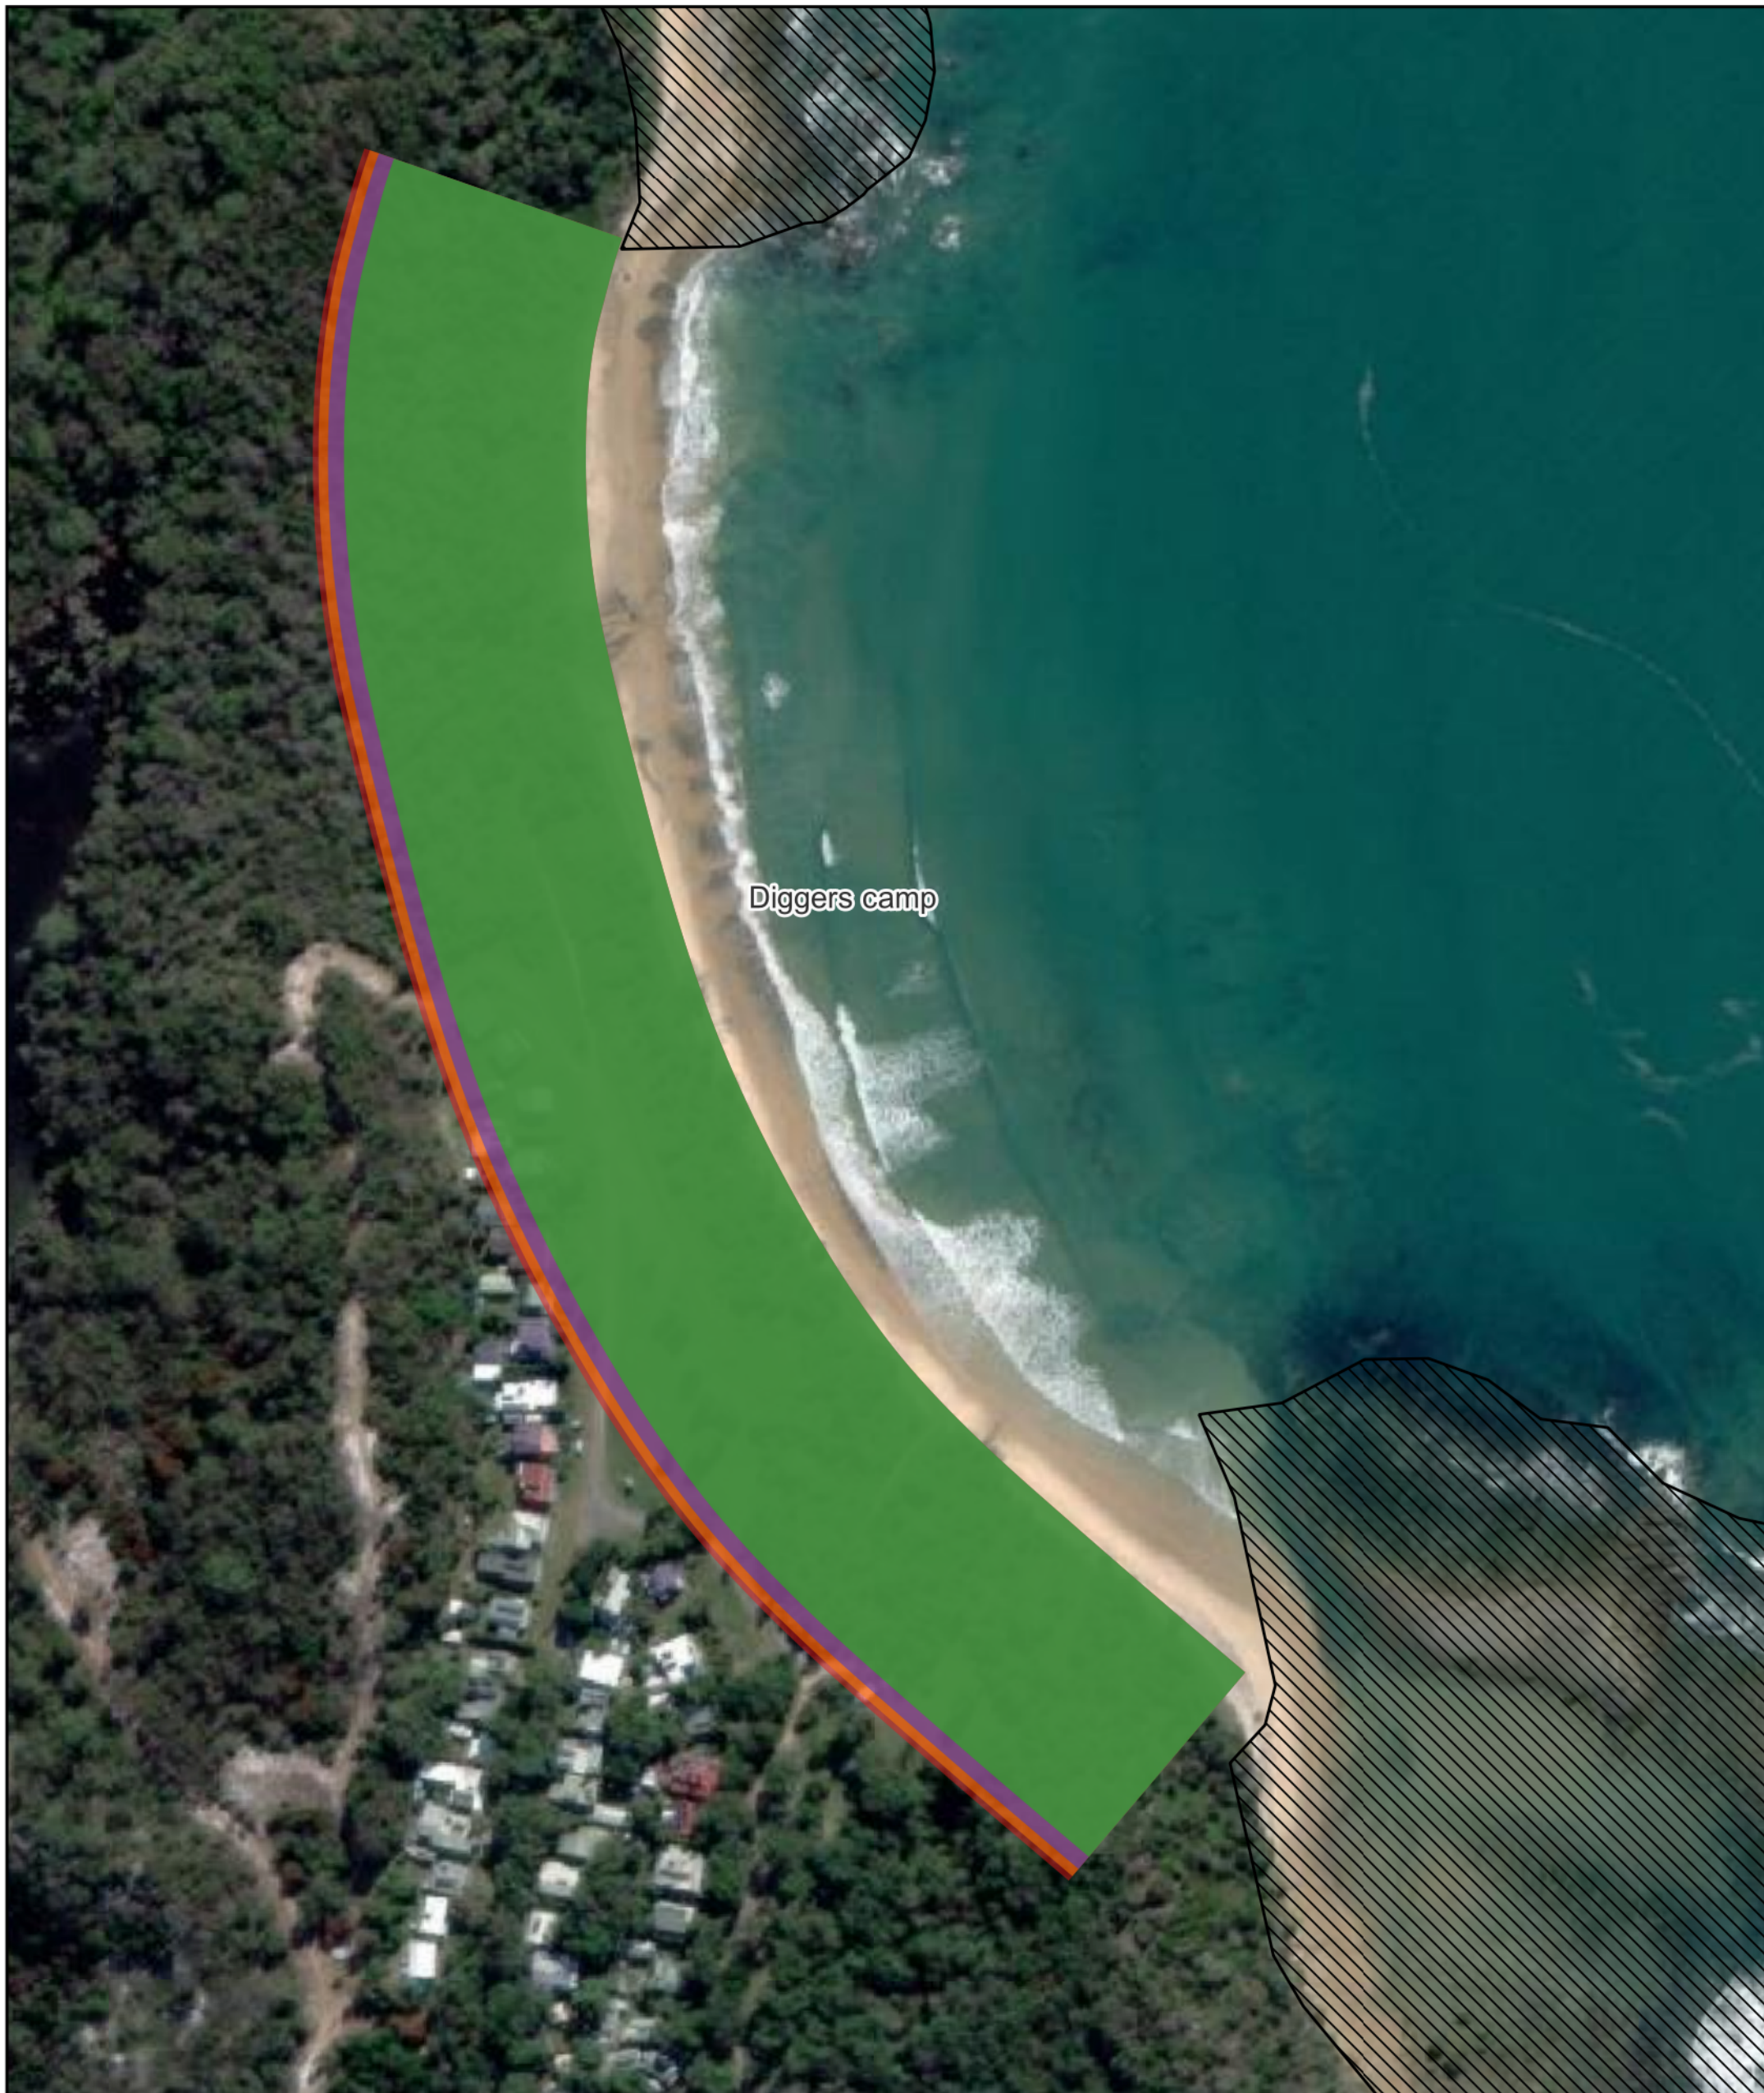
**Title**  
Erosion and recession hazard zones -SSP5 2073: Diggers Camp

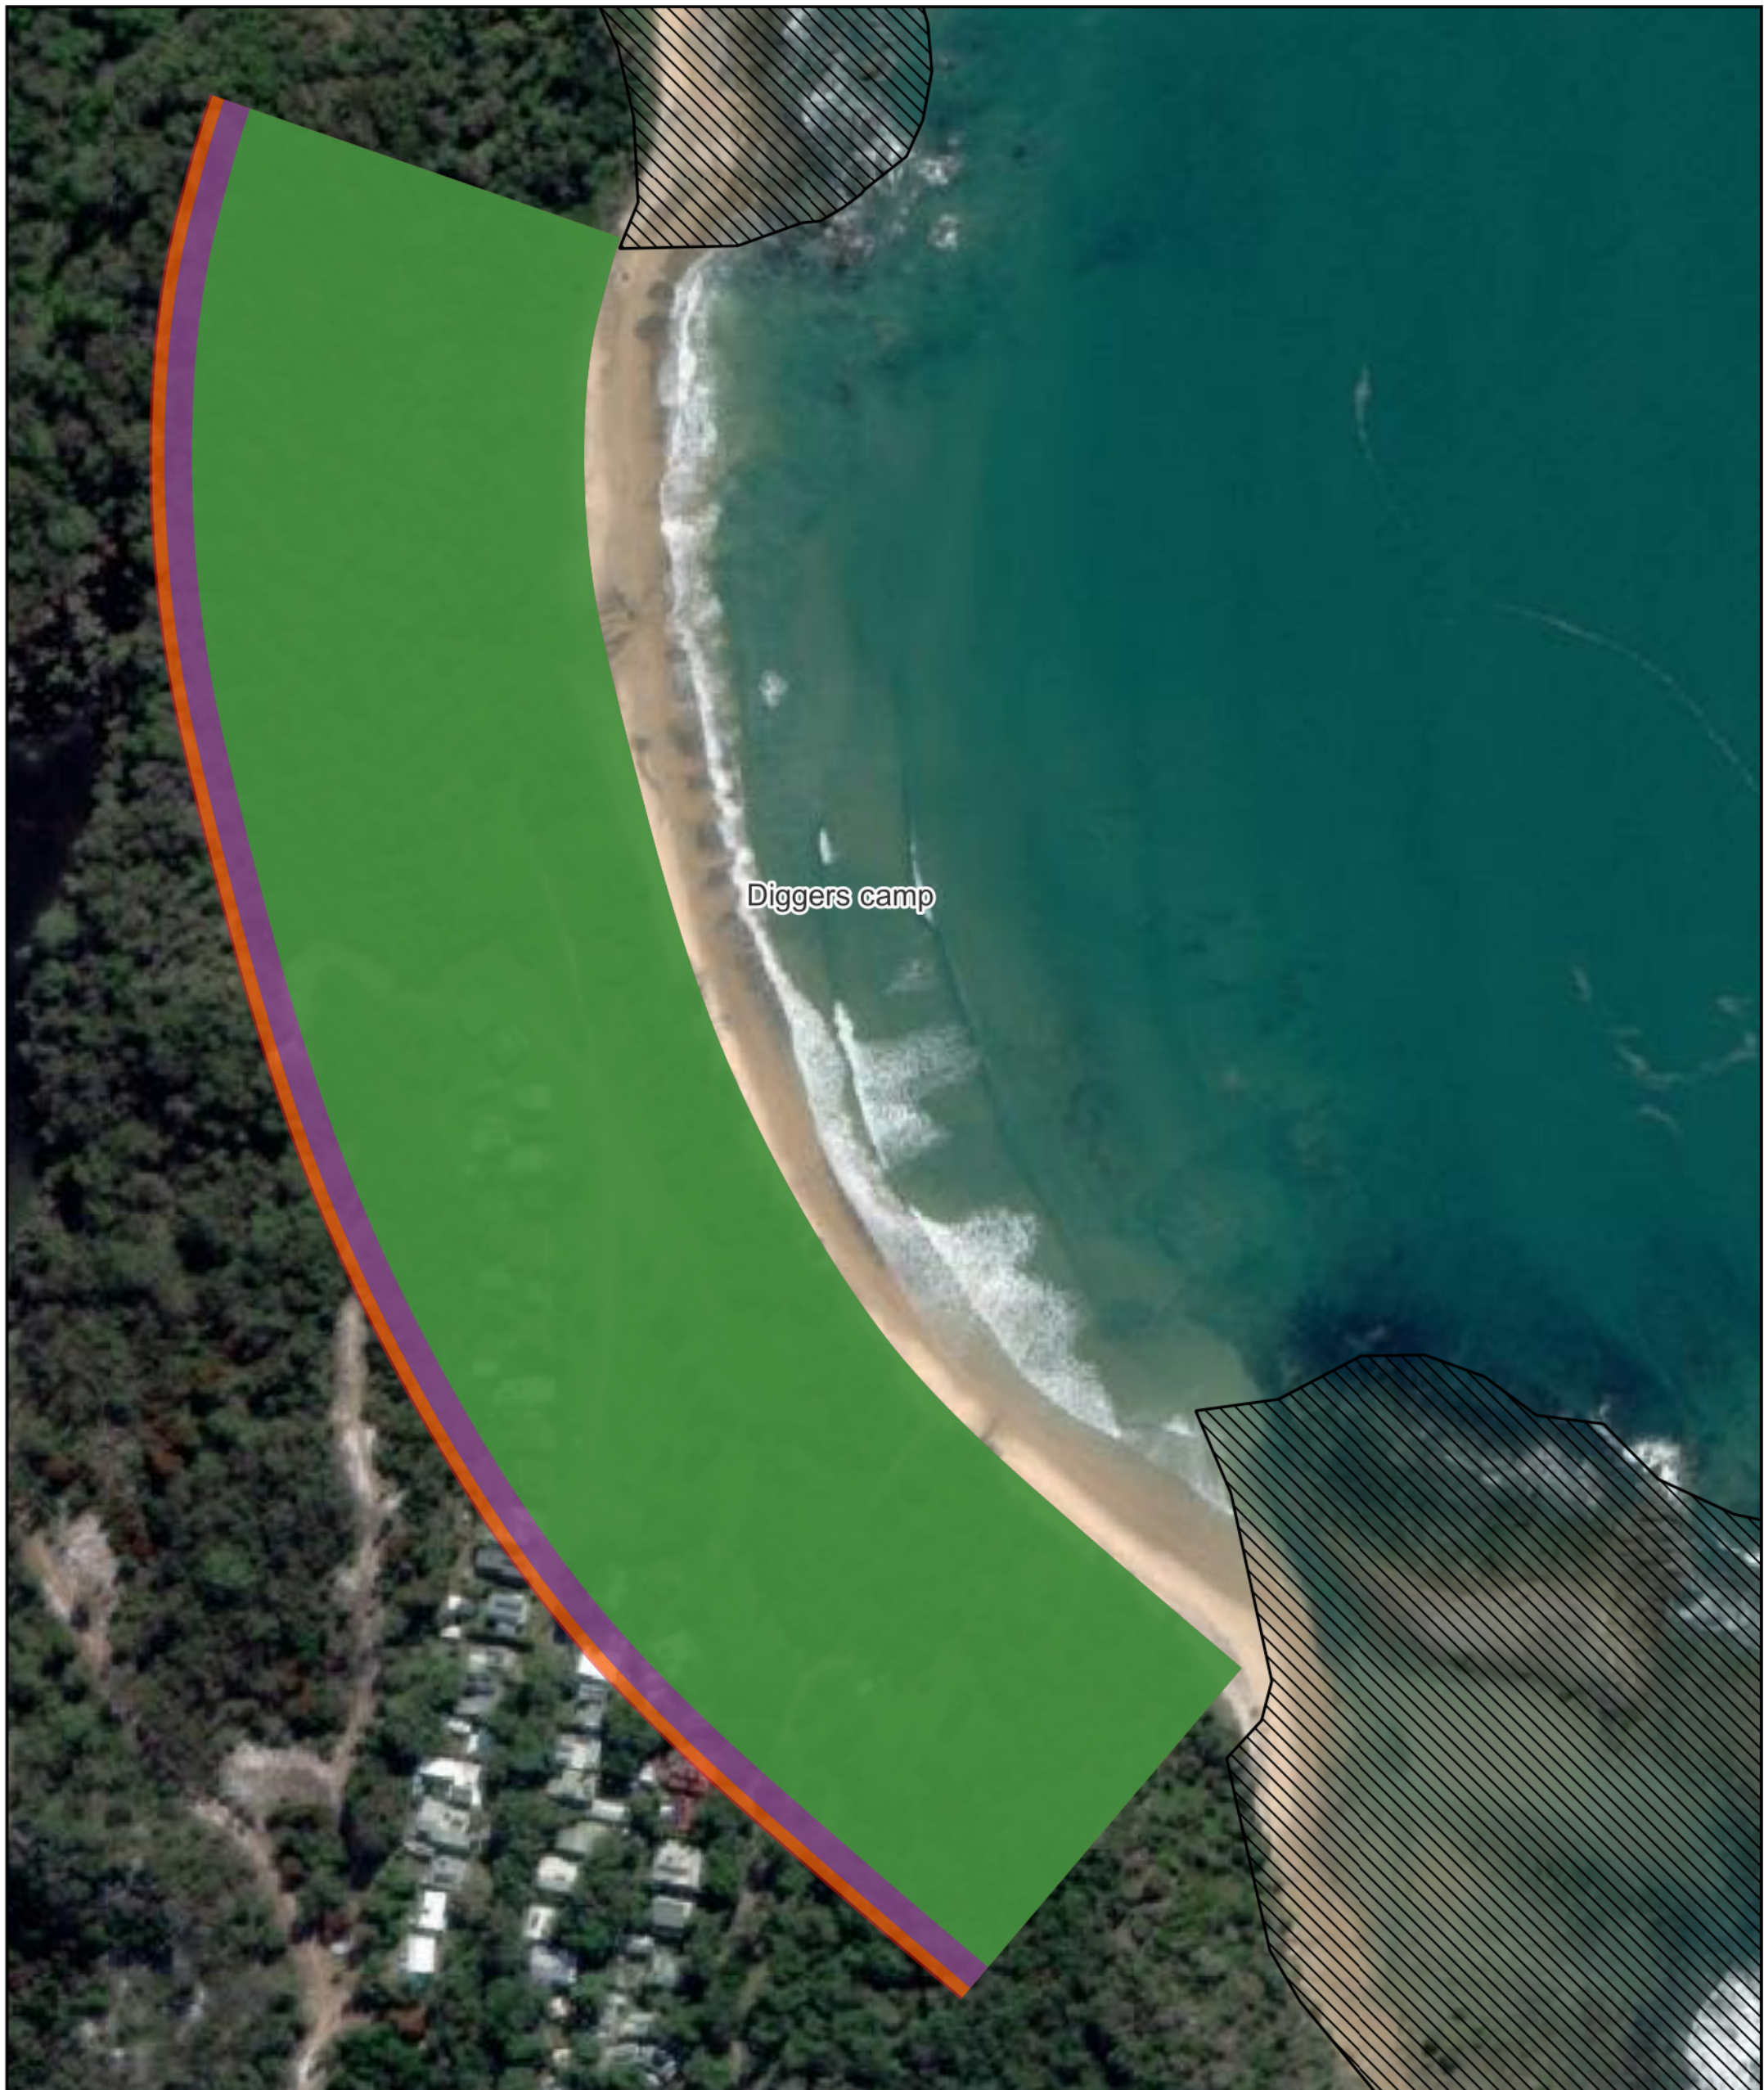
**Title**  
Erosion and recession hazard zones -SSP5 2123: Diggers Camp
