Title
Erosion and recession hazard zones - Present Day: Lake Cakora entrance and Brooms Head

Project
2021s1471 - Hydrosphere - CVC CMP Stage 2 - 4

Client
Hydrosphere Consulting

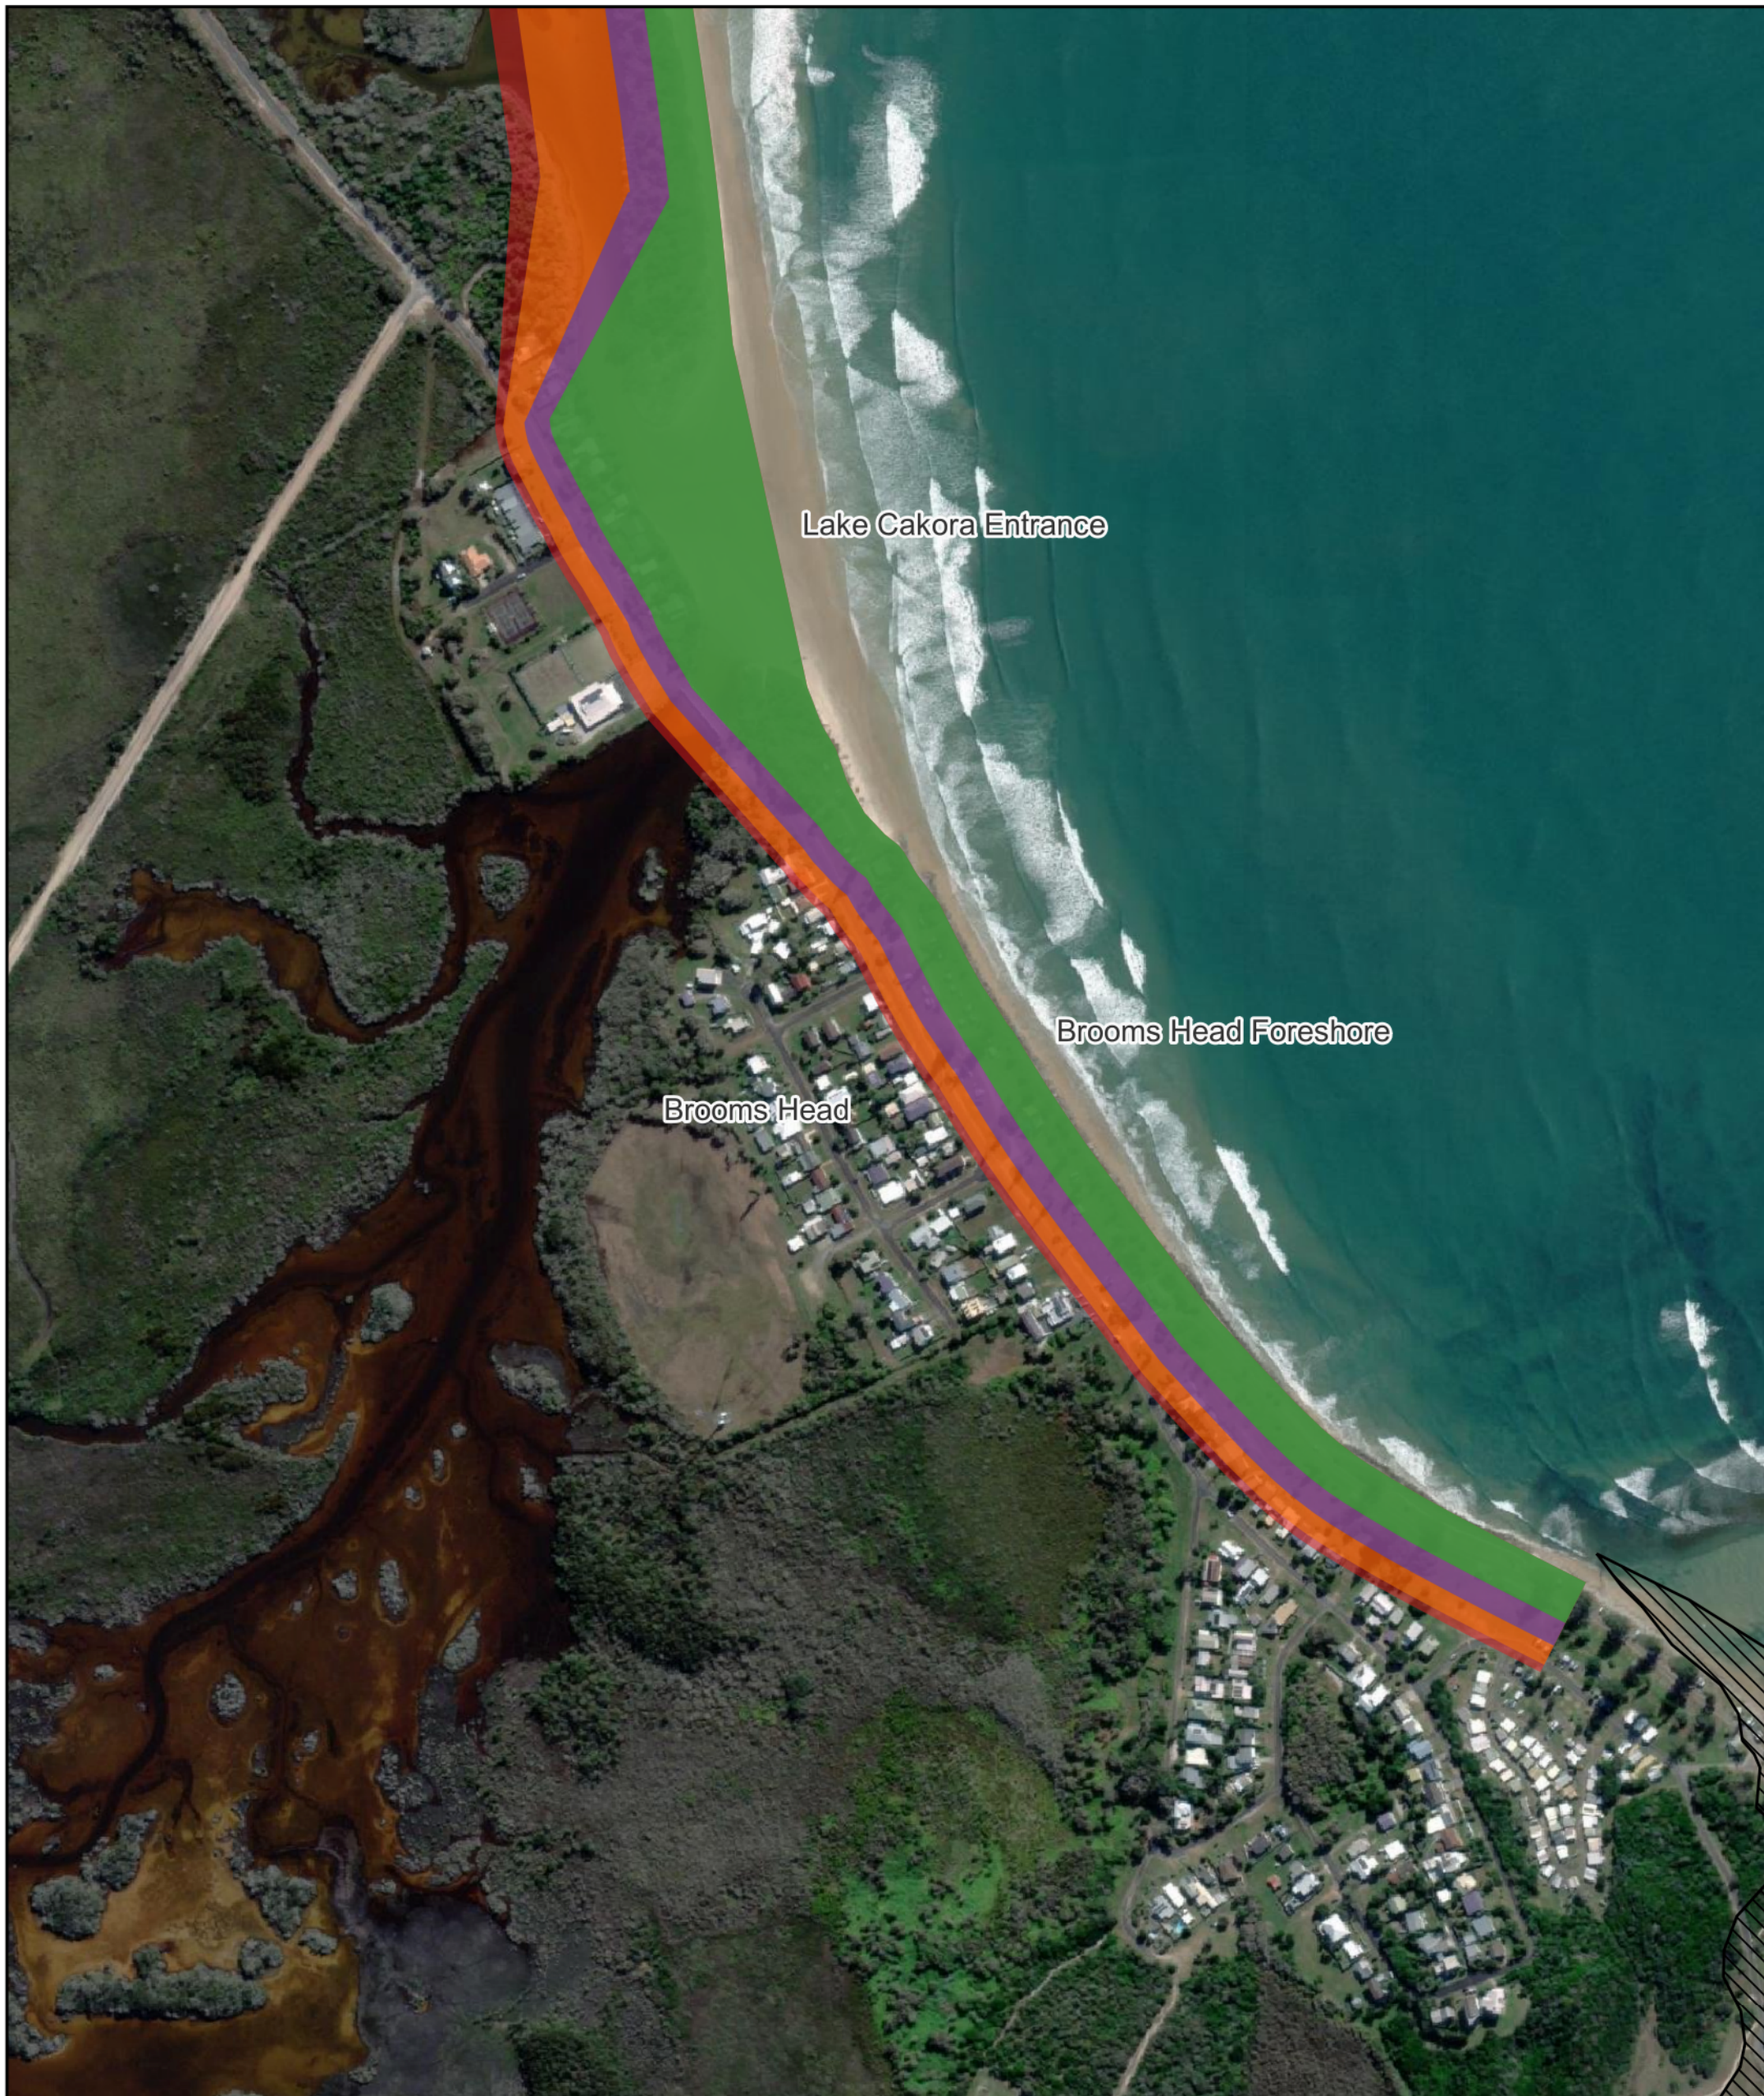
Title
 Erosion and recession hazard zones -SSP2 2043: Lake Cakora entrance and Brooms Head Foreshore

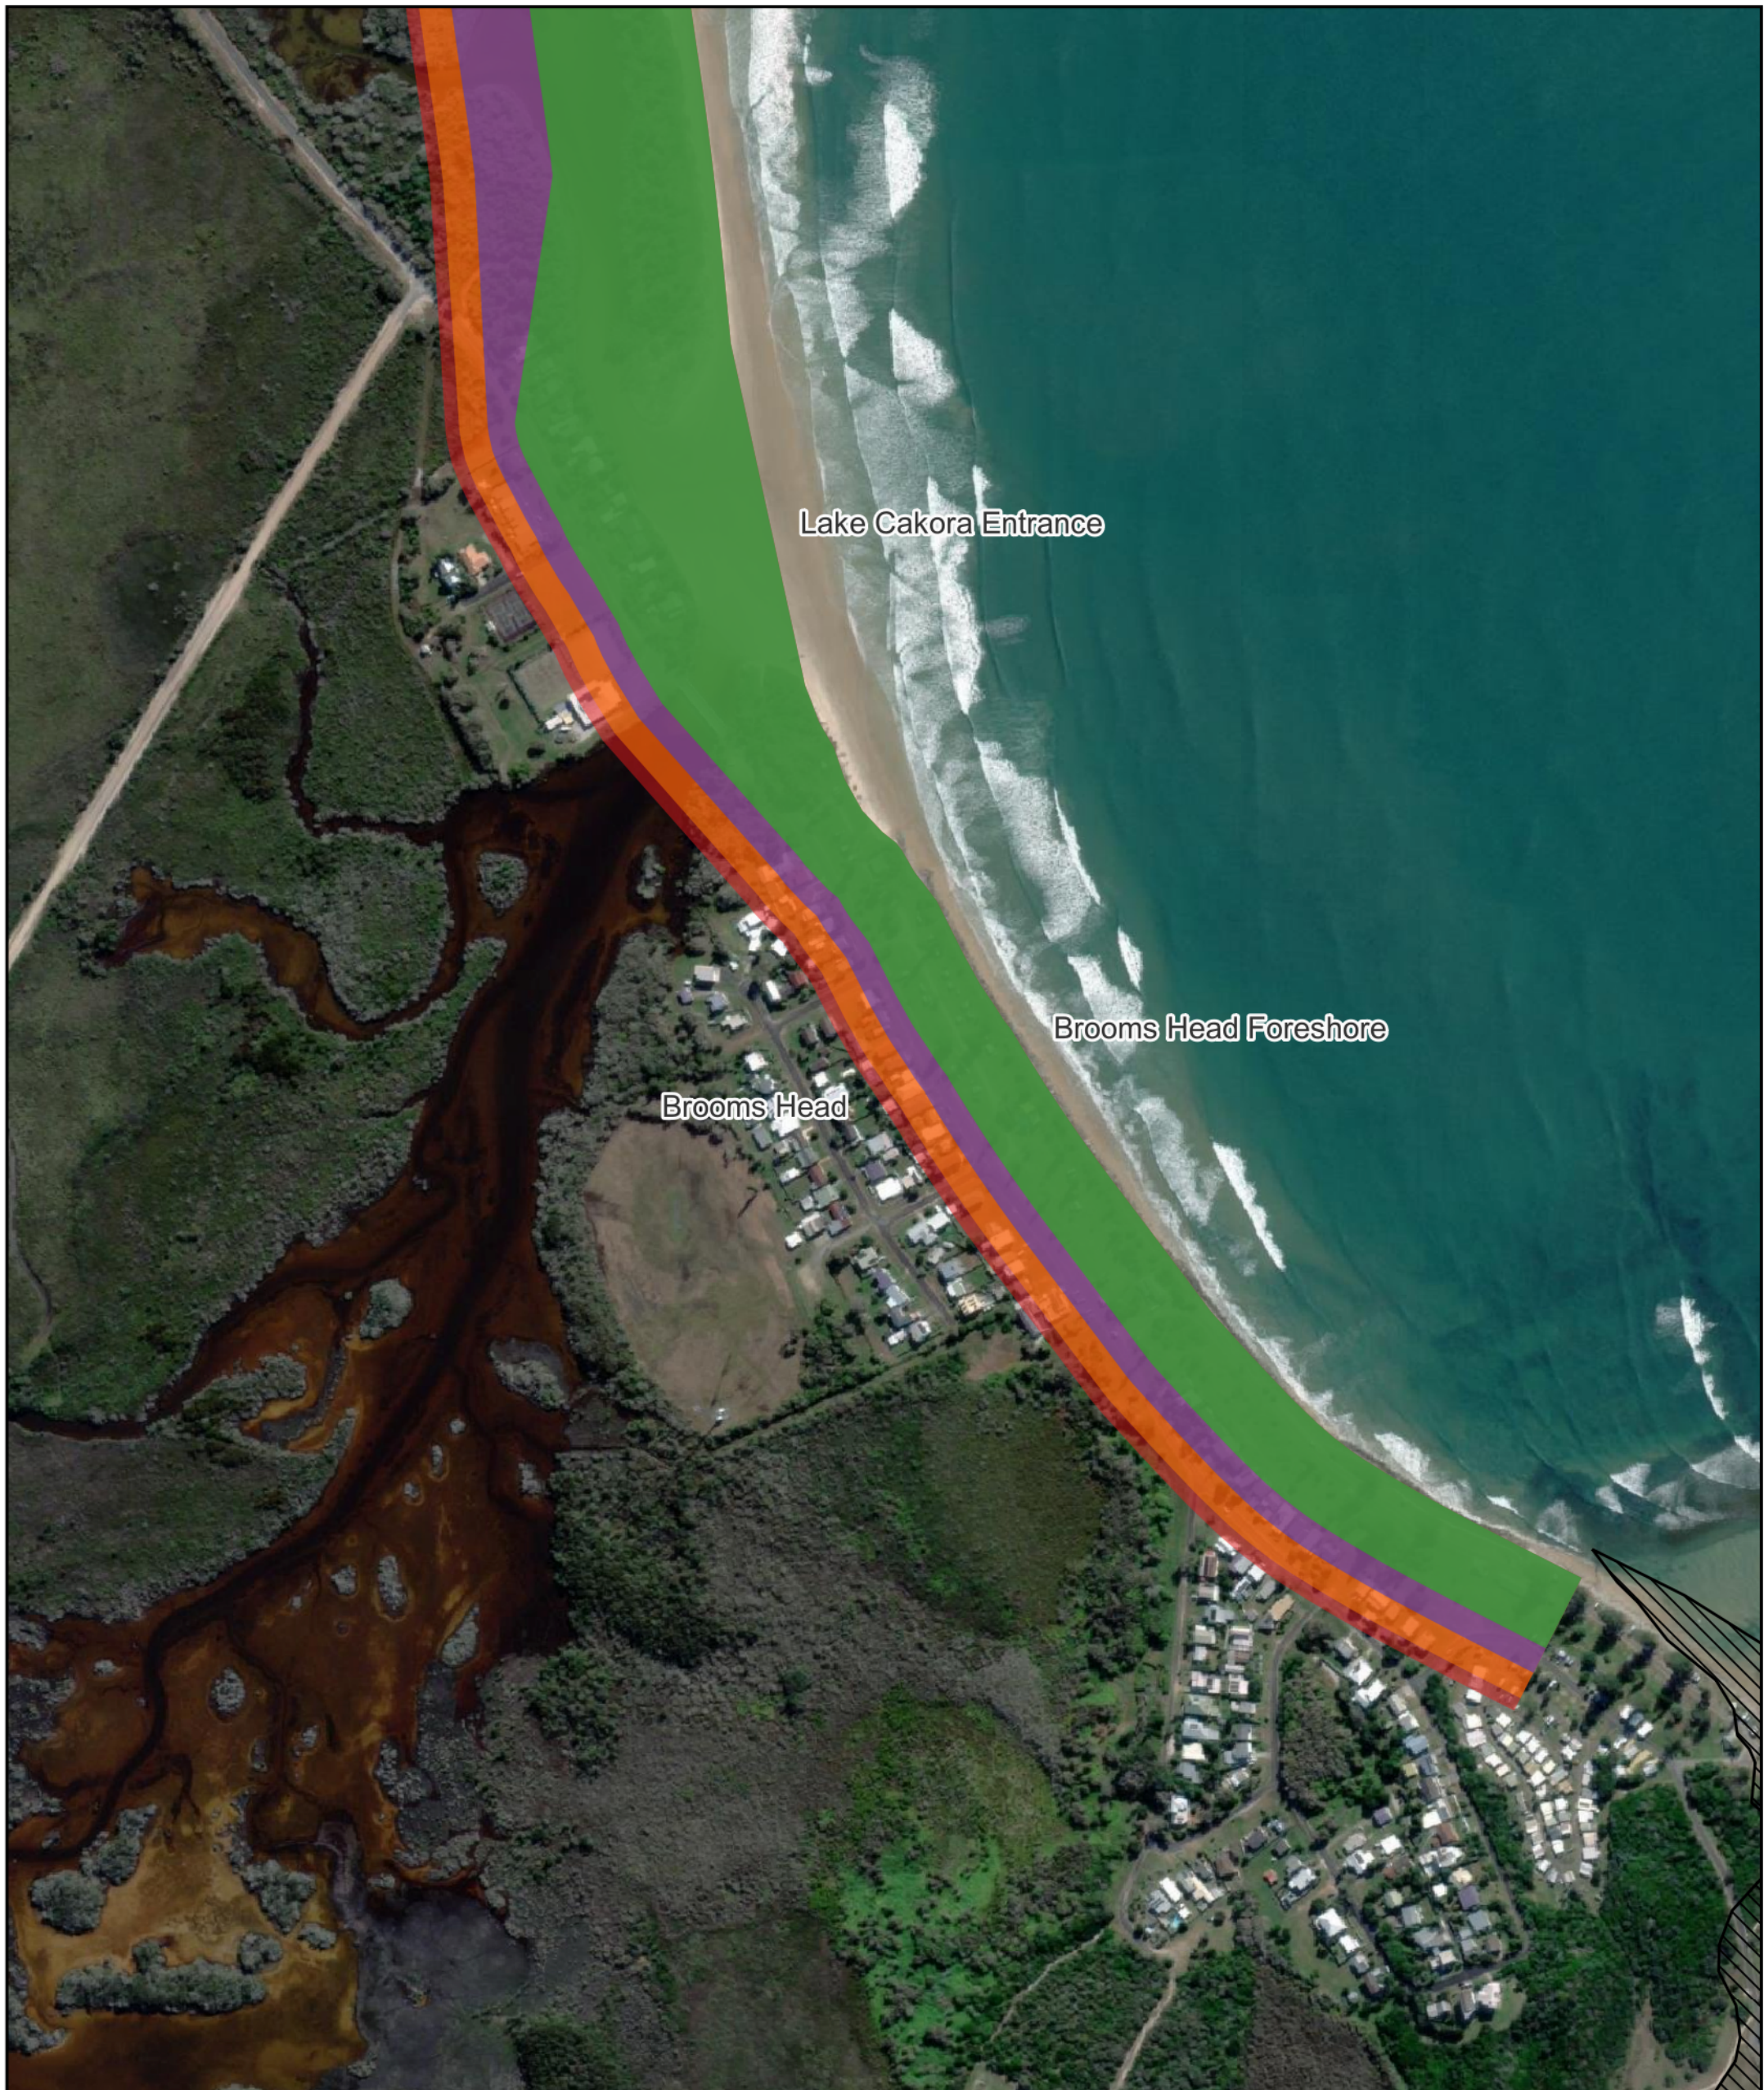
Title
 Erosion and recession hazard zones -SSP2 2073: Lake Cakora entrance and Brooms Head Foreshore

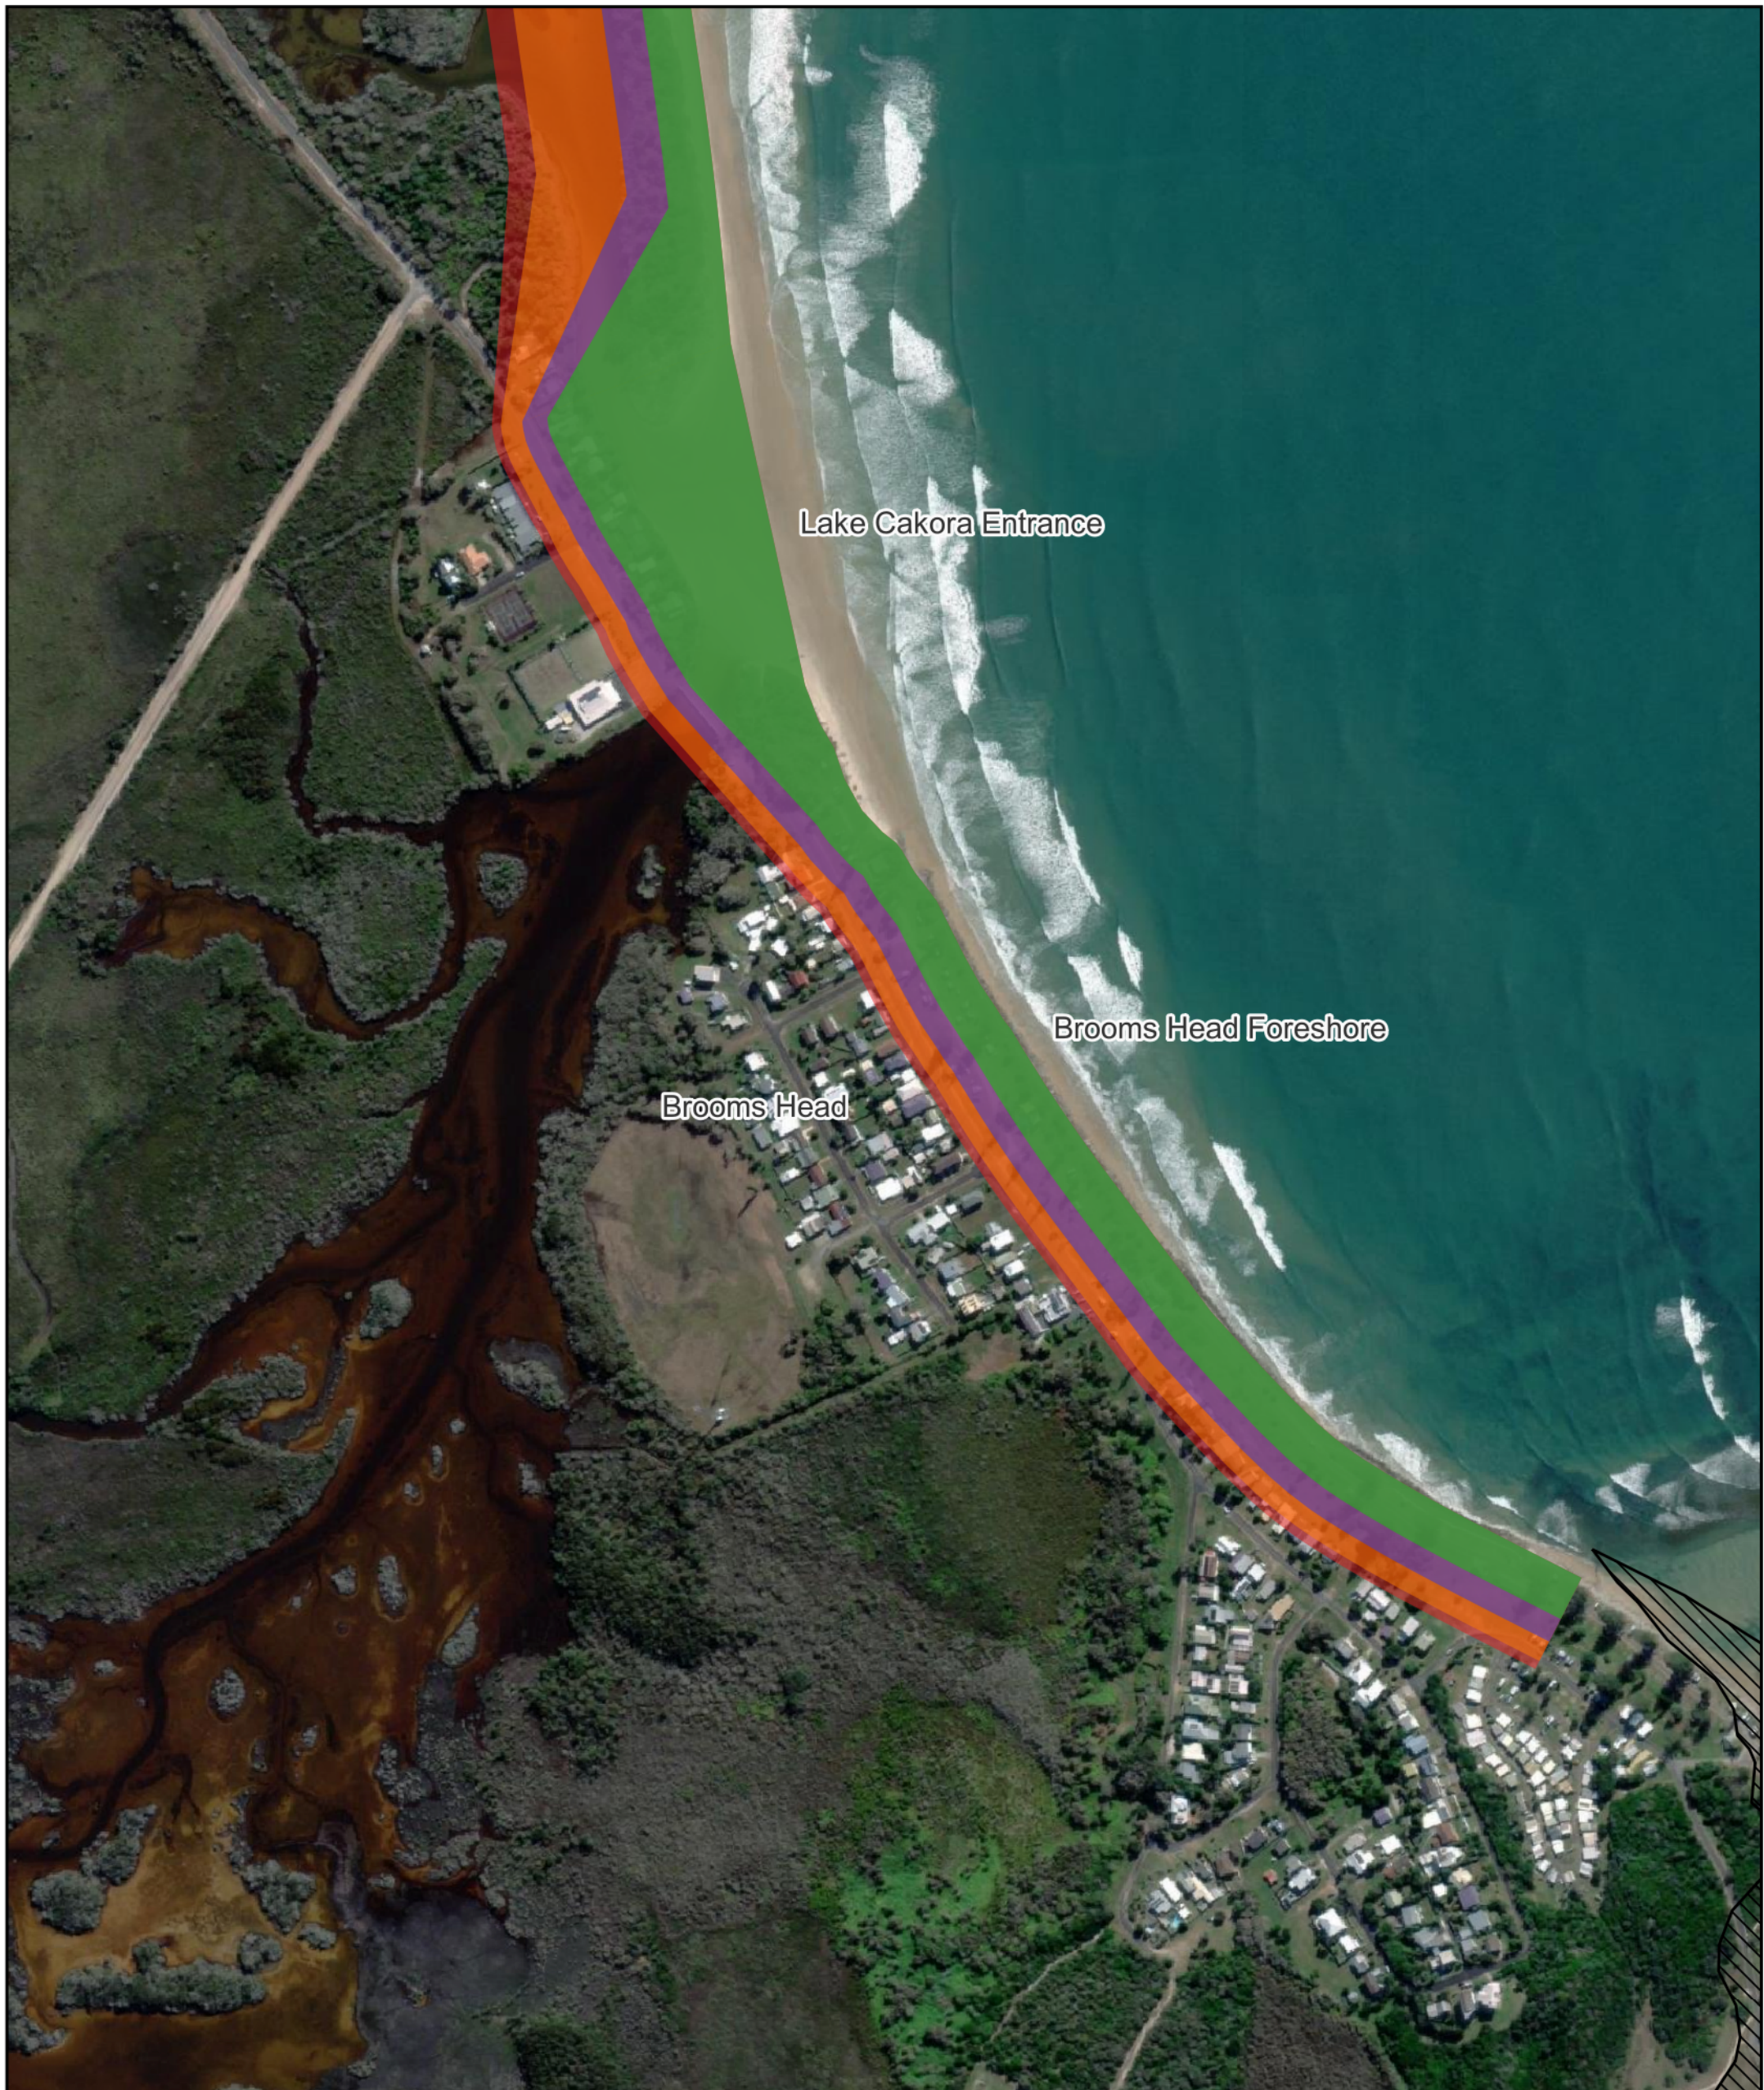
Title
Erosion and recession hazard zones -SSP5 2043: Lake Cakora entrance and Brooms Head Foreshore

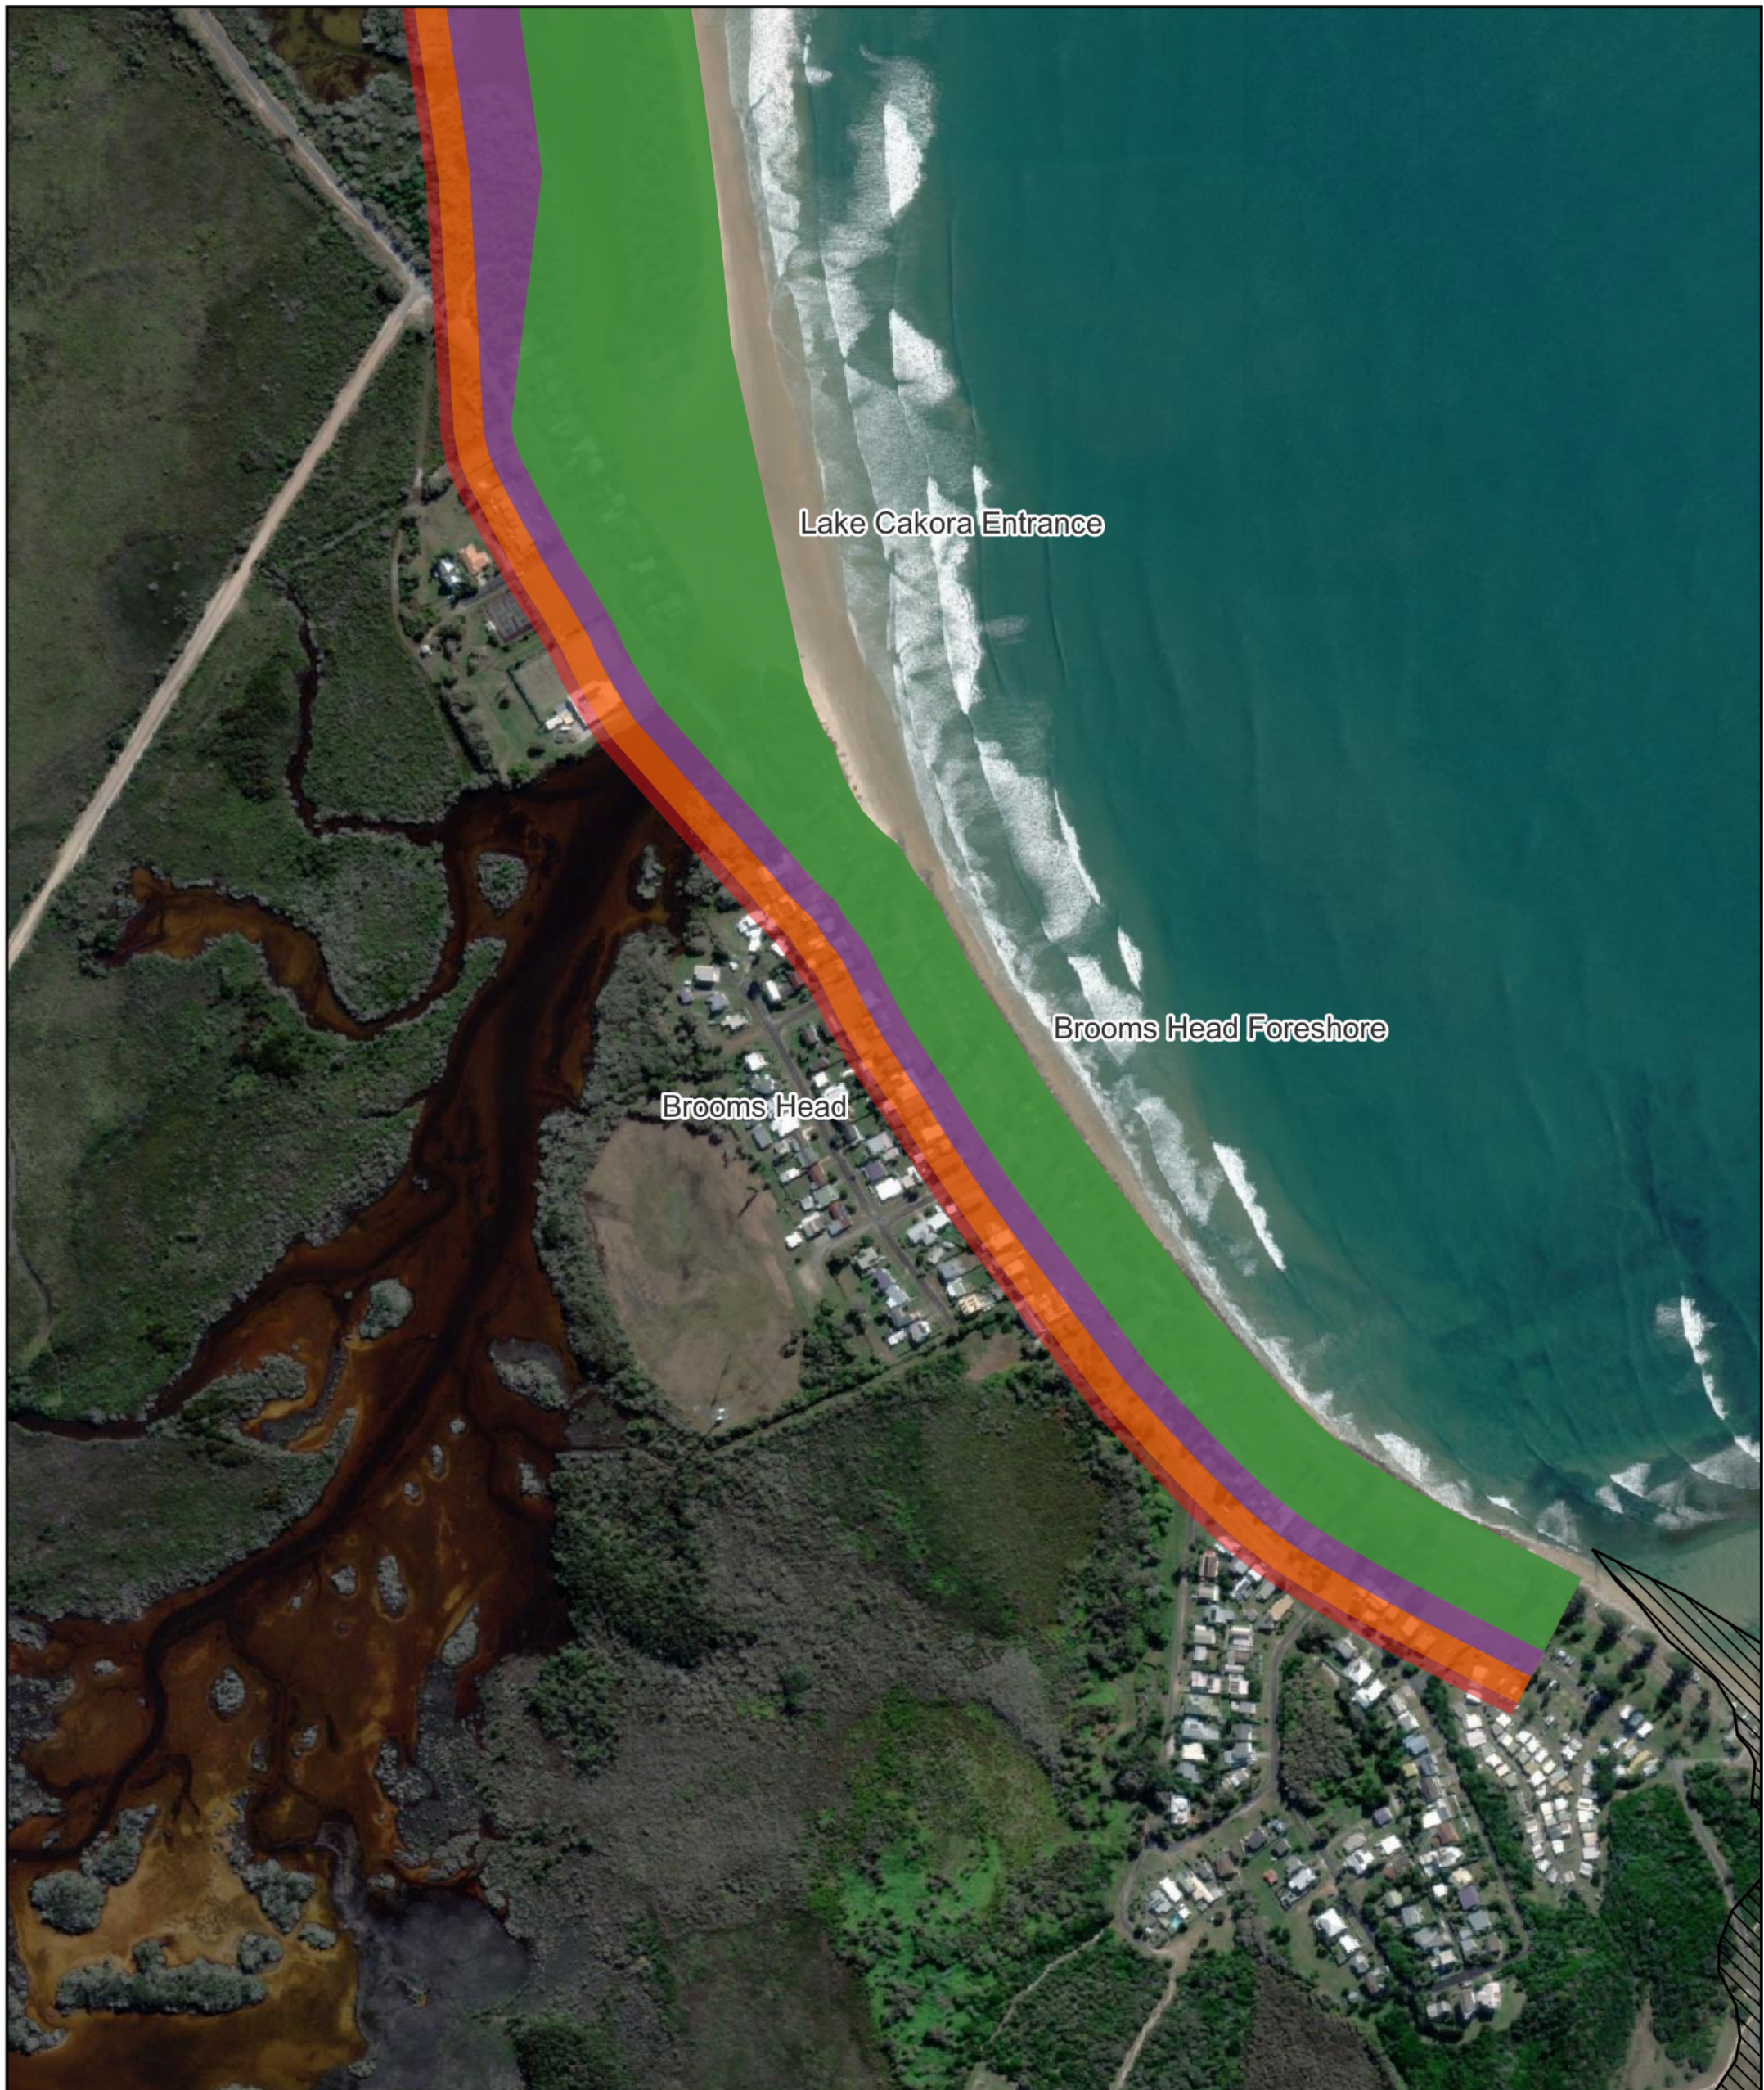
Title
 Erosion and recession hazard zones -SSP5 2073: Lake Cakora entrance and Brooms Head Foreshore
