**Title**  
Erosion and recession hazard zones - Present Day: Sandon

**Project**  
2021s1471 - Hydrosphere - CVC CMP Stage 2 - 4

**Client**  
Hydrosphere Consulting

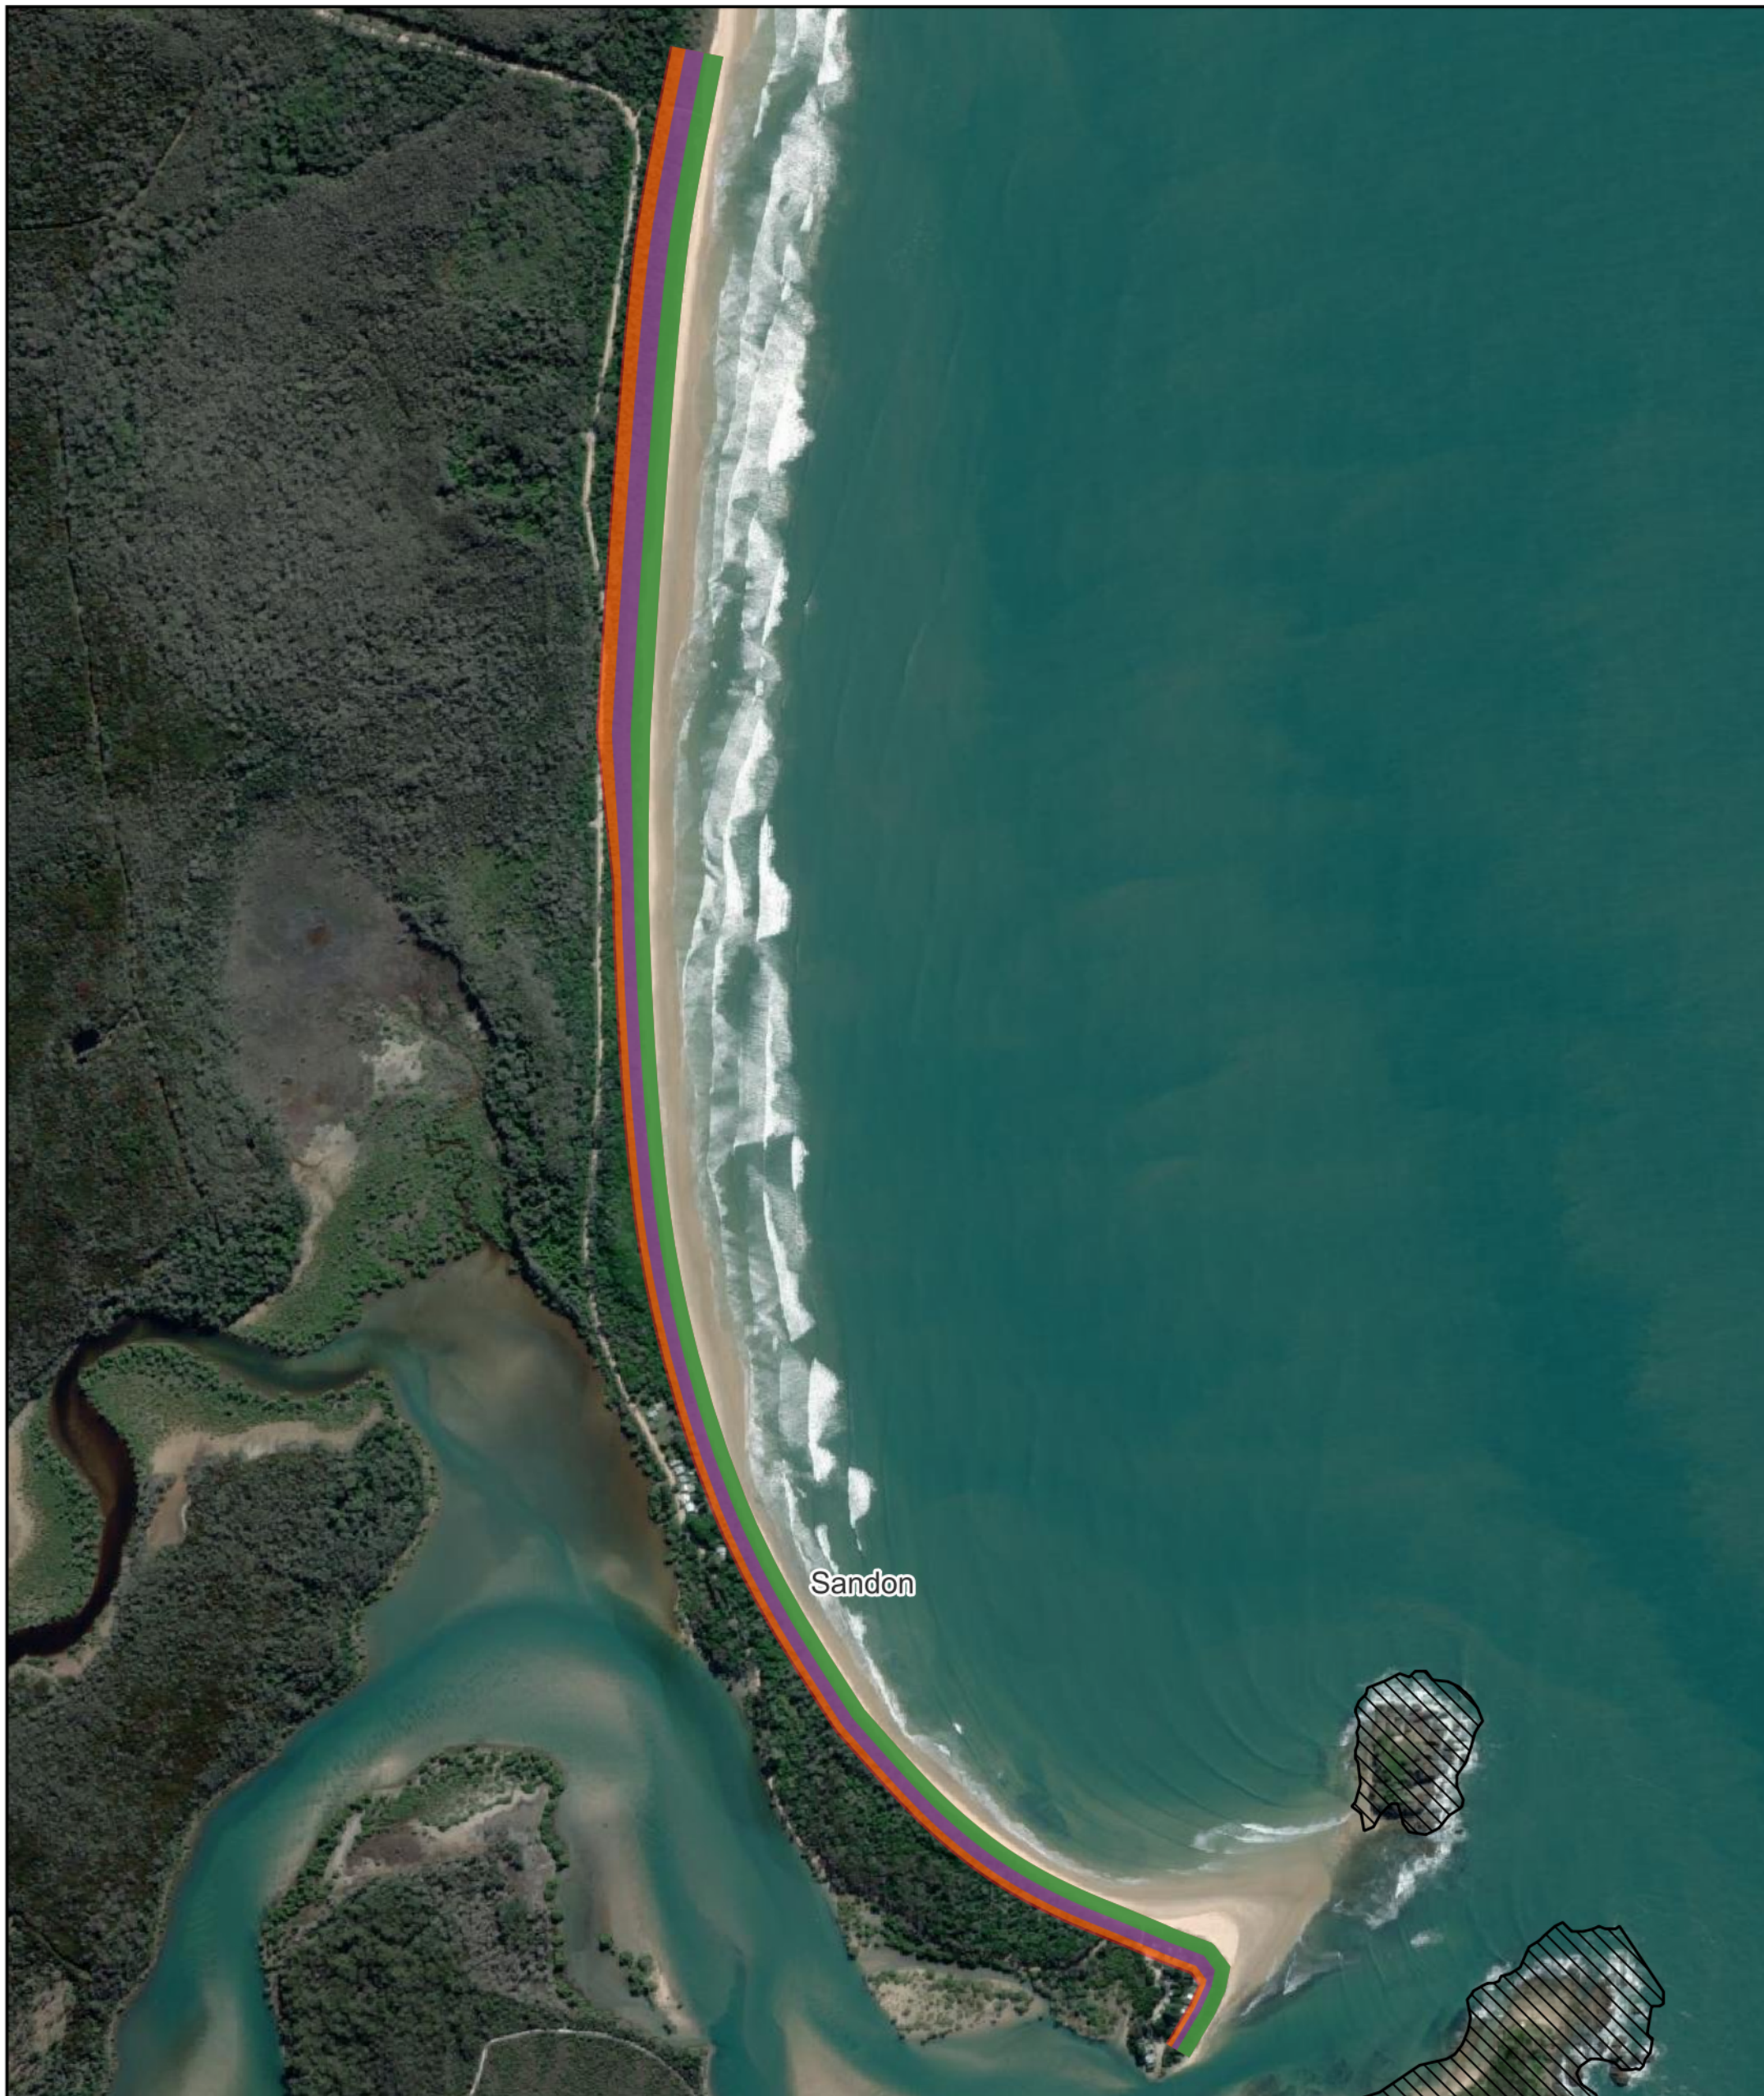
- Erosion and recession hazard zones (without protection)
- 50% exceedance probability ■
  - 10% exceedance probability ■
  - 2% exceedance probability ■
  - 1% exceedance probability ■
  - Bedrock

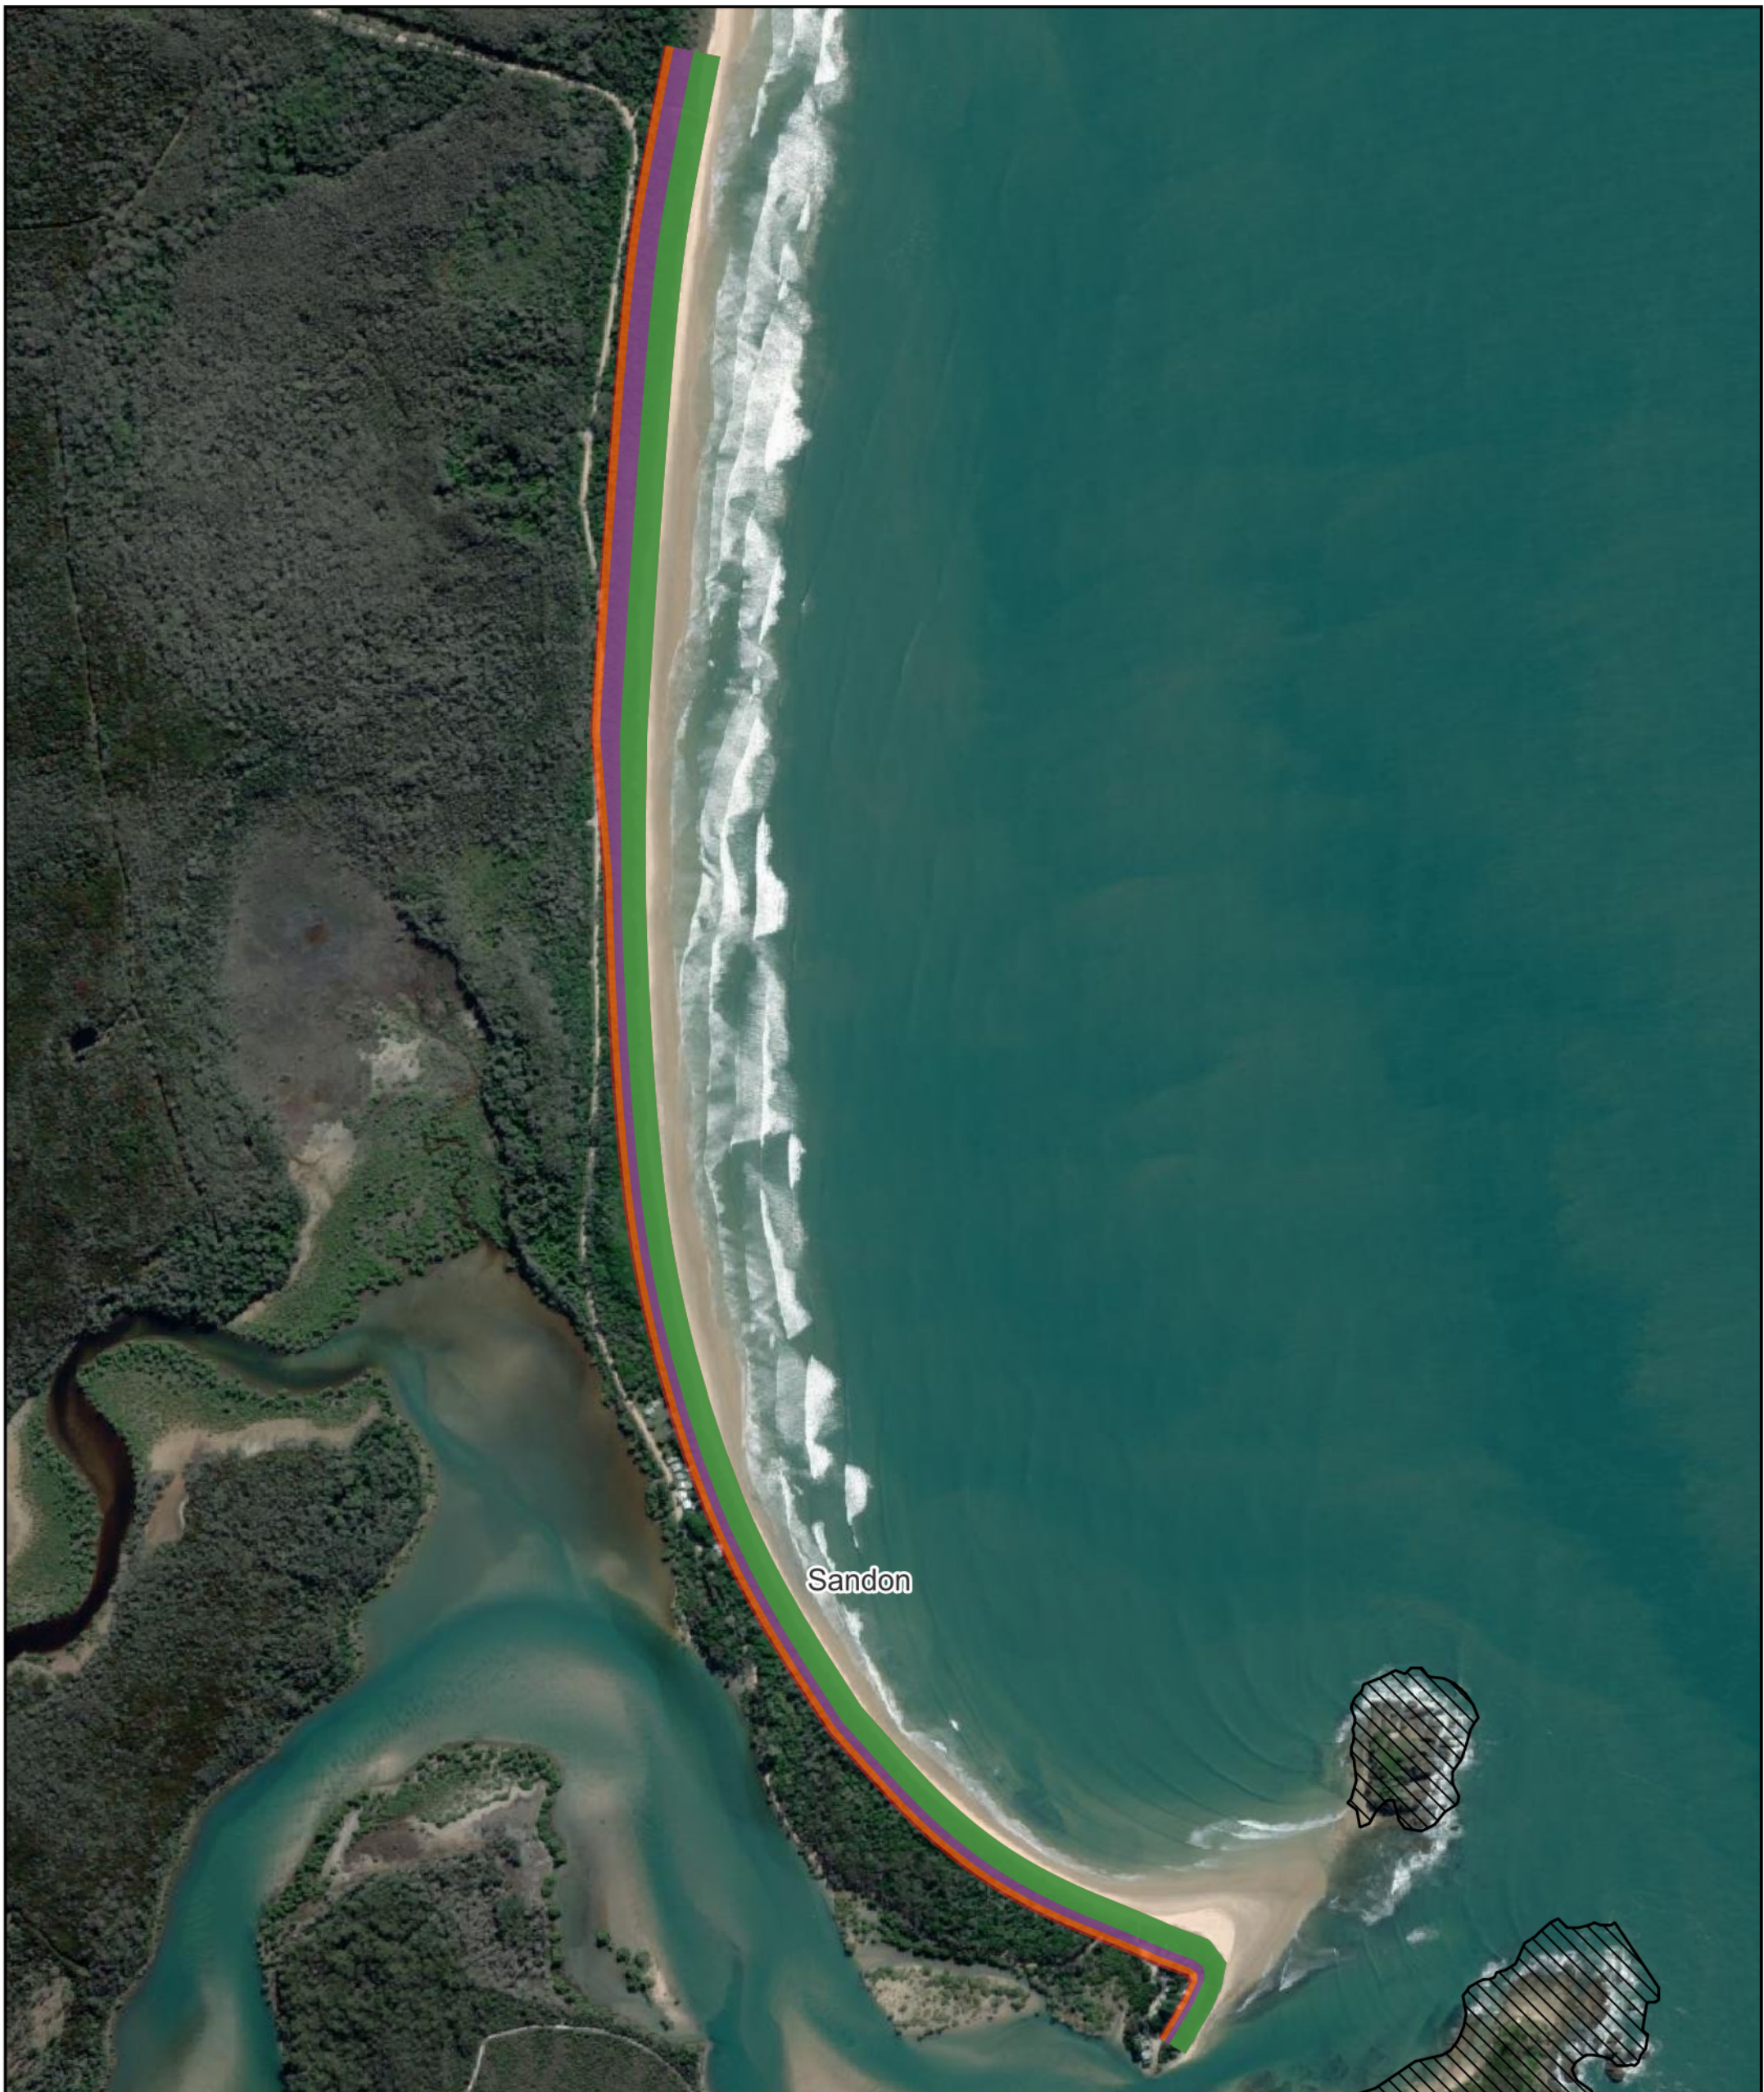
**Title**  
 Erosion and recession hazard zones -SSP2 2043: Sandon

- Erosion and recession hazard zones (without protection)
- 50% exceedance probability ■
  - 10% exceedance probability ■
  - 2% exceedance probability ■
  - 1% exceedance probability ■
  - Bedrock

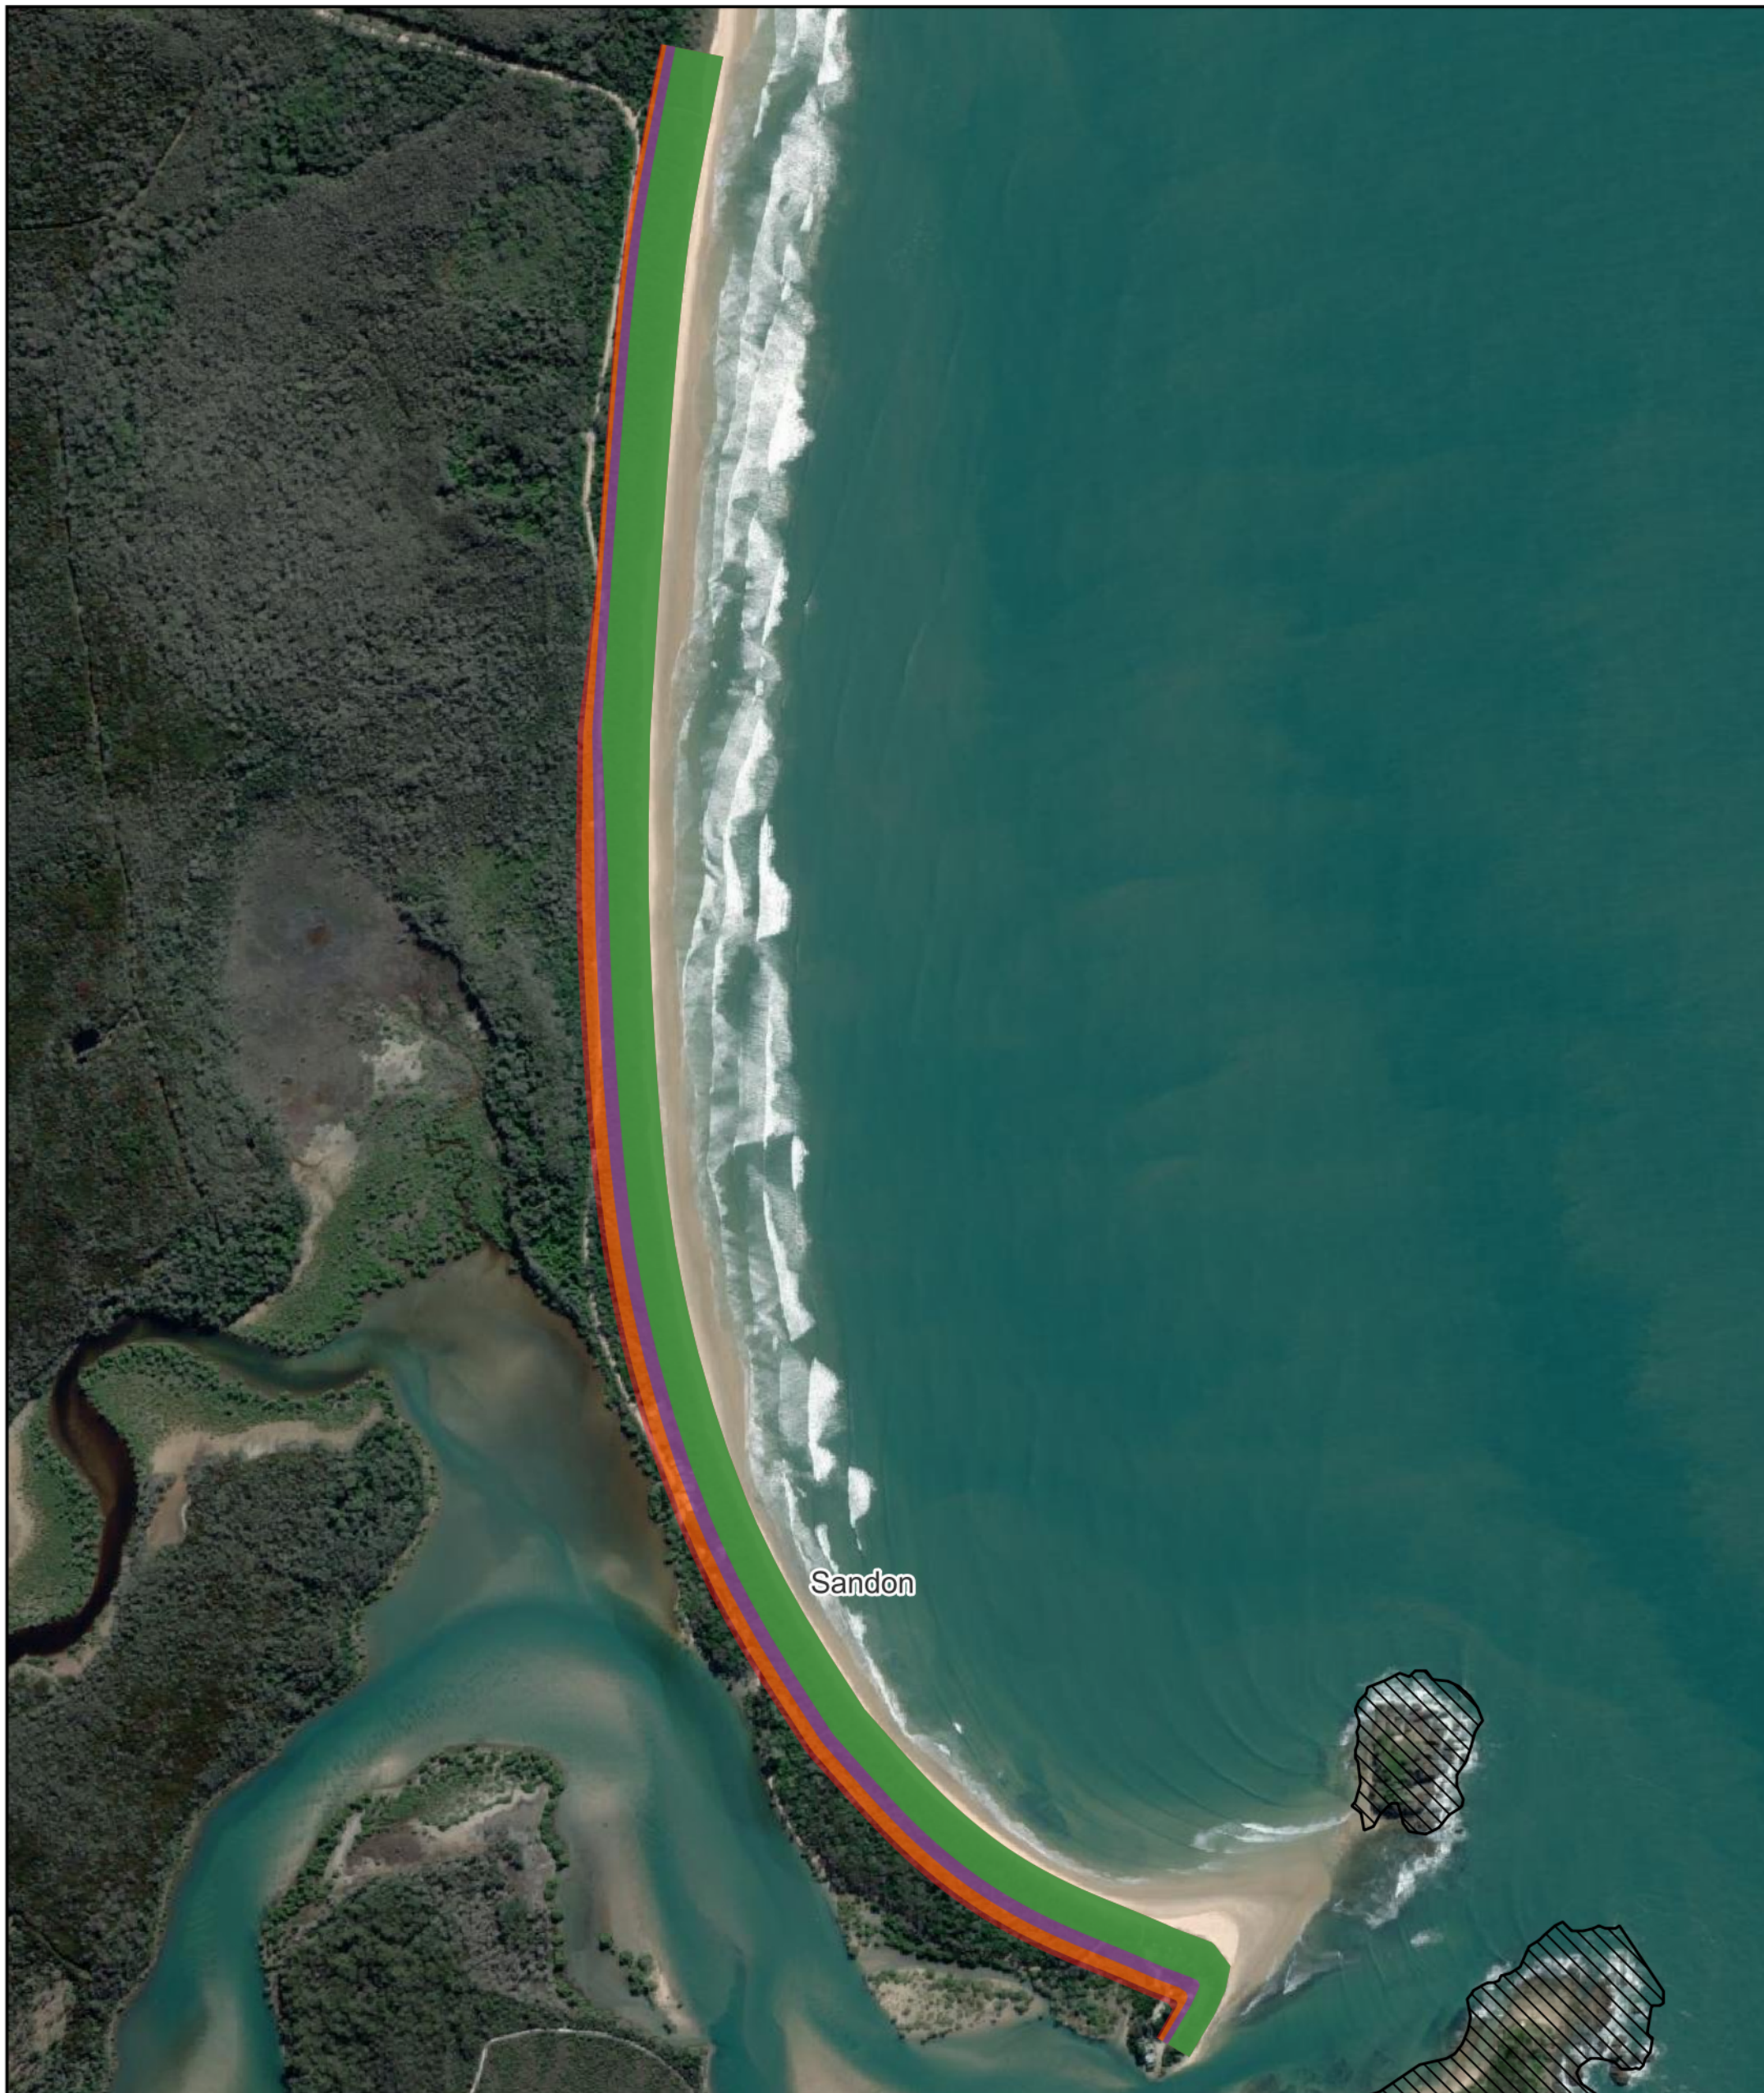
**Title**  
Erosion and recession hazard zones -SSP2 2073: Sandon

Erosion and recession hazard zones (without protection)

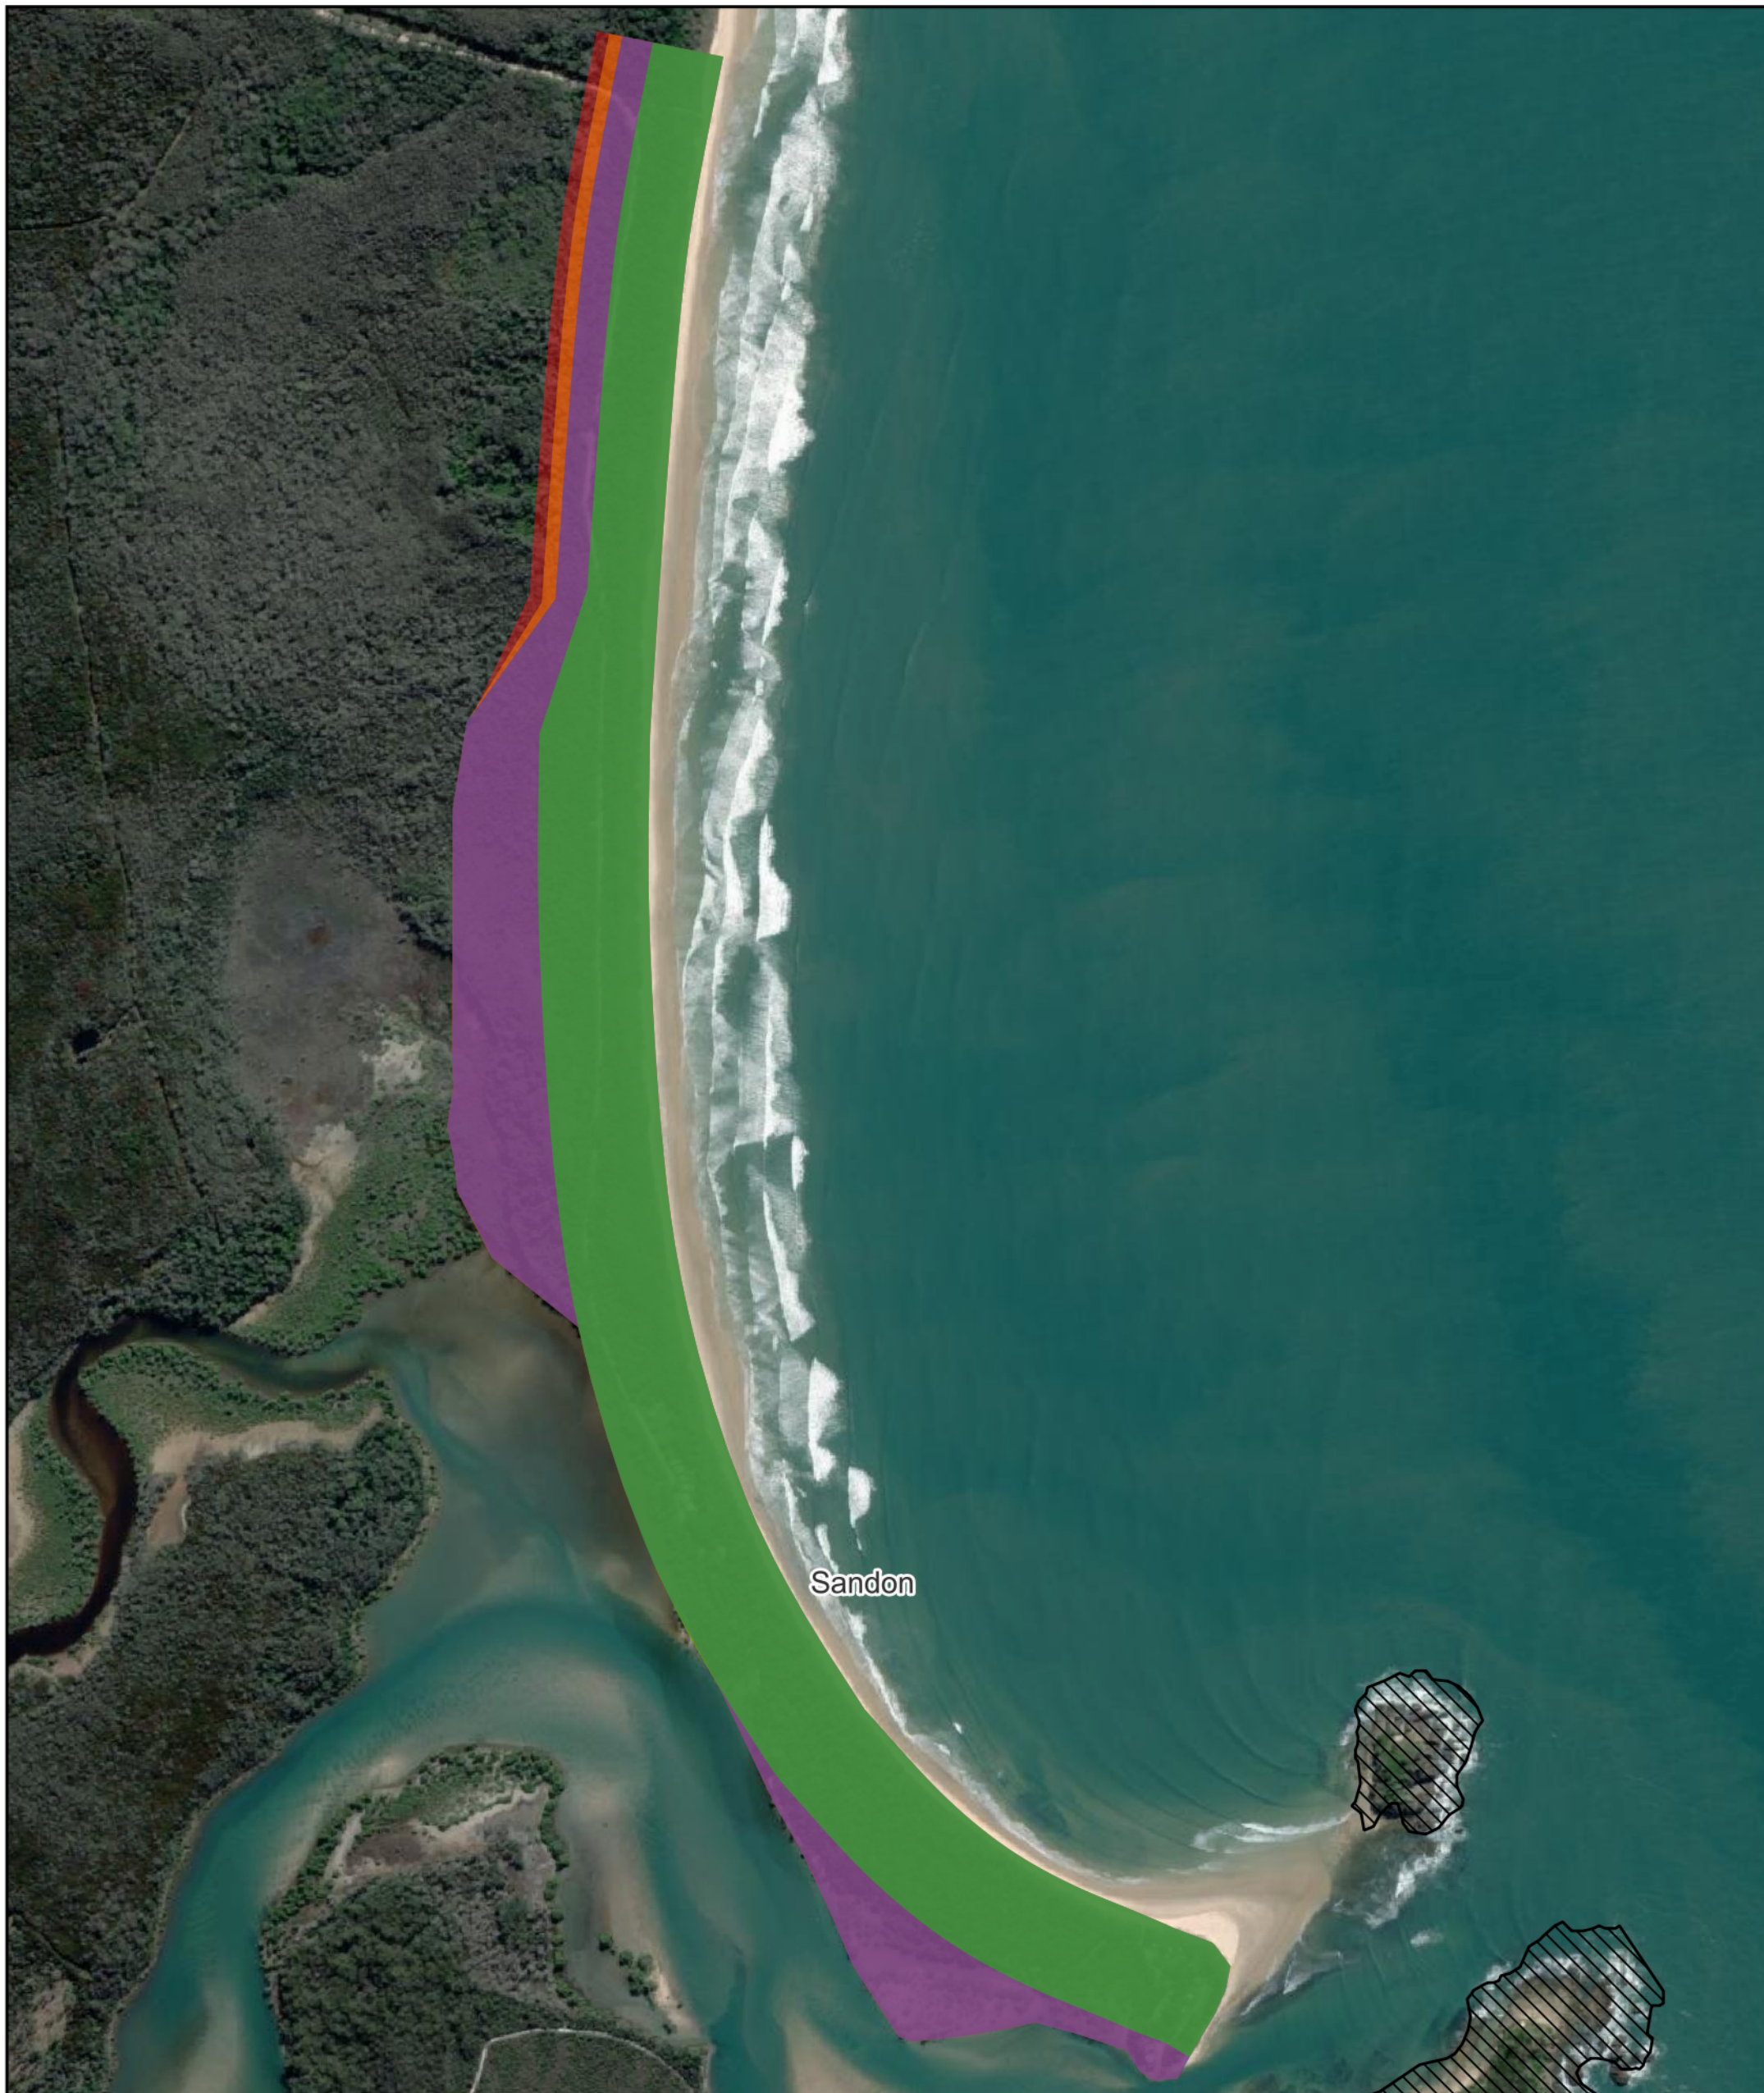
**Title**  
 Erosion and recession hazard zones -SSP2 2123: Sandon

- Erosion and recession hazard zones (without protection)
- 50% exceedance probability ■
  - 10% exceedance probability ■
  - 2% exceedance probability ■
  - 1% exceedance probability ■
  - Bedrock

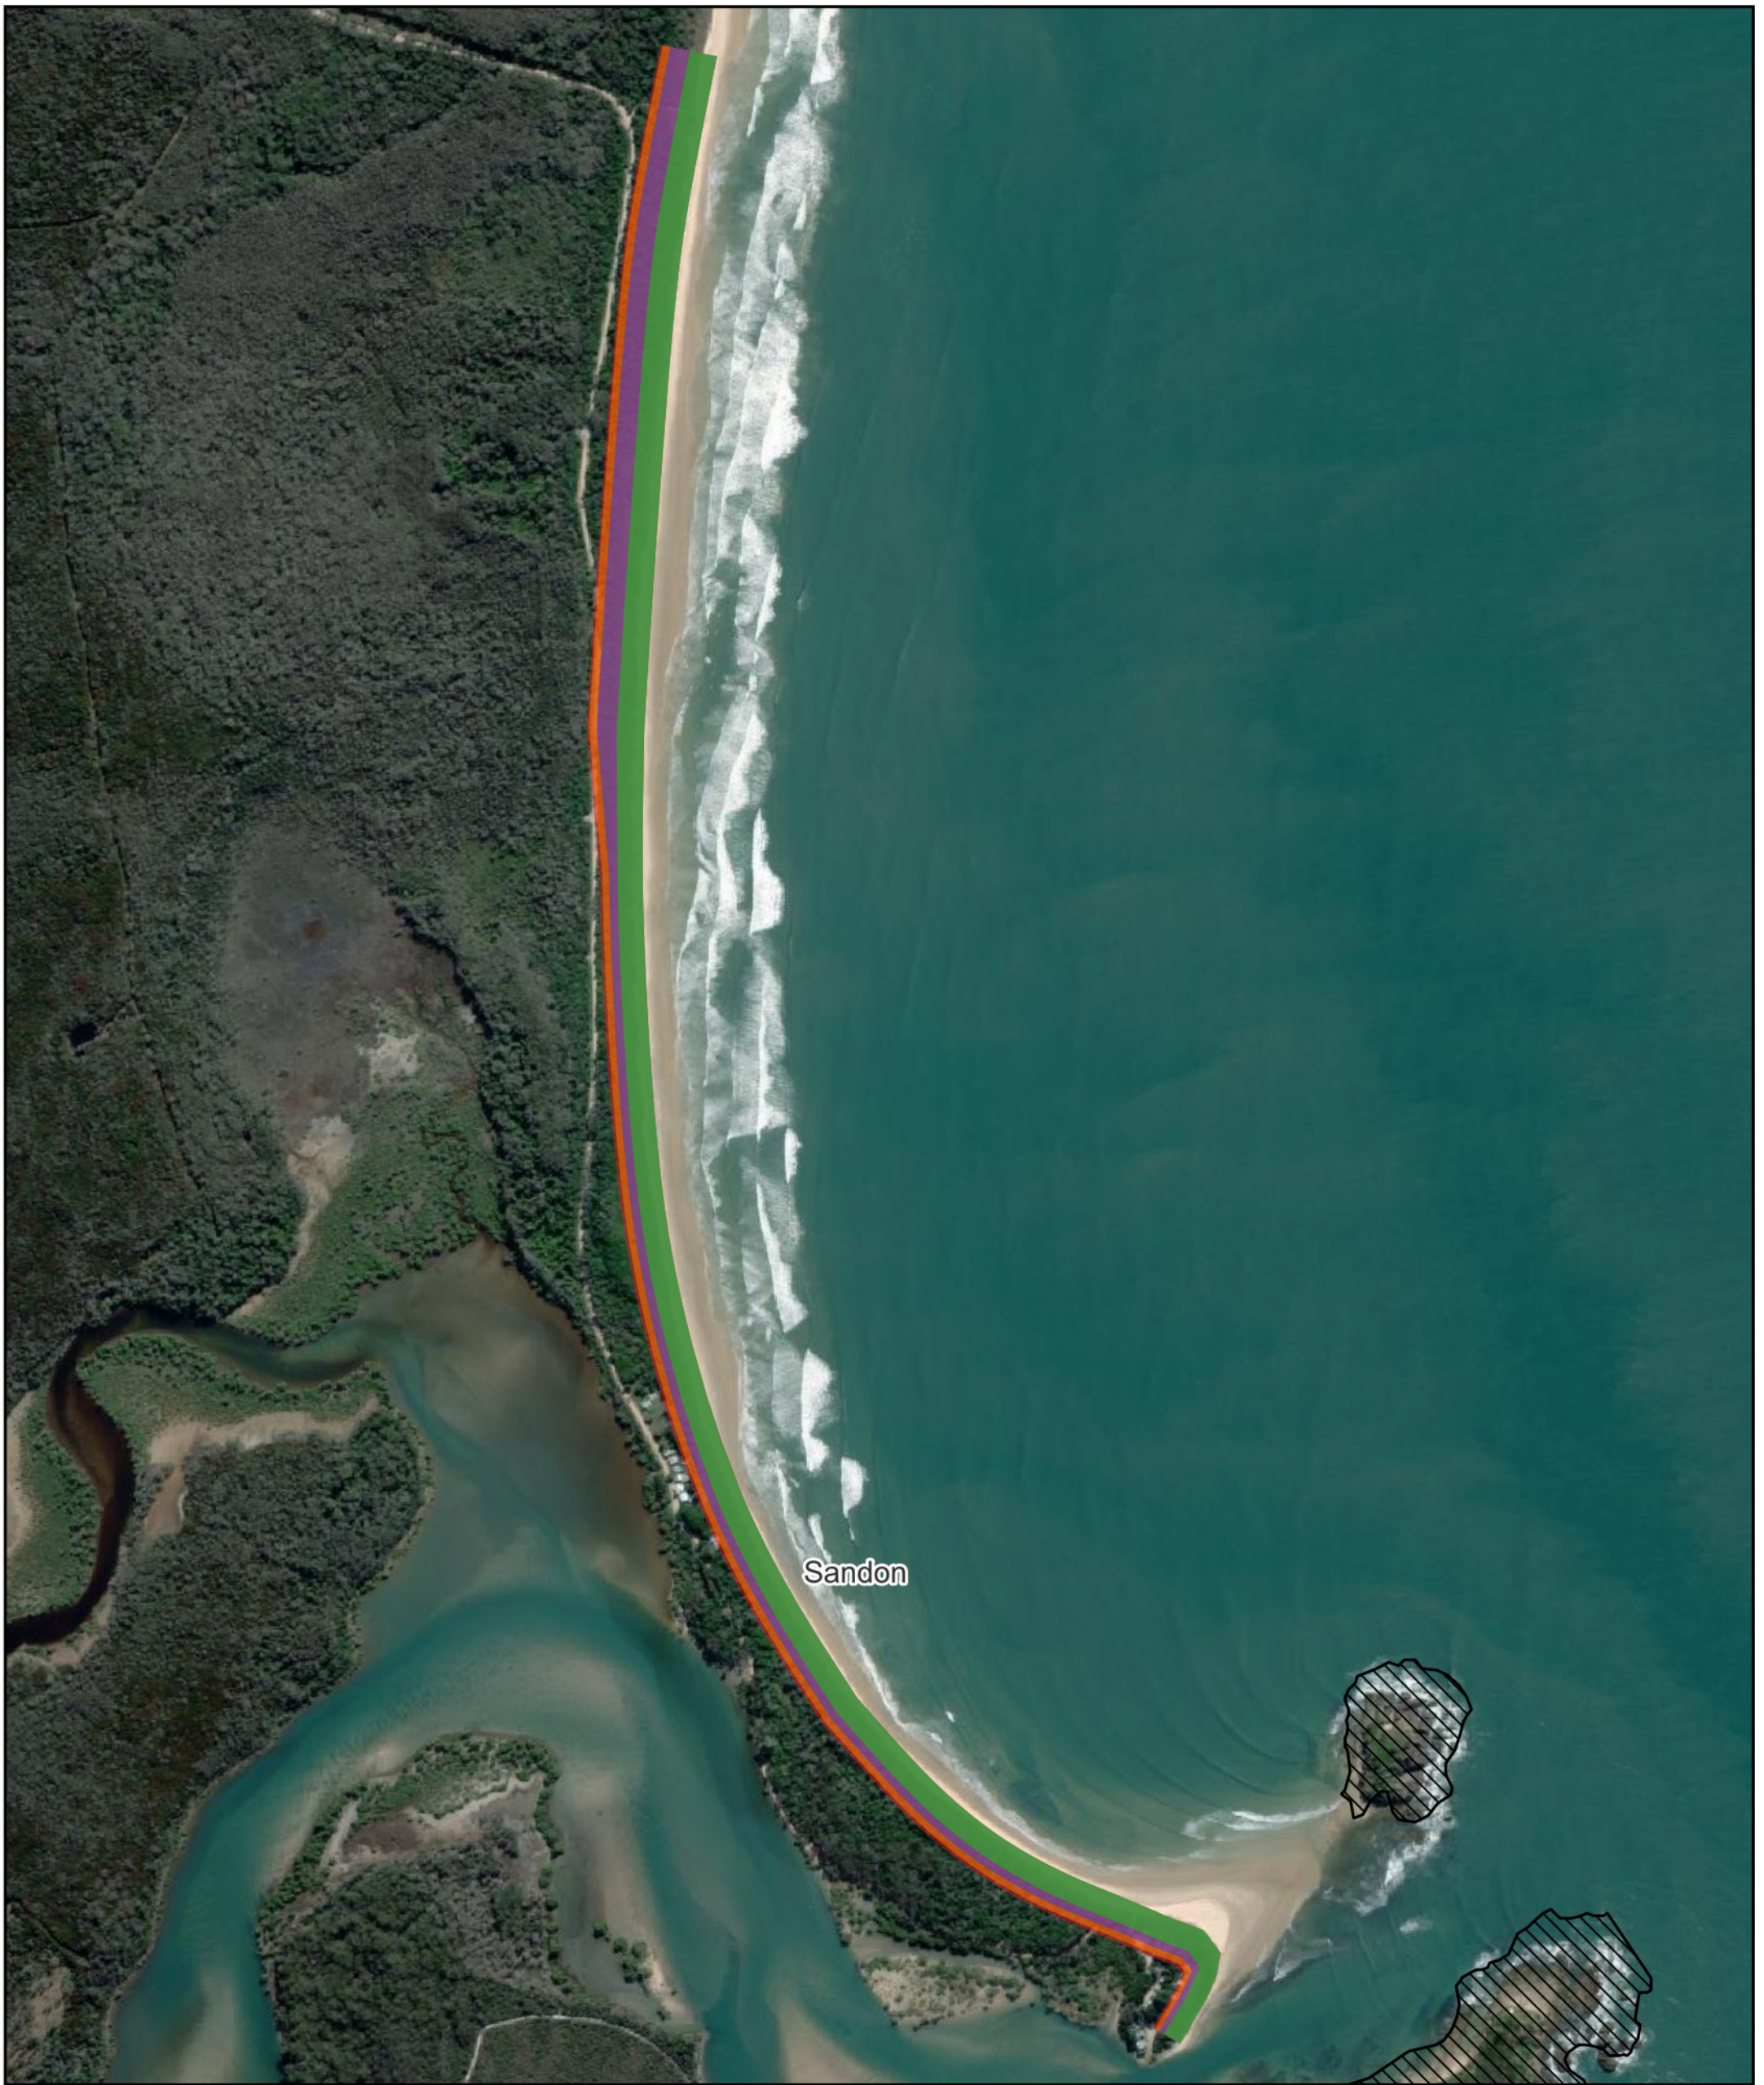
**Title**  
 Erosion and recession hazard zones -SSP5 2043: Sandon

- Erosion and recession hazard zones (without protection)
- 50% exceedance probability ■
  - 10% exceedance probability ■
  - 2% exceedance probability ■
  - 1% exceedance probability ■
  - Bedrock

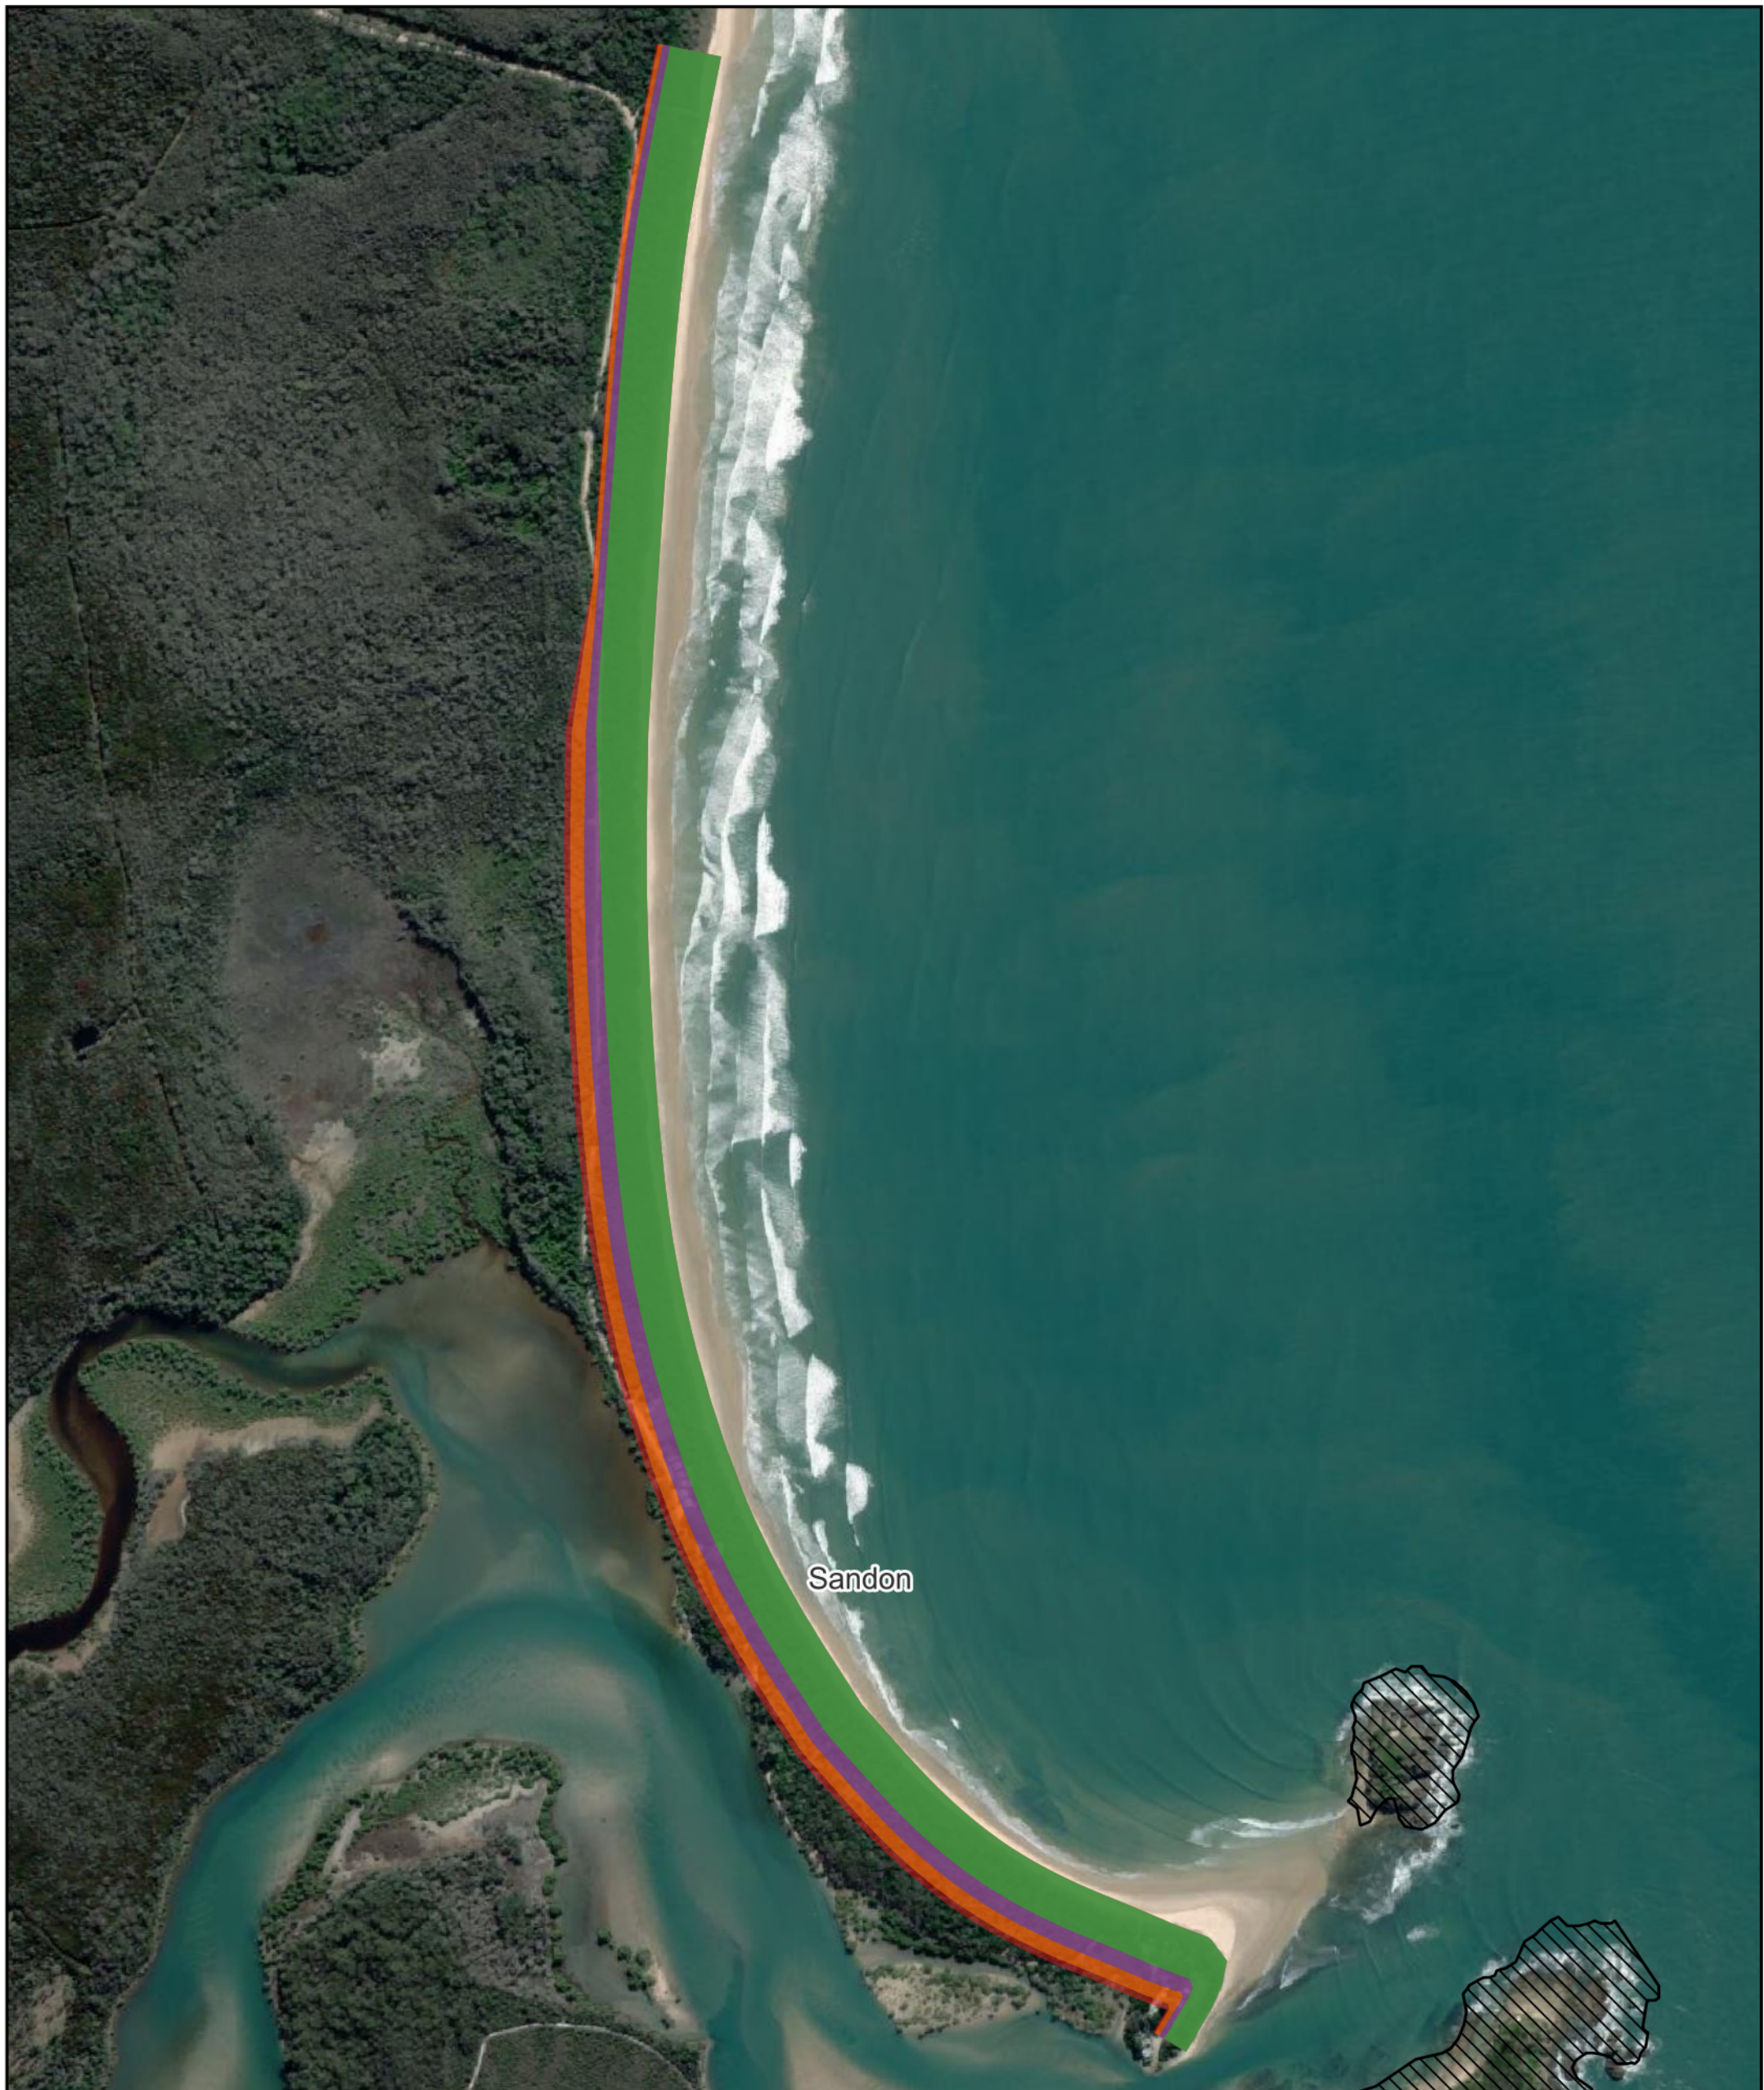
**Title**  
Erosion and recession hazard zones -SSP5 2073: Sandon

- Erosion and recession hazard zones (without protection)
- 50% exceedance probability ■
  - 10% exceedance probability ■
  - 2% exceedance probability ■
  - 1% exceedance probability ■
  - Bedrock
