**Title**  
Erosion and recession hazard zones - Present Day: Sandon

**Project**  
2021s1471 - Hydrosphere - CVC CMP Stage 2 - 4

**Client**  
Hydrosphere Consulting

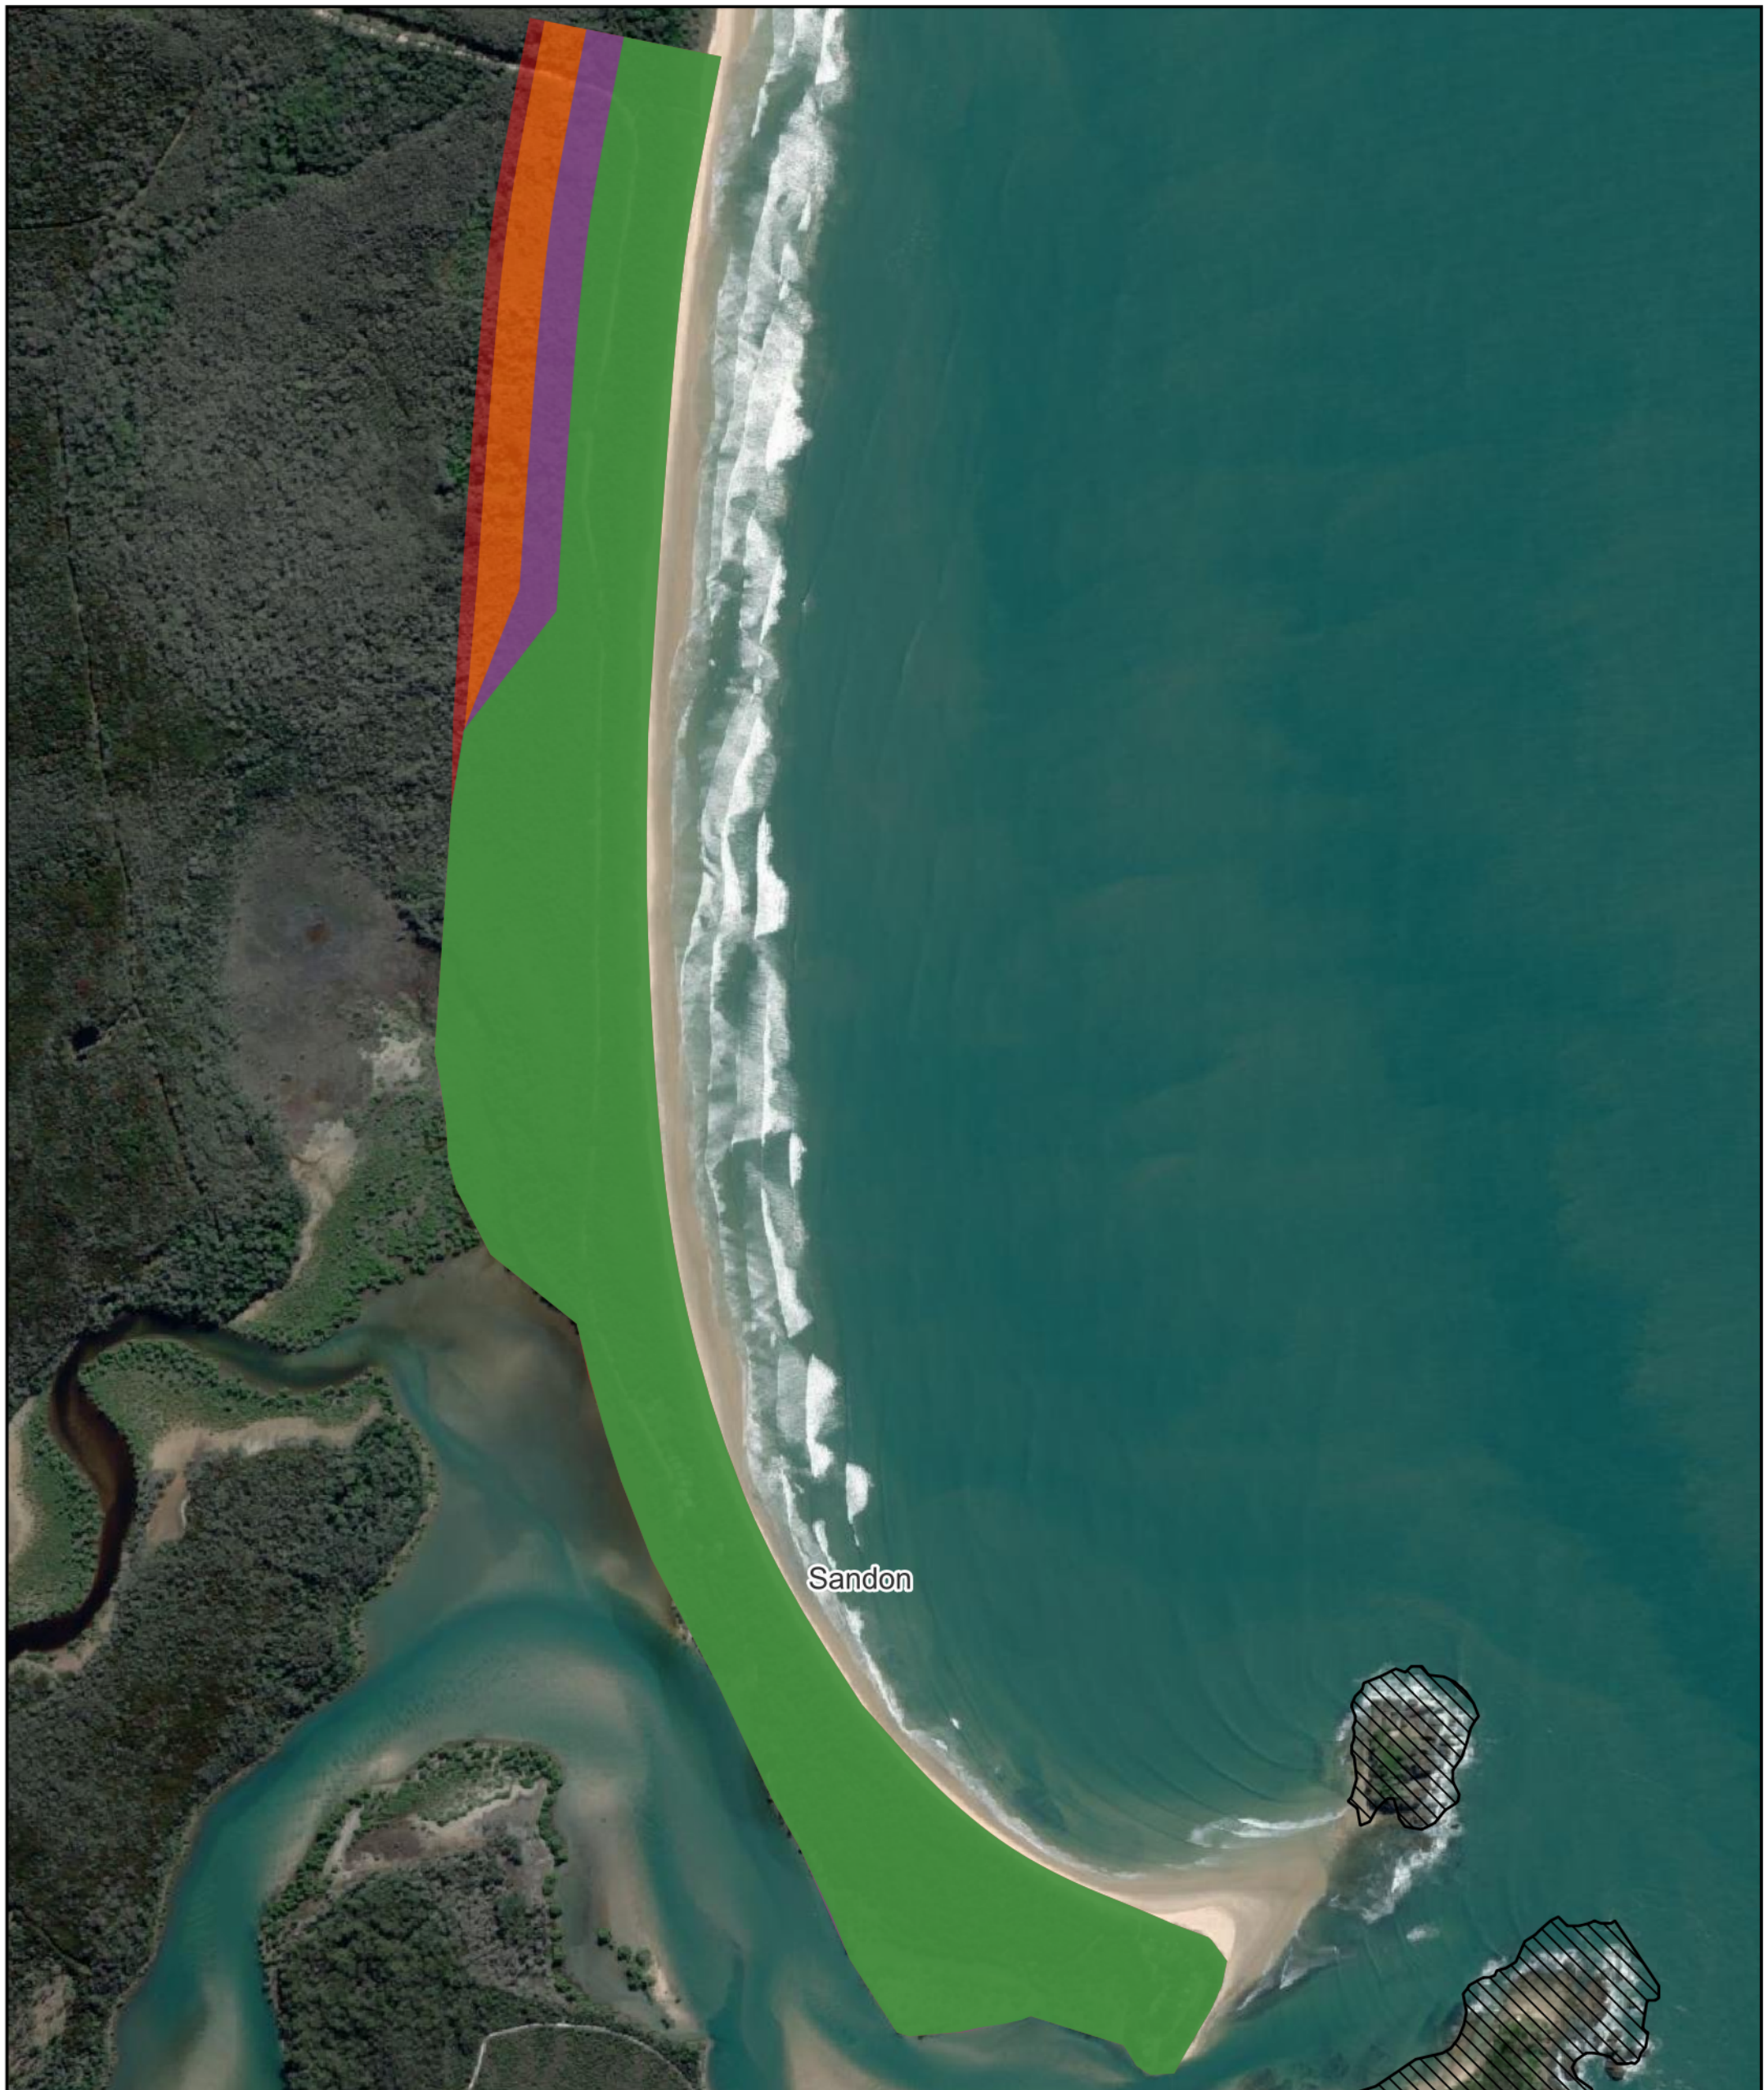
**Title**  
 Erosion and recession hazard zones -SSP5 2123: Sandon

- Erosion and recession hazard zones (without protection)
- 50% exceedance probability ■
  - 10% exceedance probability ■
  - 2% exceedance probability ■
  - 1% exceedance probability ■
  - Bedrock
