Title
Erosion and recession hazard zones
- Present Day: Sandon Village

Project
2021s1471 - Hydrosphere -
CVC CMP Stage 2 - 4

Client
Hydrosphere Consulting

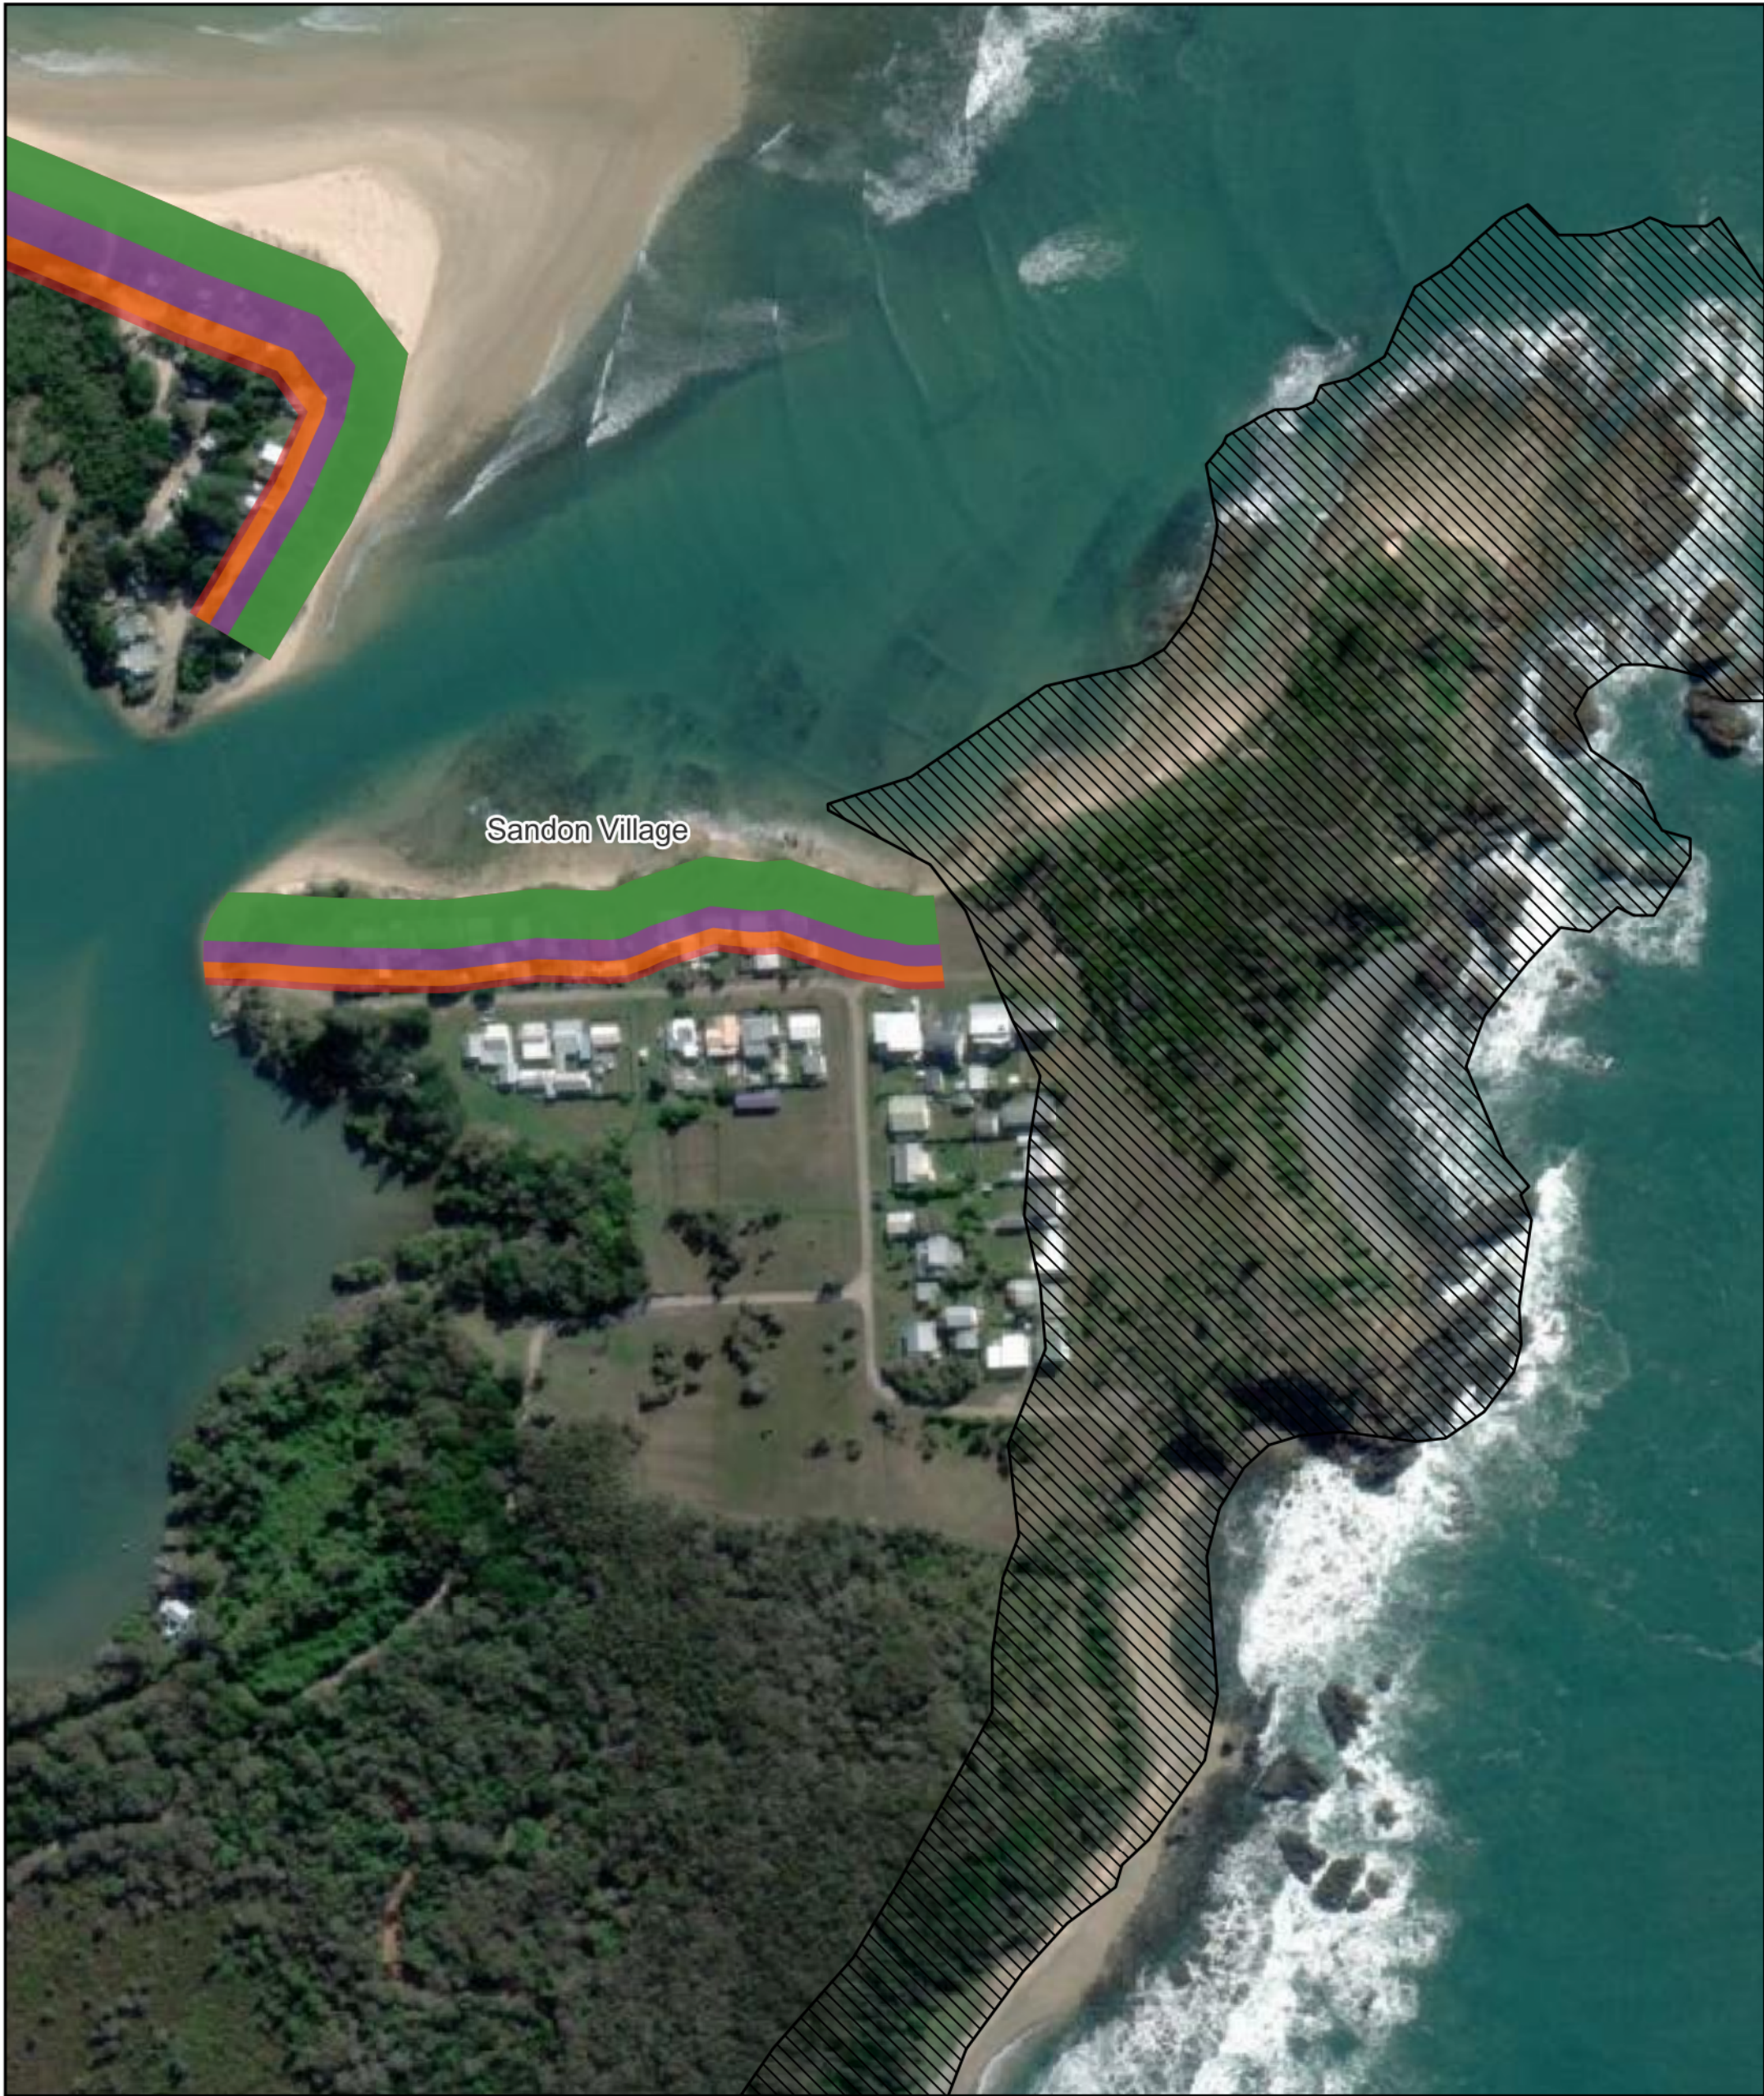
Erosion and recession hazard zones
(without protection)

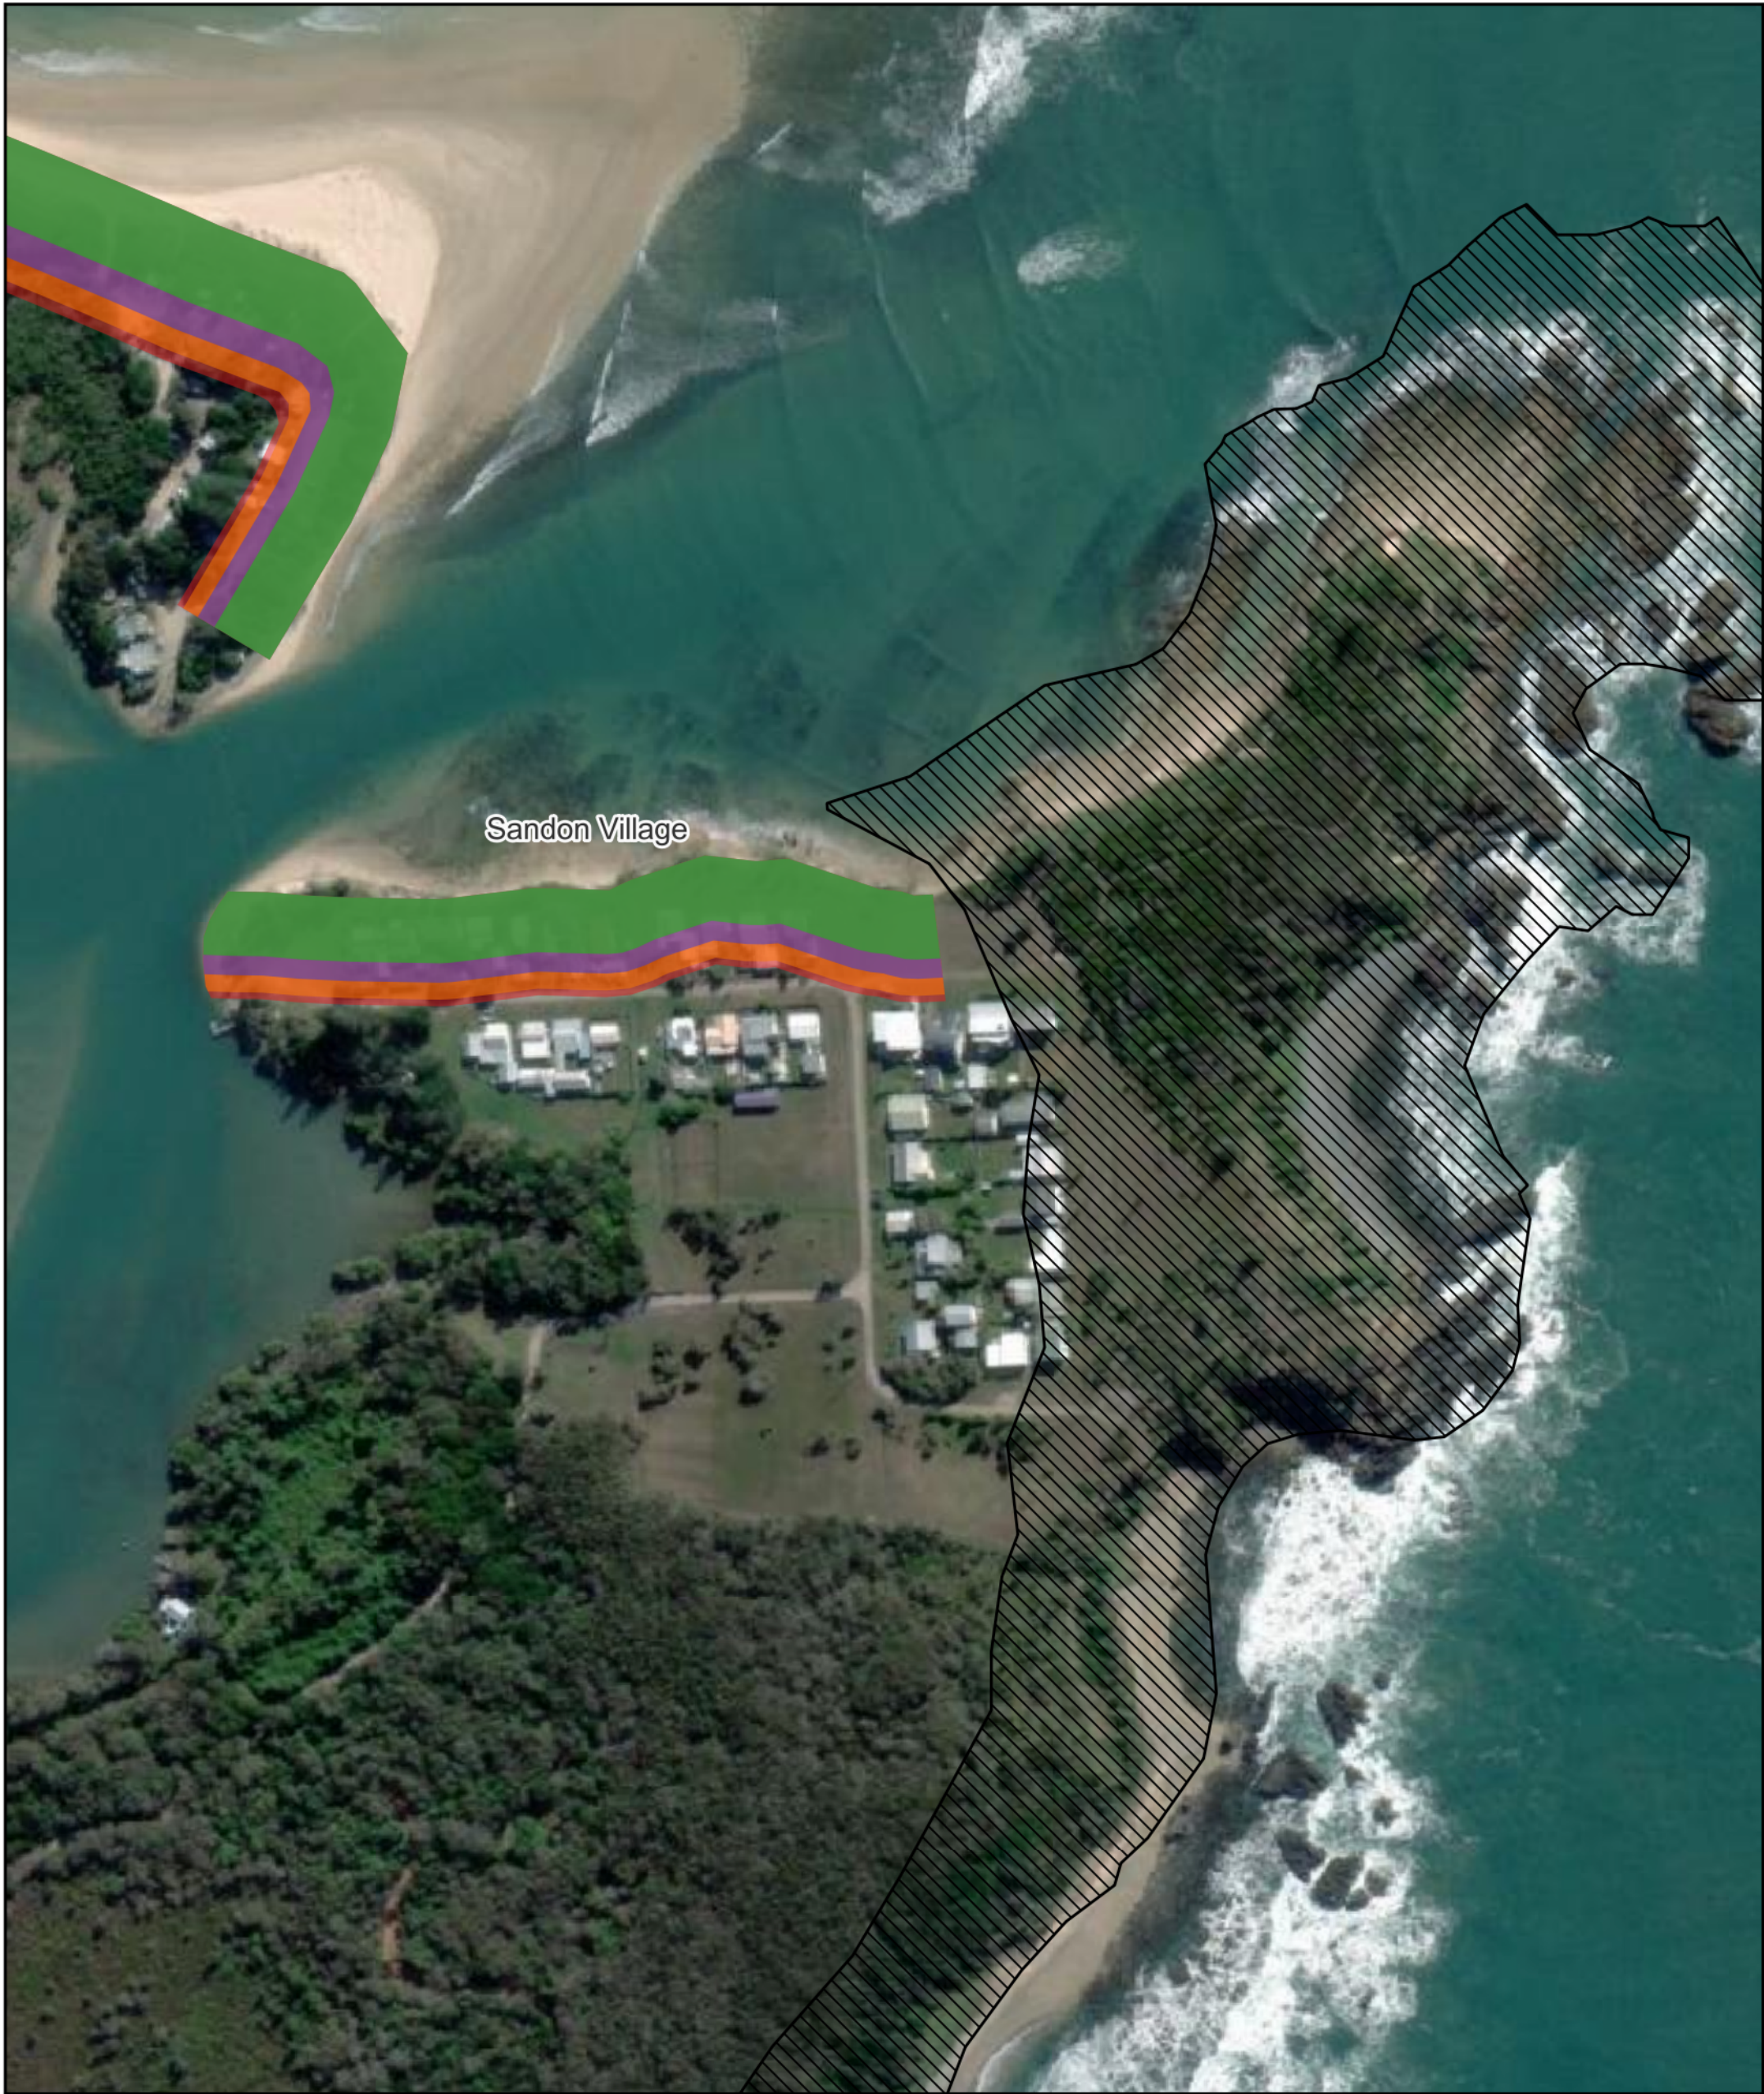
Erosion and recession hazard zones
(without protection)

Title
Erosion and recession hazard zones
-SSP2 2043: Sandon Village

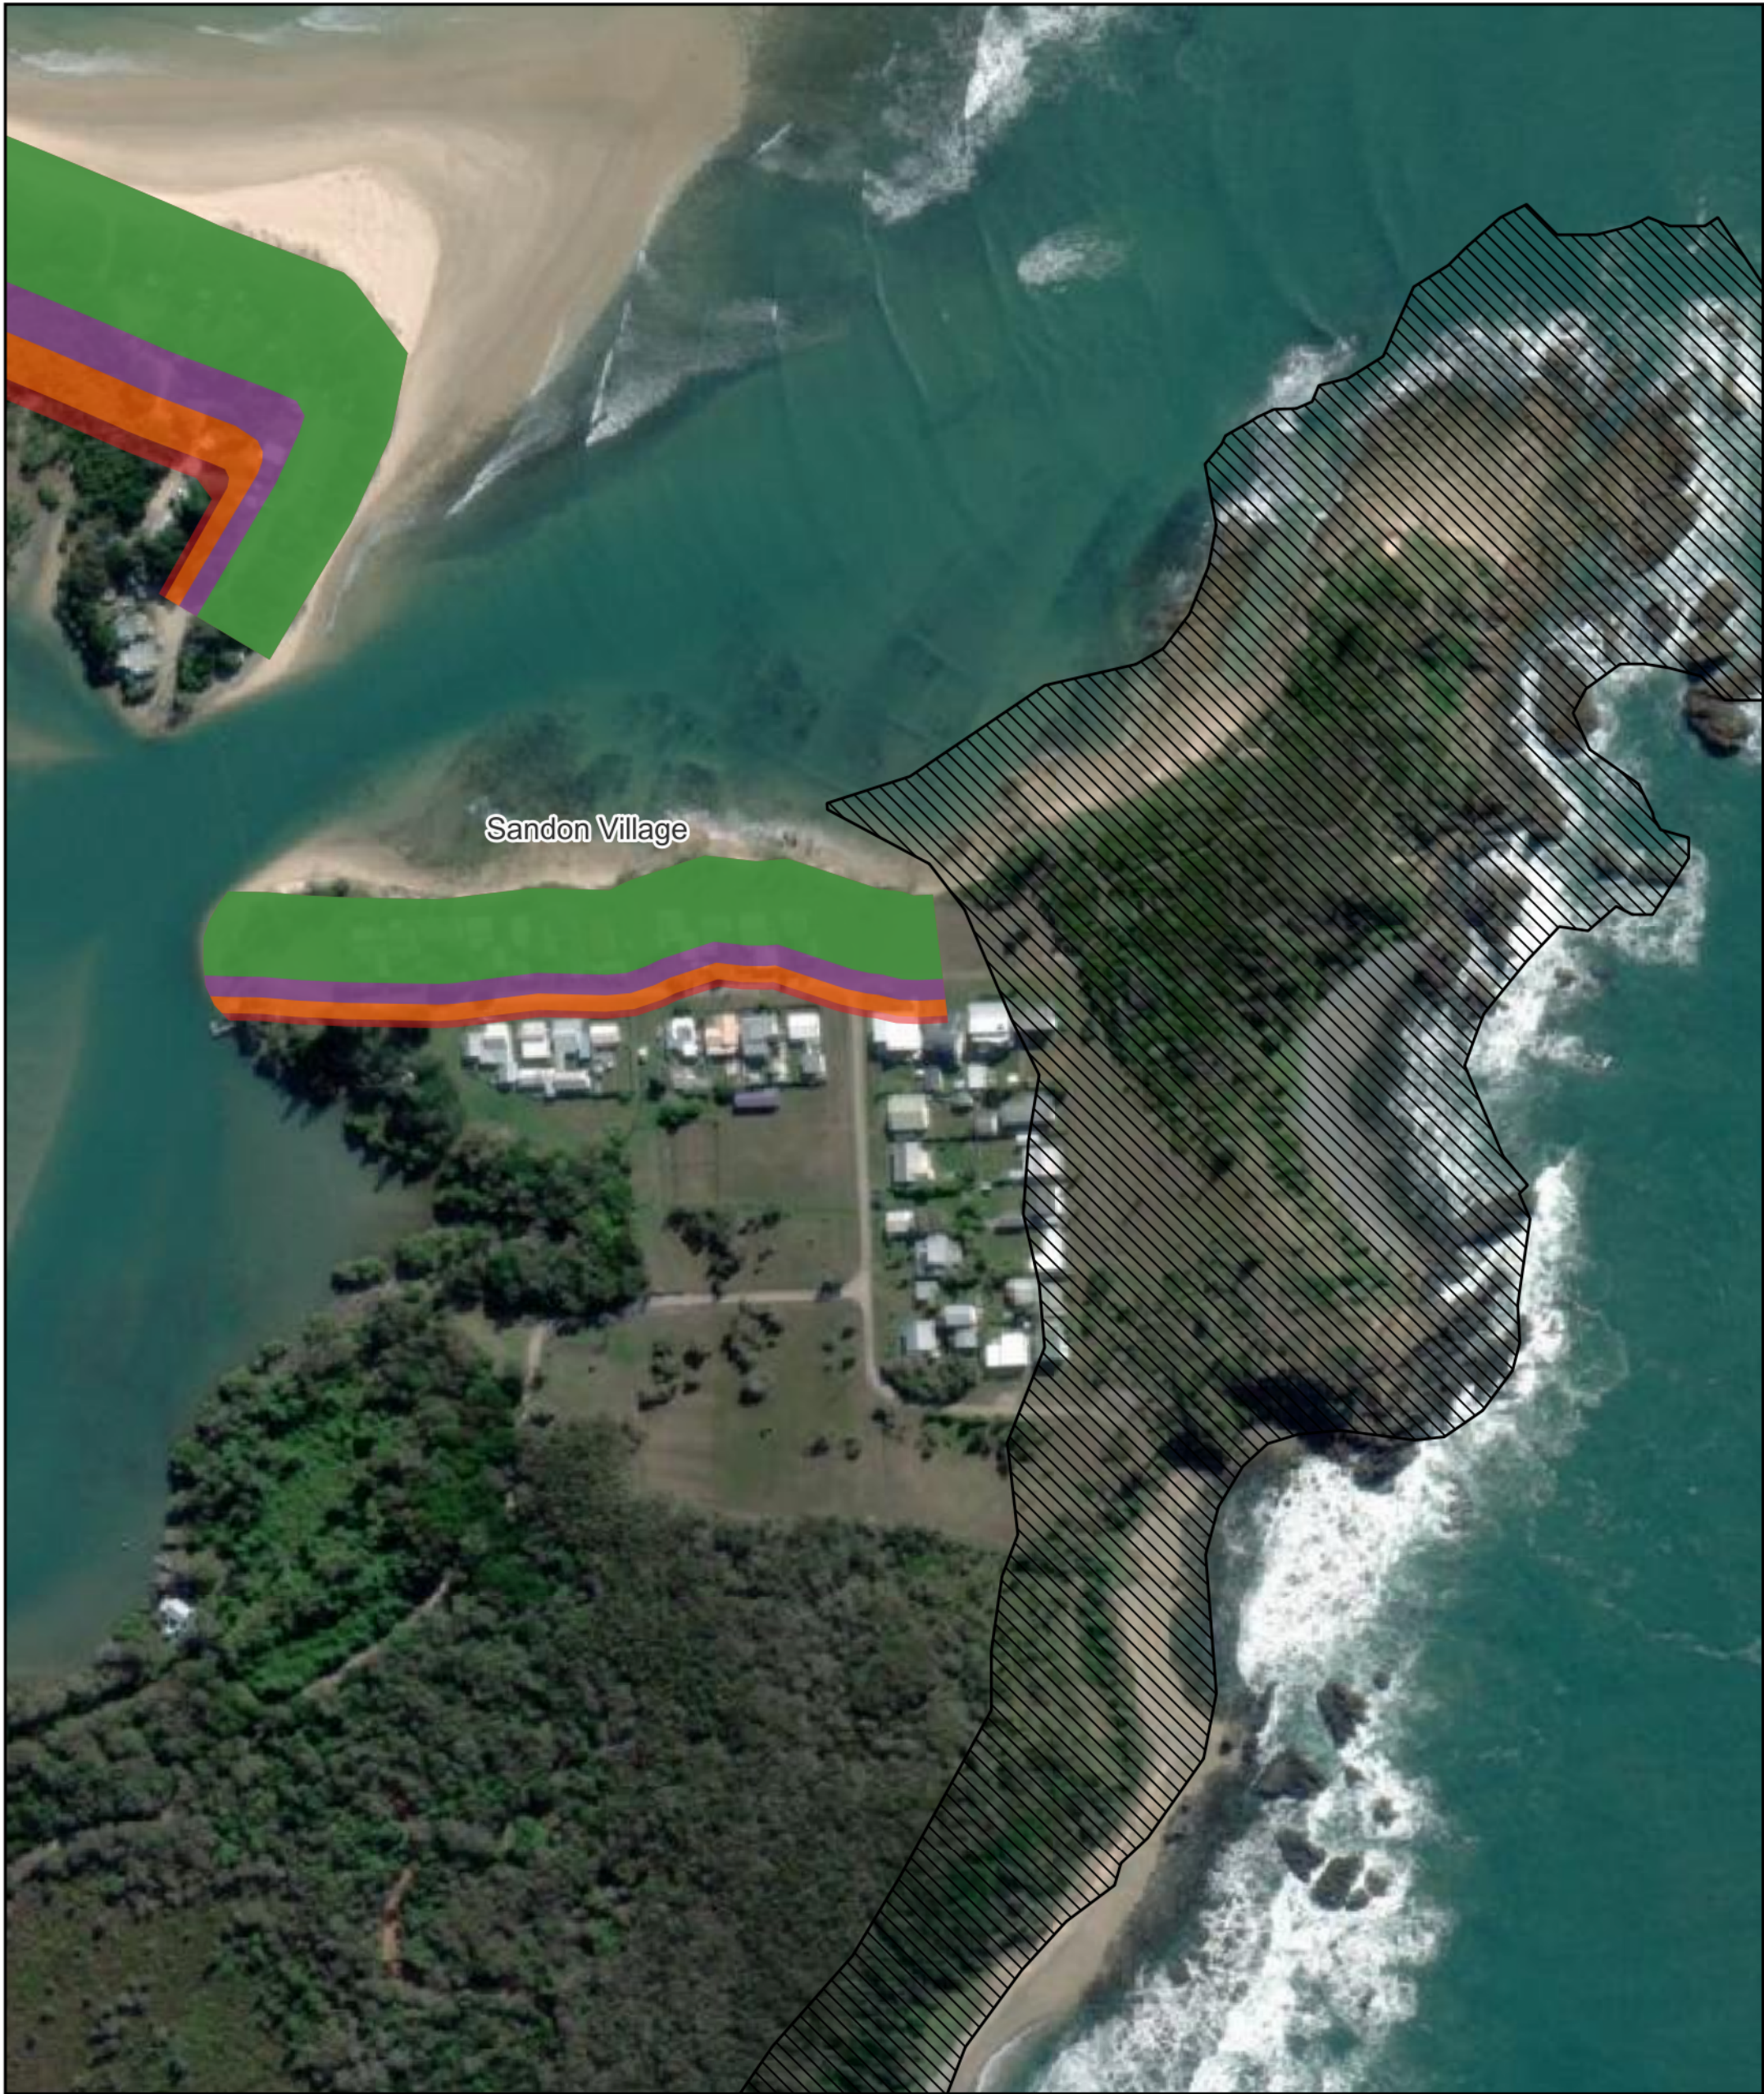
- Erosion and recession hazard zones
(without protection)
- 50% exceedance probability

Erosion and recession hazard zones
-SSP2 2073: Sandon Village

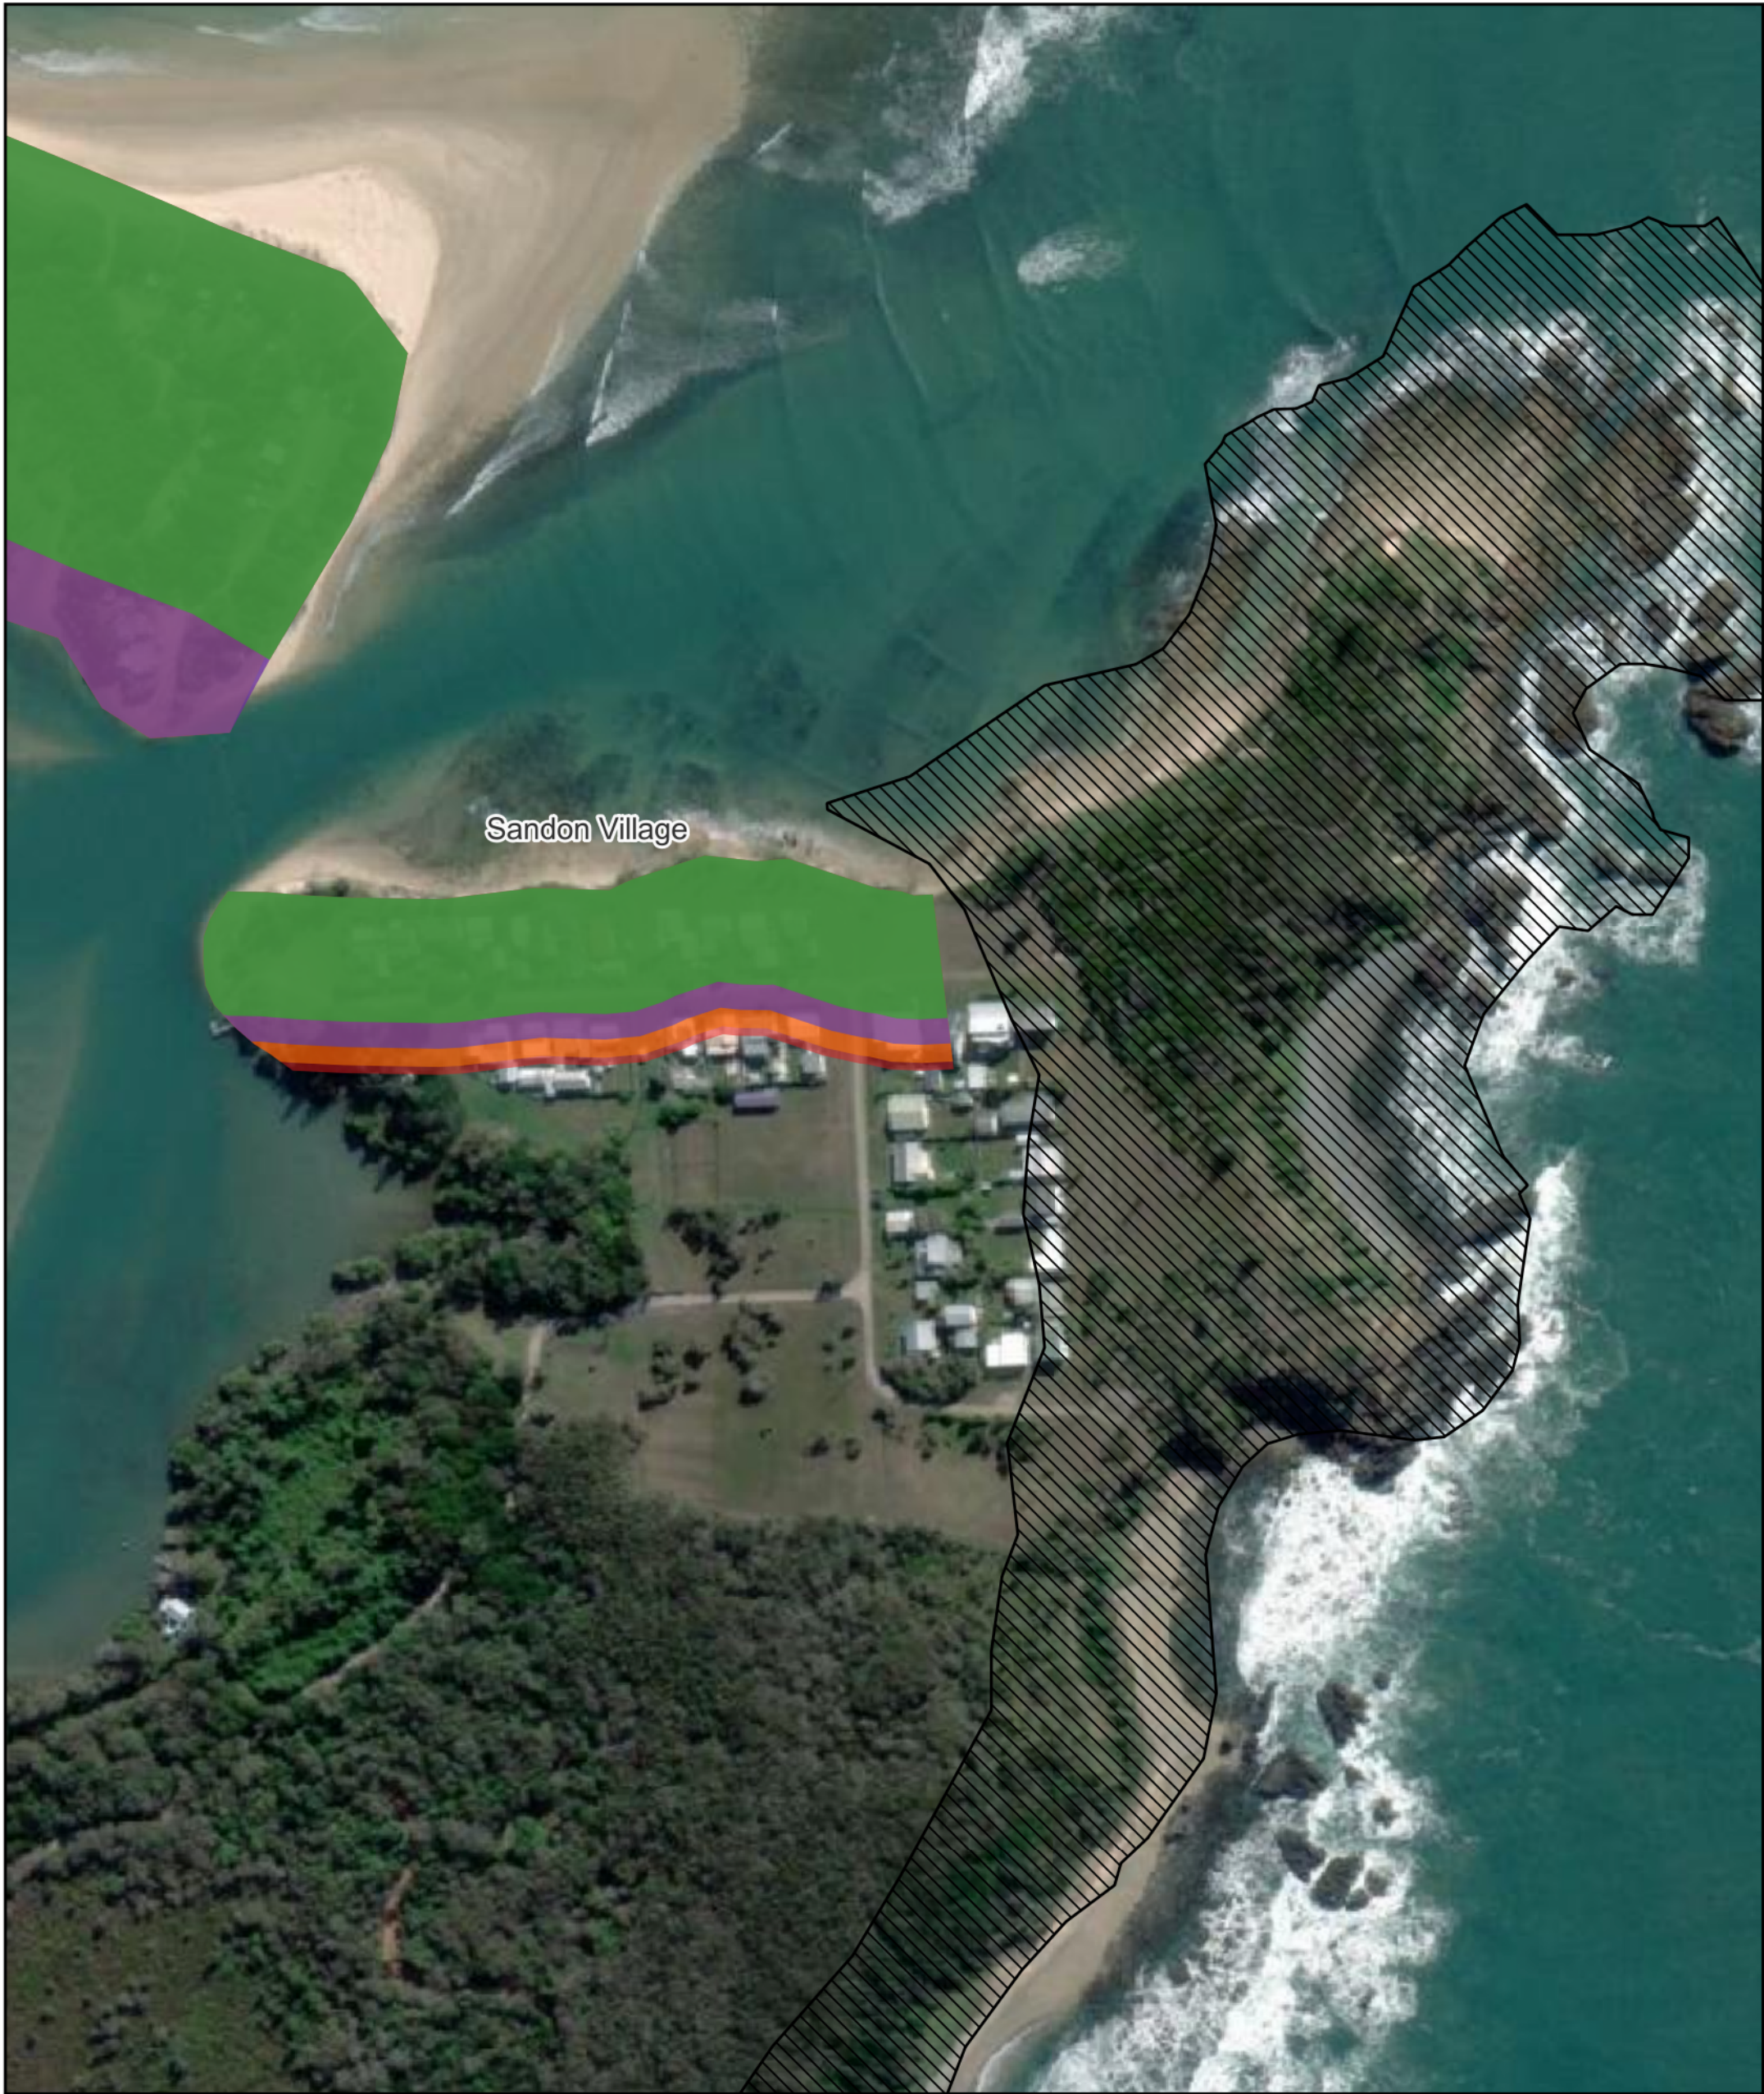
Erosion and recession hazard zones
(without protection)

Title
Erosion and recession hazard zones
-SSP2 2123: Sandon Village

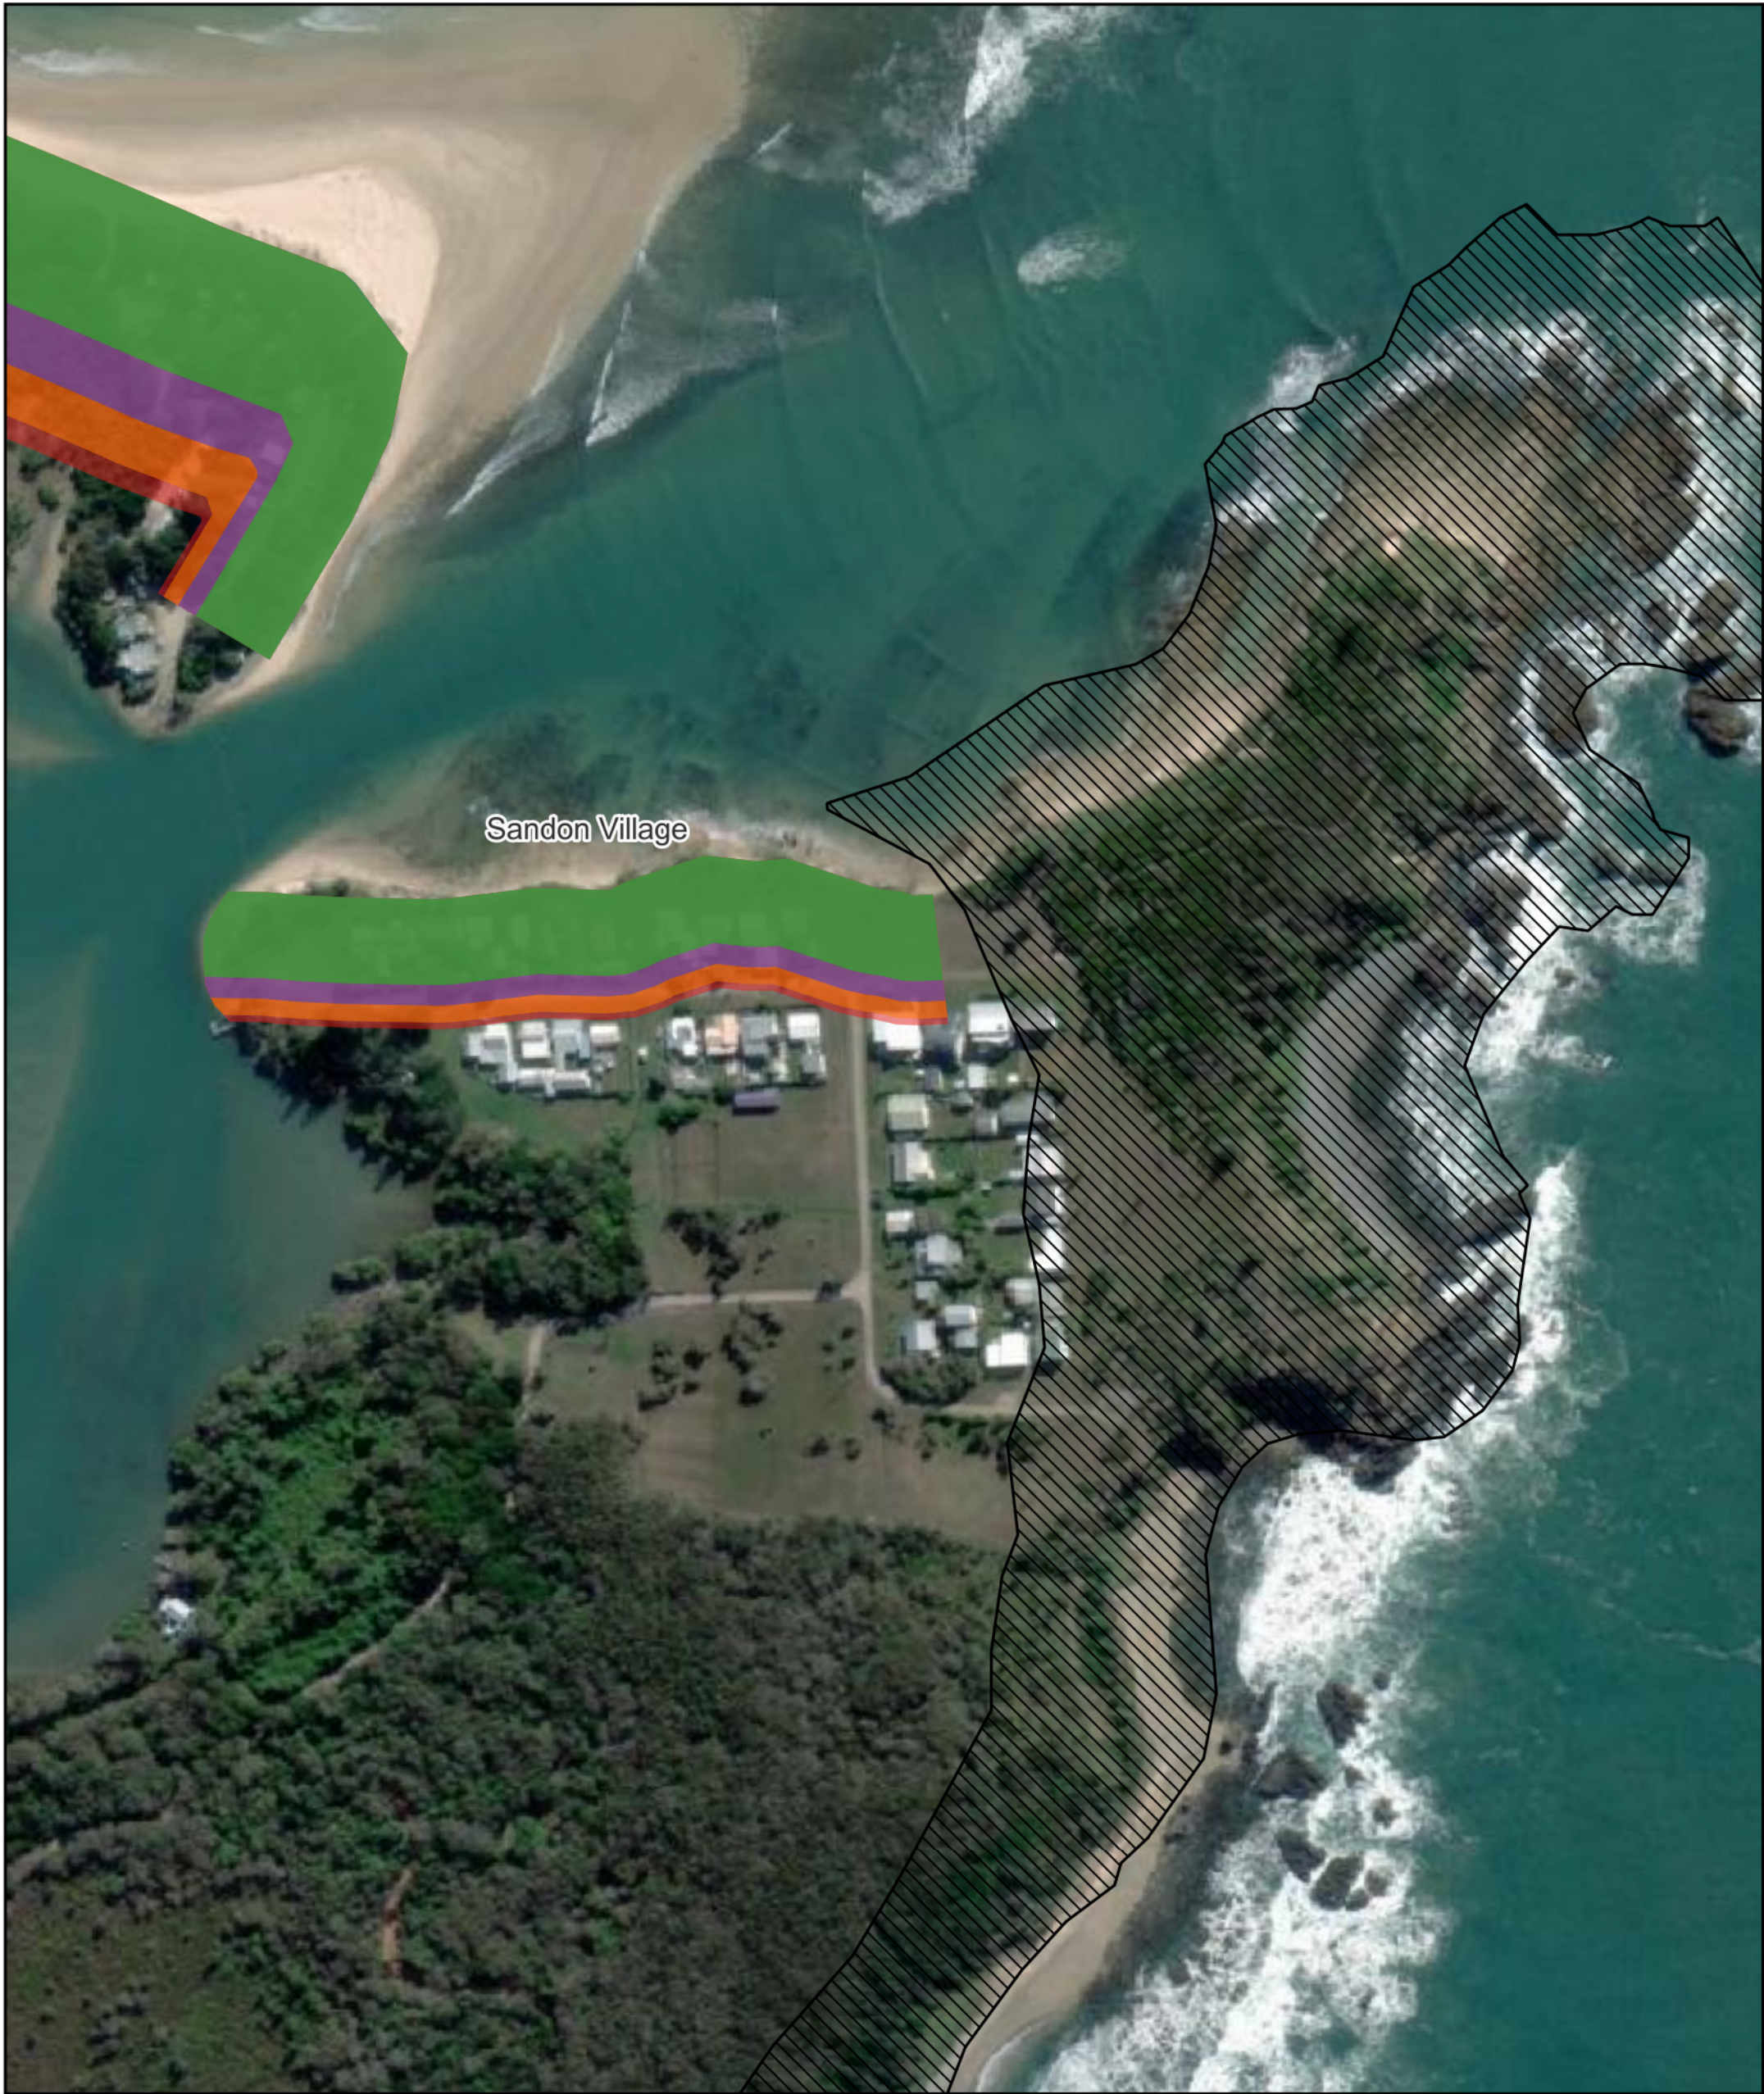
- Erosion and recession hazard zones
(without protection)
- 50% exceedance probability

Erosion and recession hazard zones
-SSP5 2073: Sandon Village

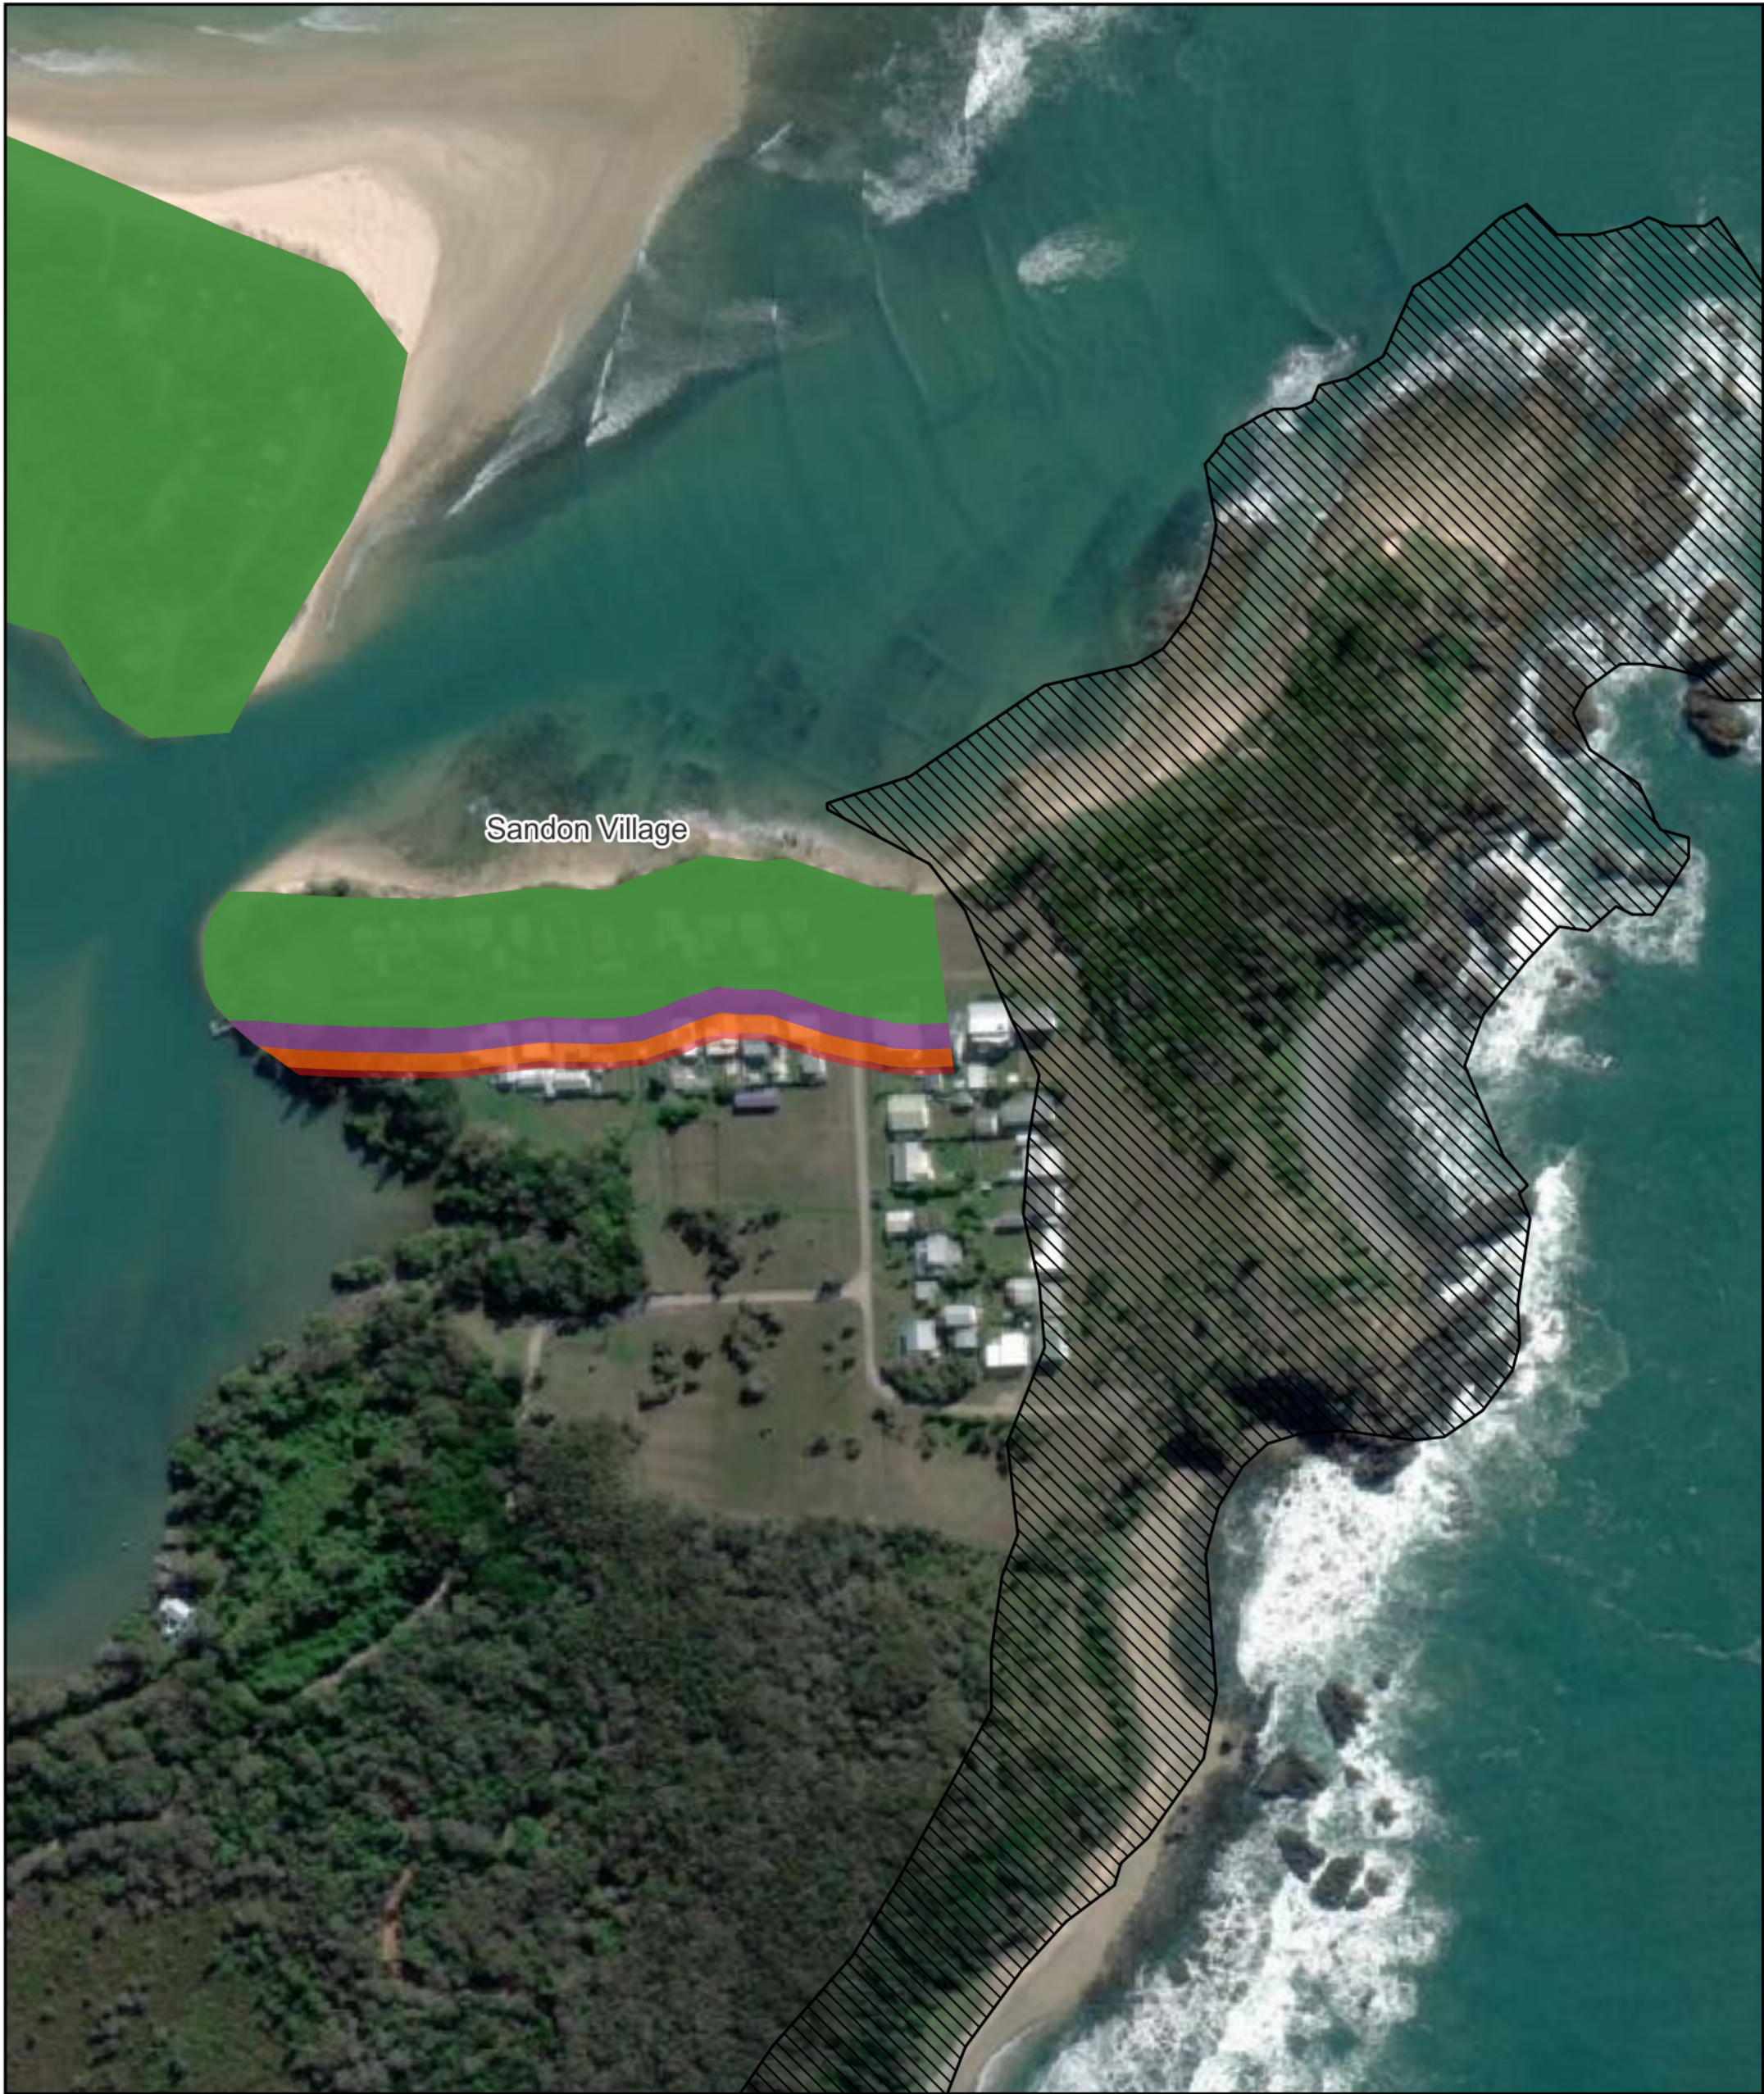
Erosion and recession hazard zones (without protection)

Erosion and recession hazard zones -SSP5 2123: Sandon Village
