**Title**  
Erosion and recession hazard zones - Present Day: Woody Bay

**Project**  
2021s1471 - Hydrosphere - CVC CMP Stage 2 - 4

**Client**  
Hydrosphere Consulting

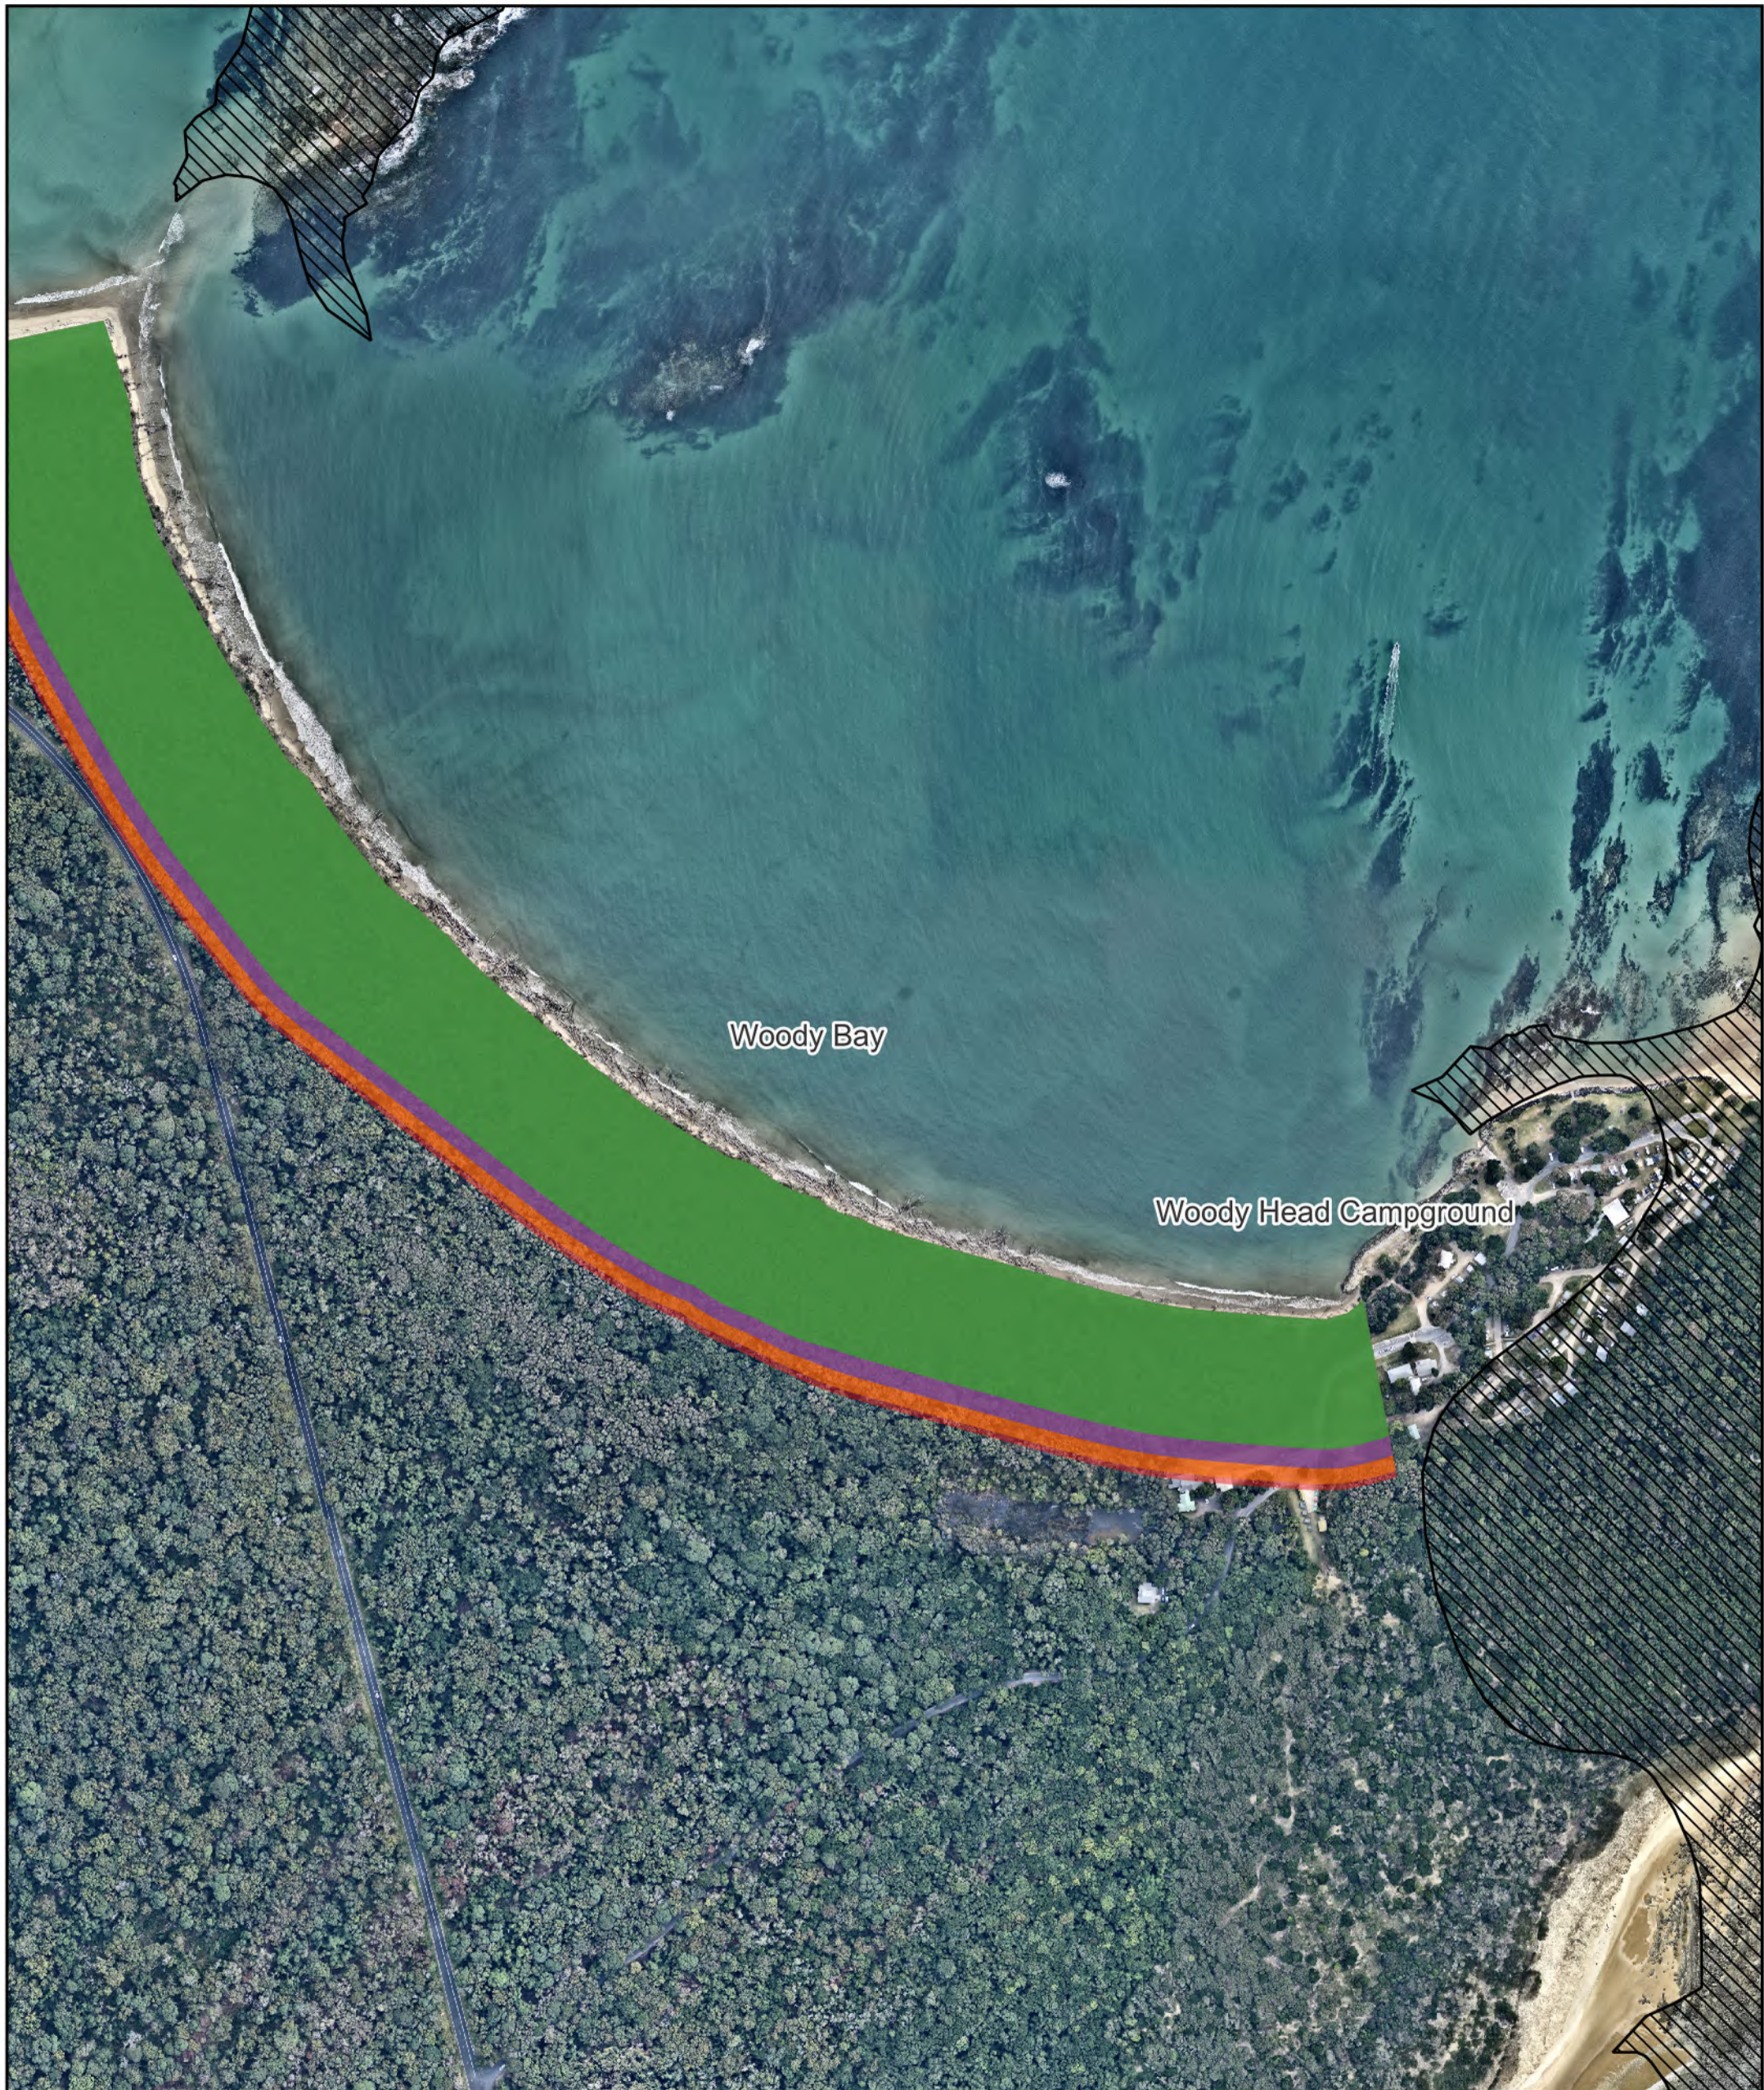
**Title**  
Erosion and recession hazard zones -SSP2 2043: Woody Bay

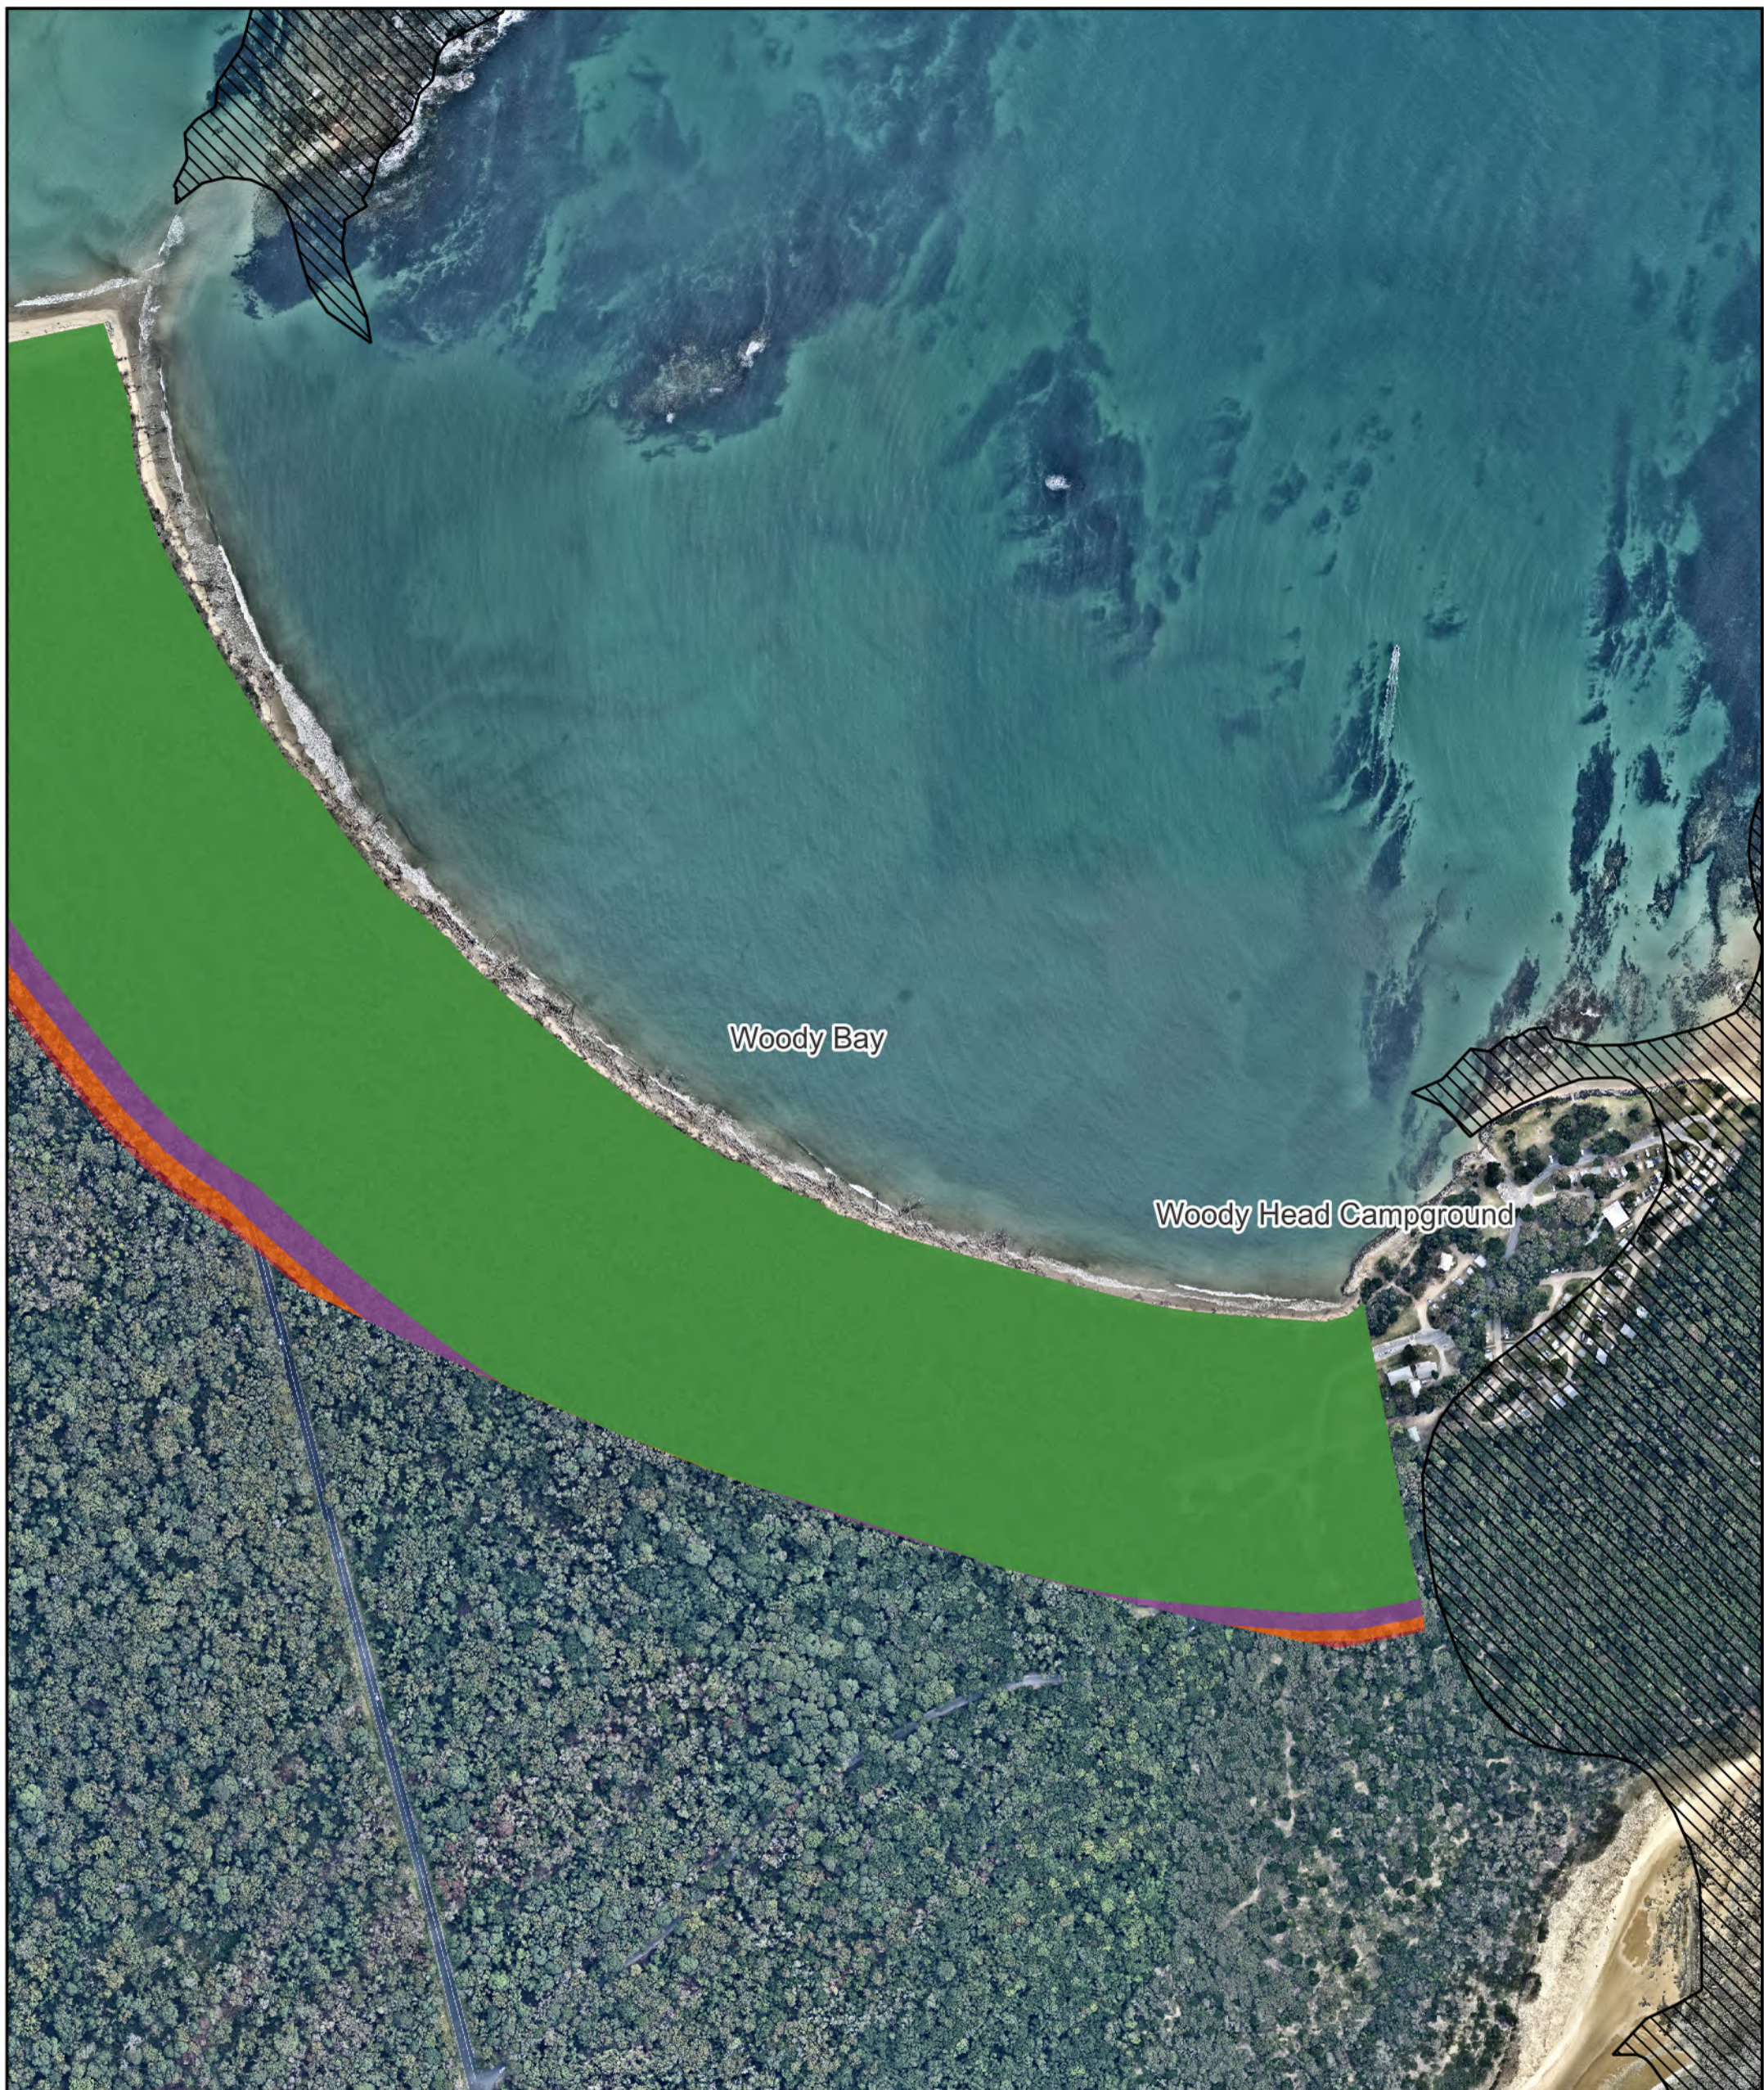
**Title**  
Erosion and recession hazard zones -SSP2 2073: Woody Bay

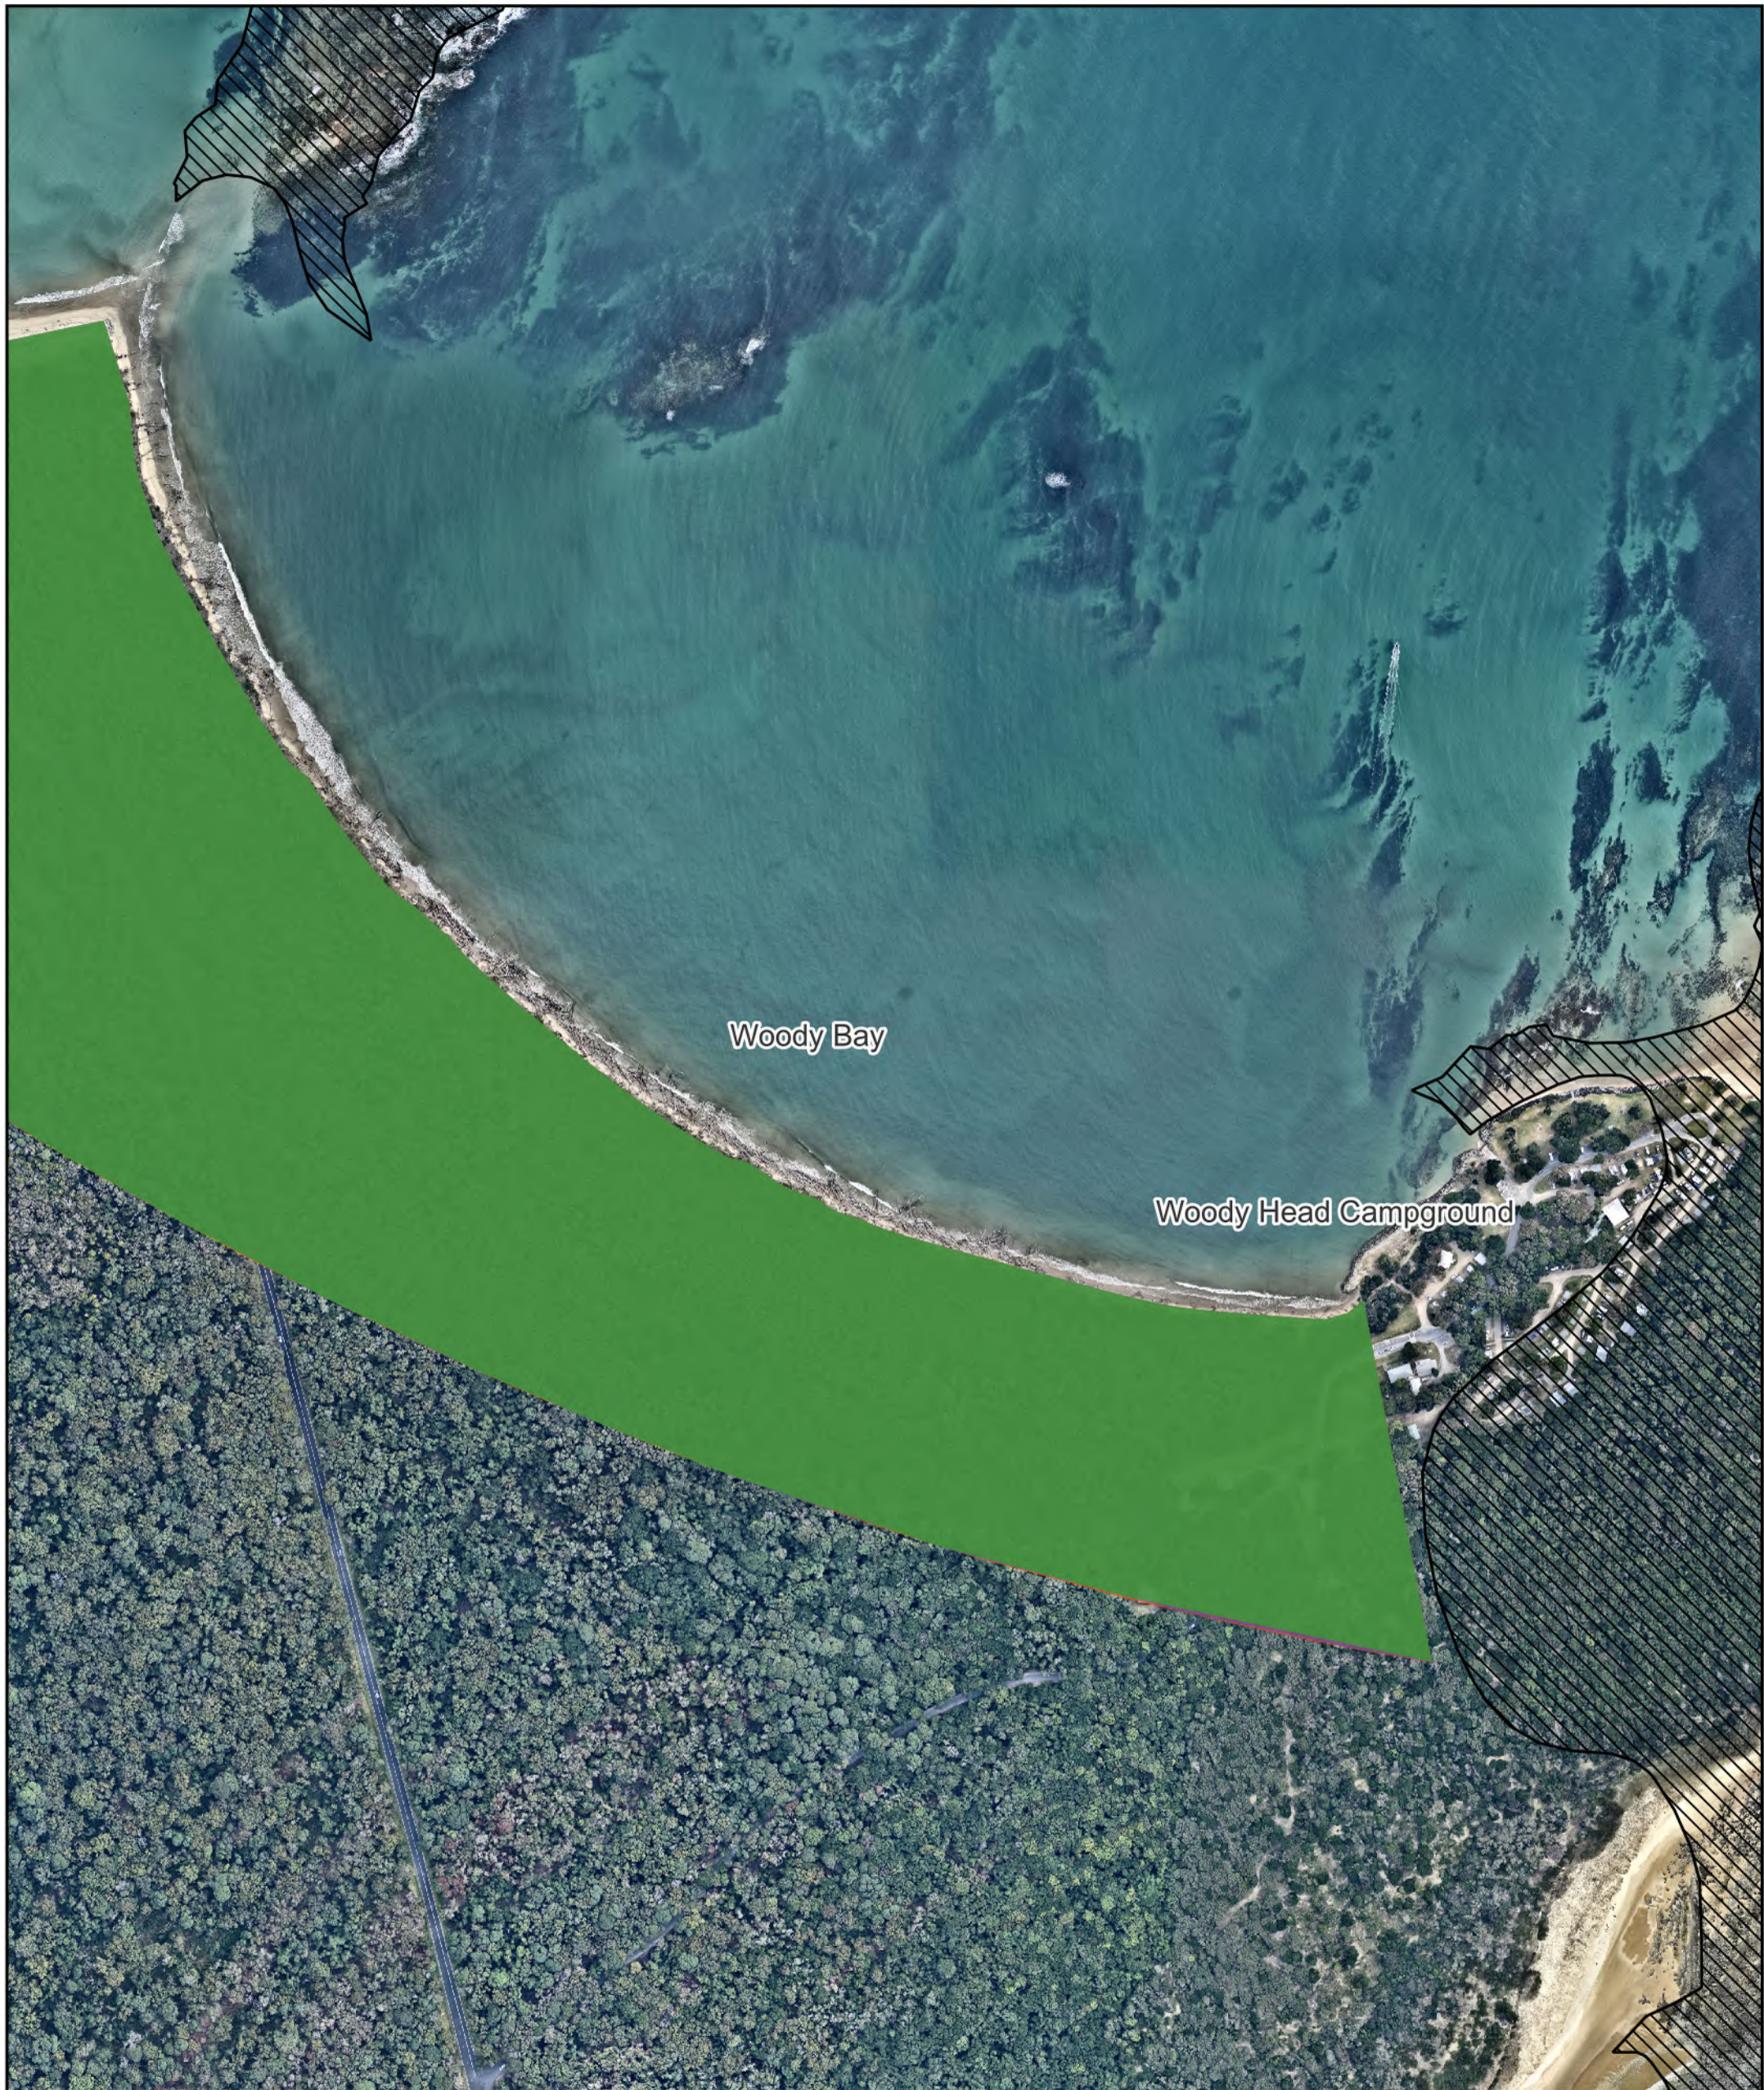
**Title**  
Erosion and recession hazard zones -SSP2 2123: Woody Bay

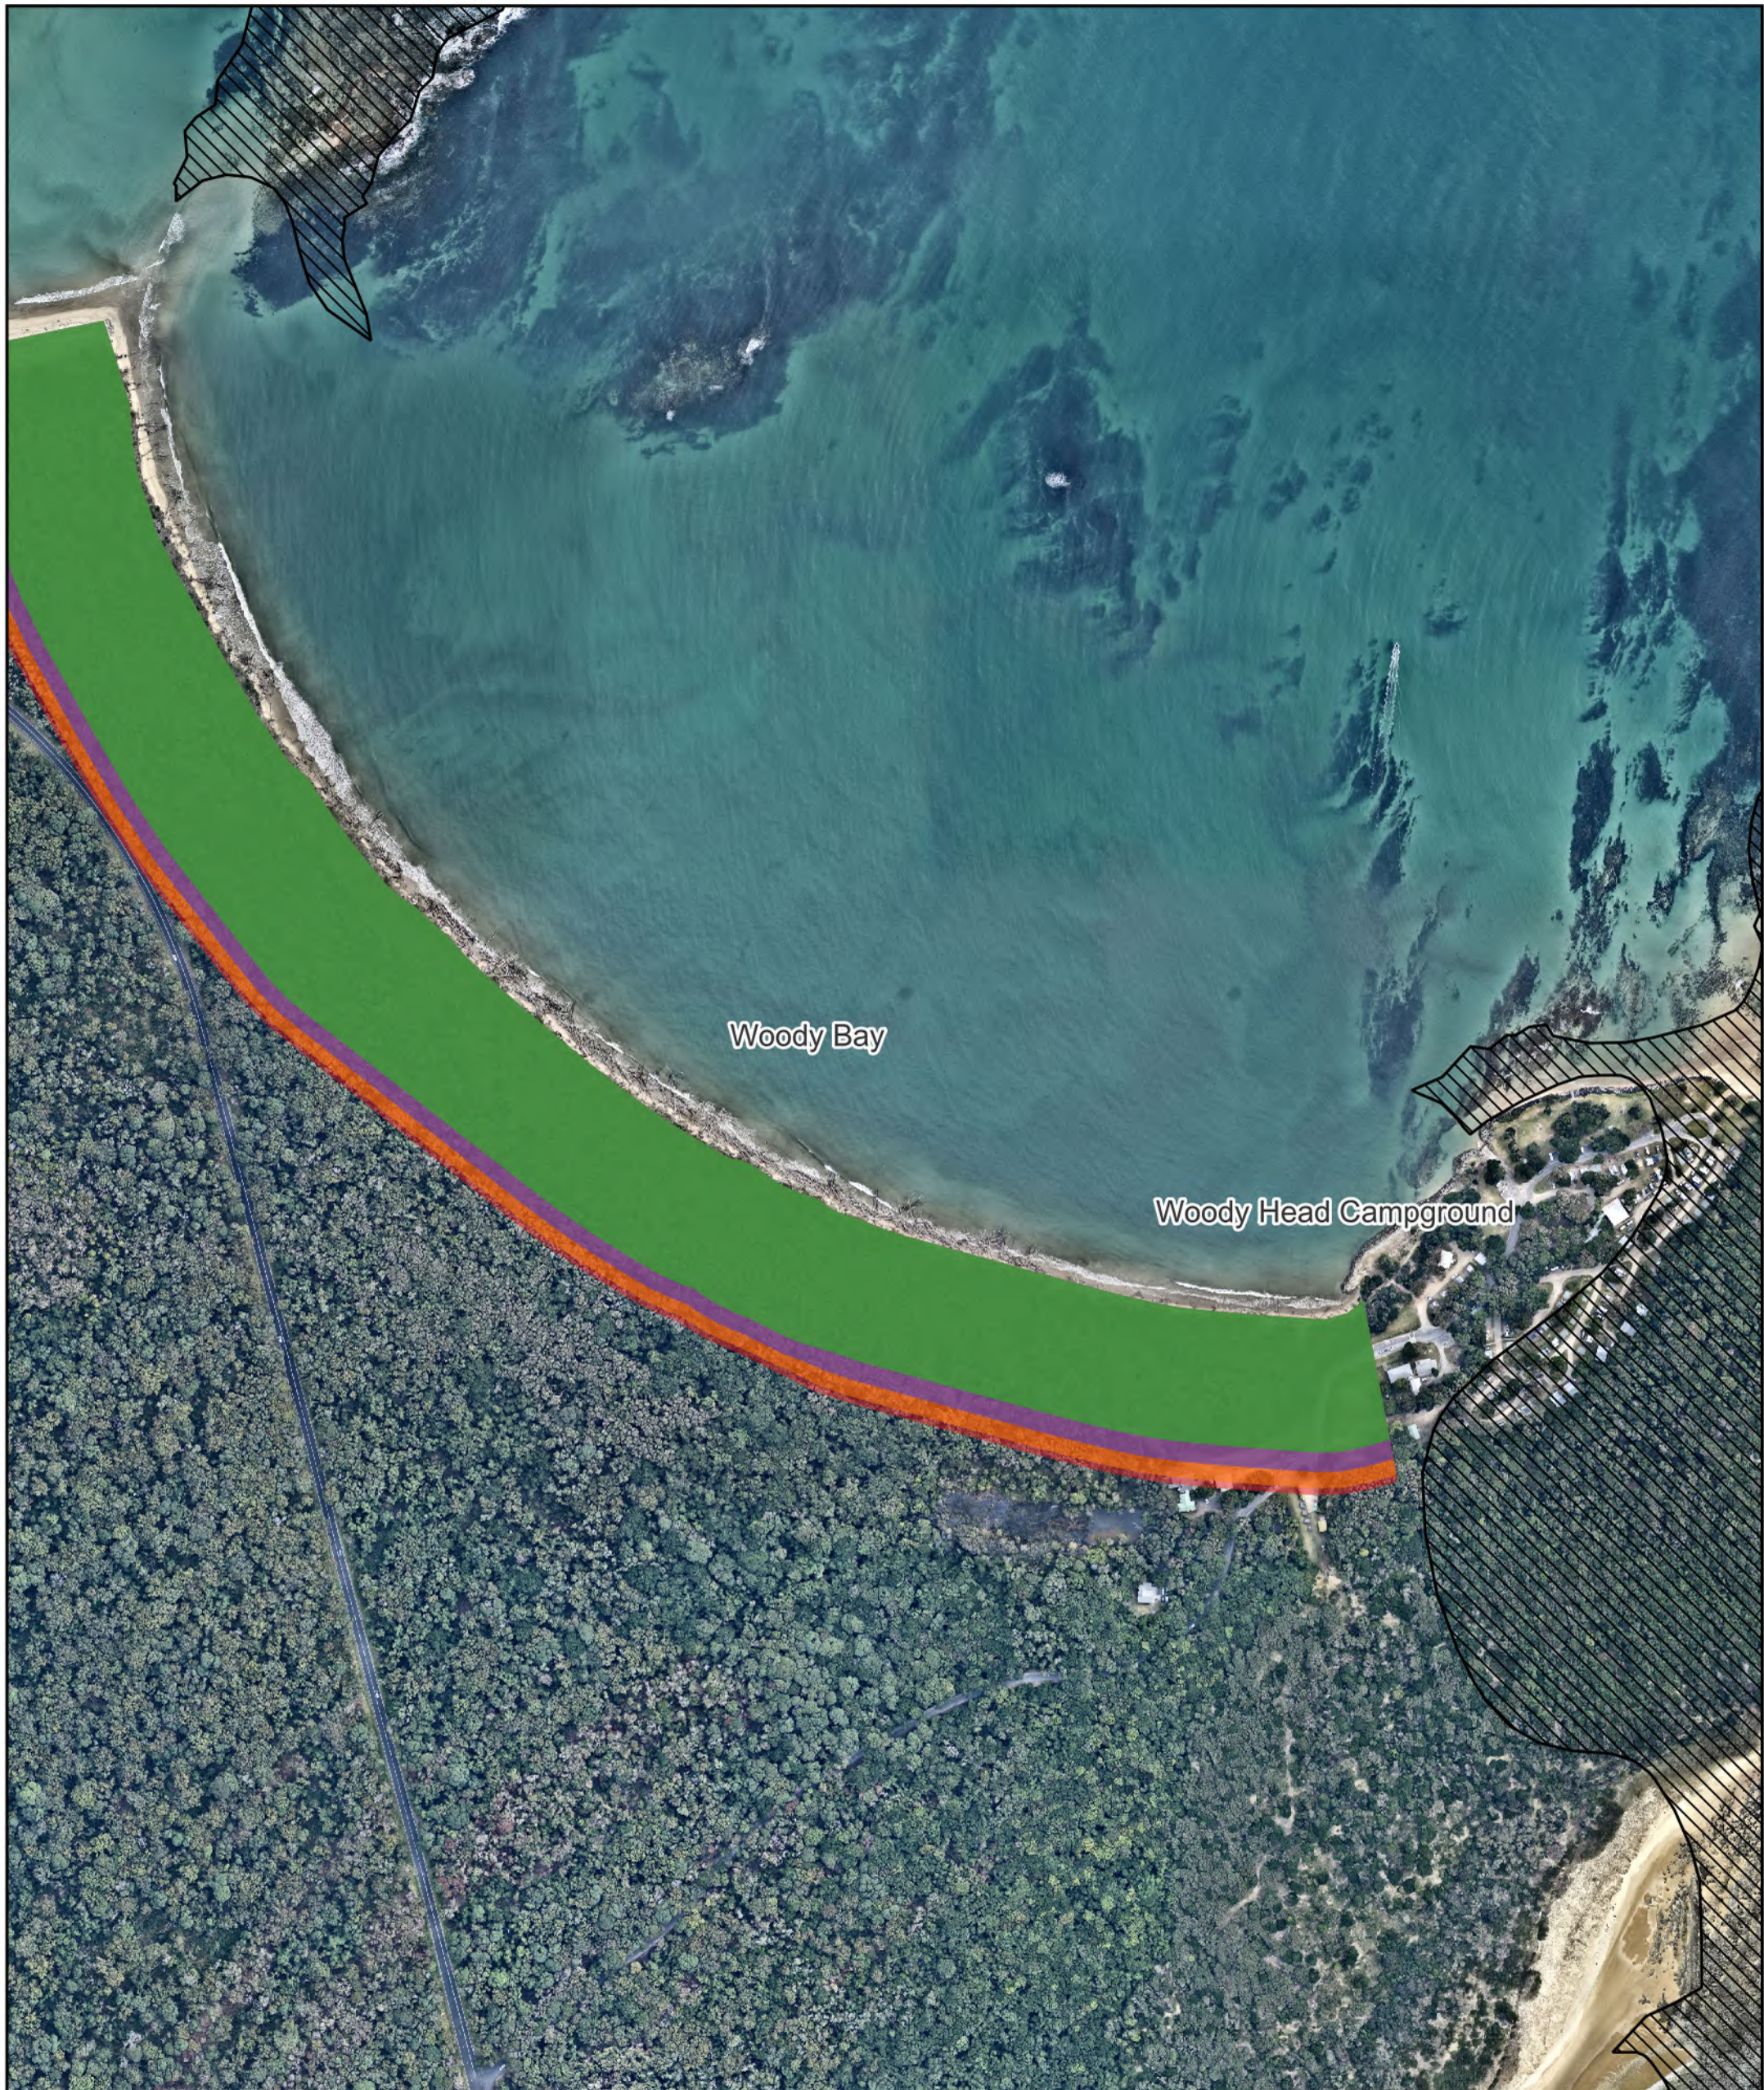
**Title**  
Erosion and recession hazard zones -SSP5 2043: Woody Bay

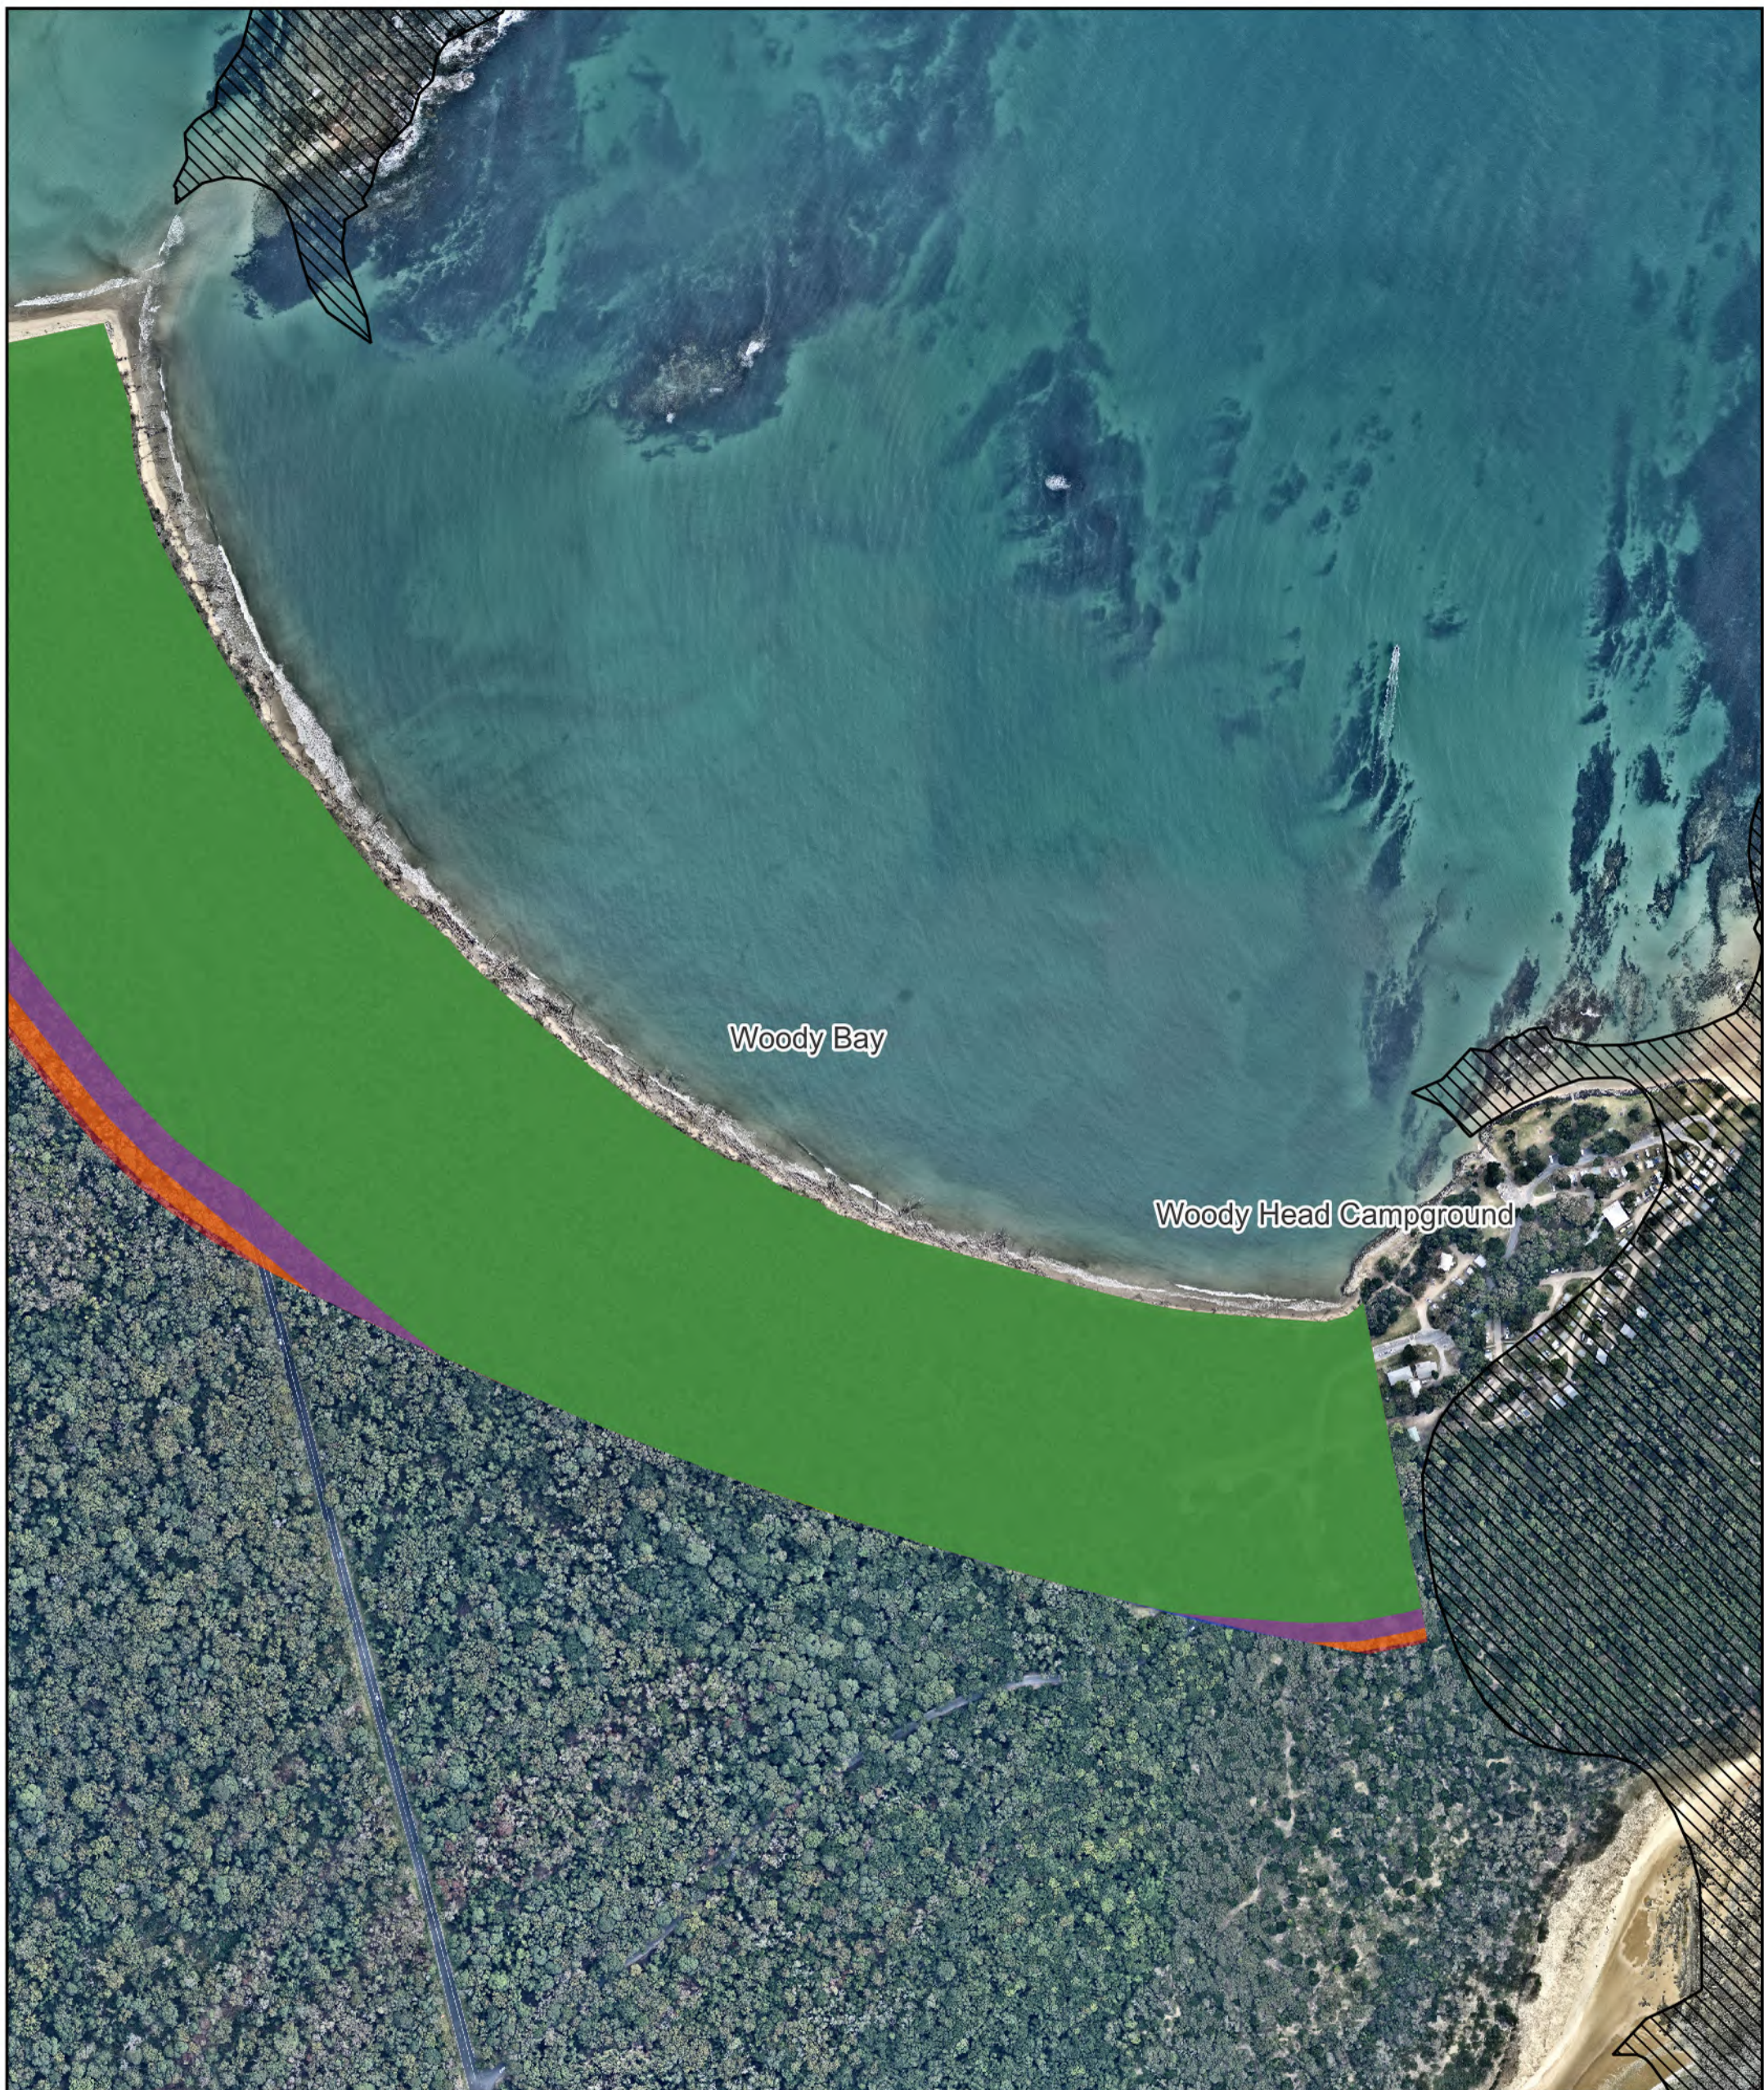
**Title**  
Erosion and recession hazard zones -SSP5 2073: Woody Bay

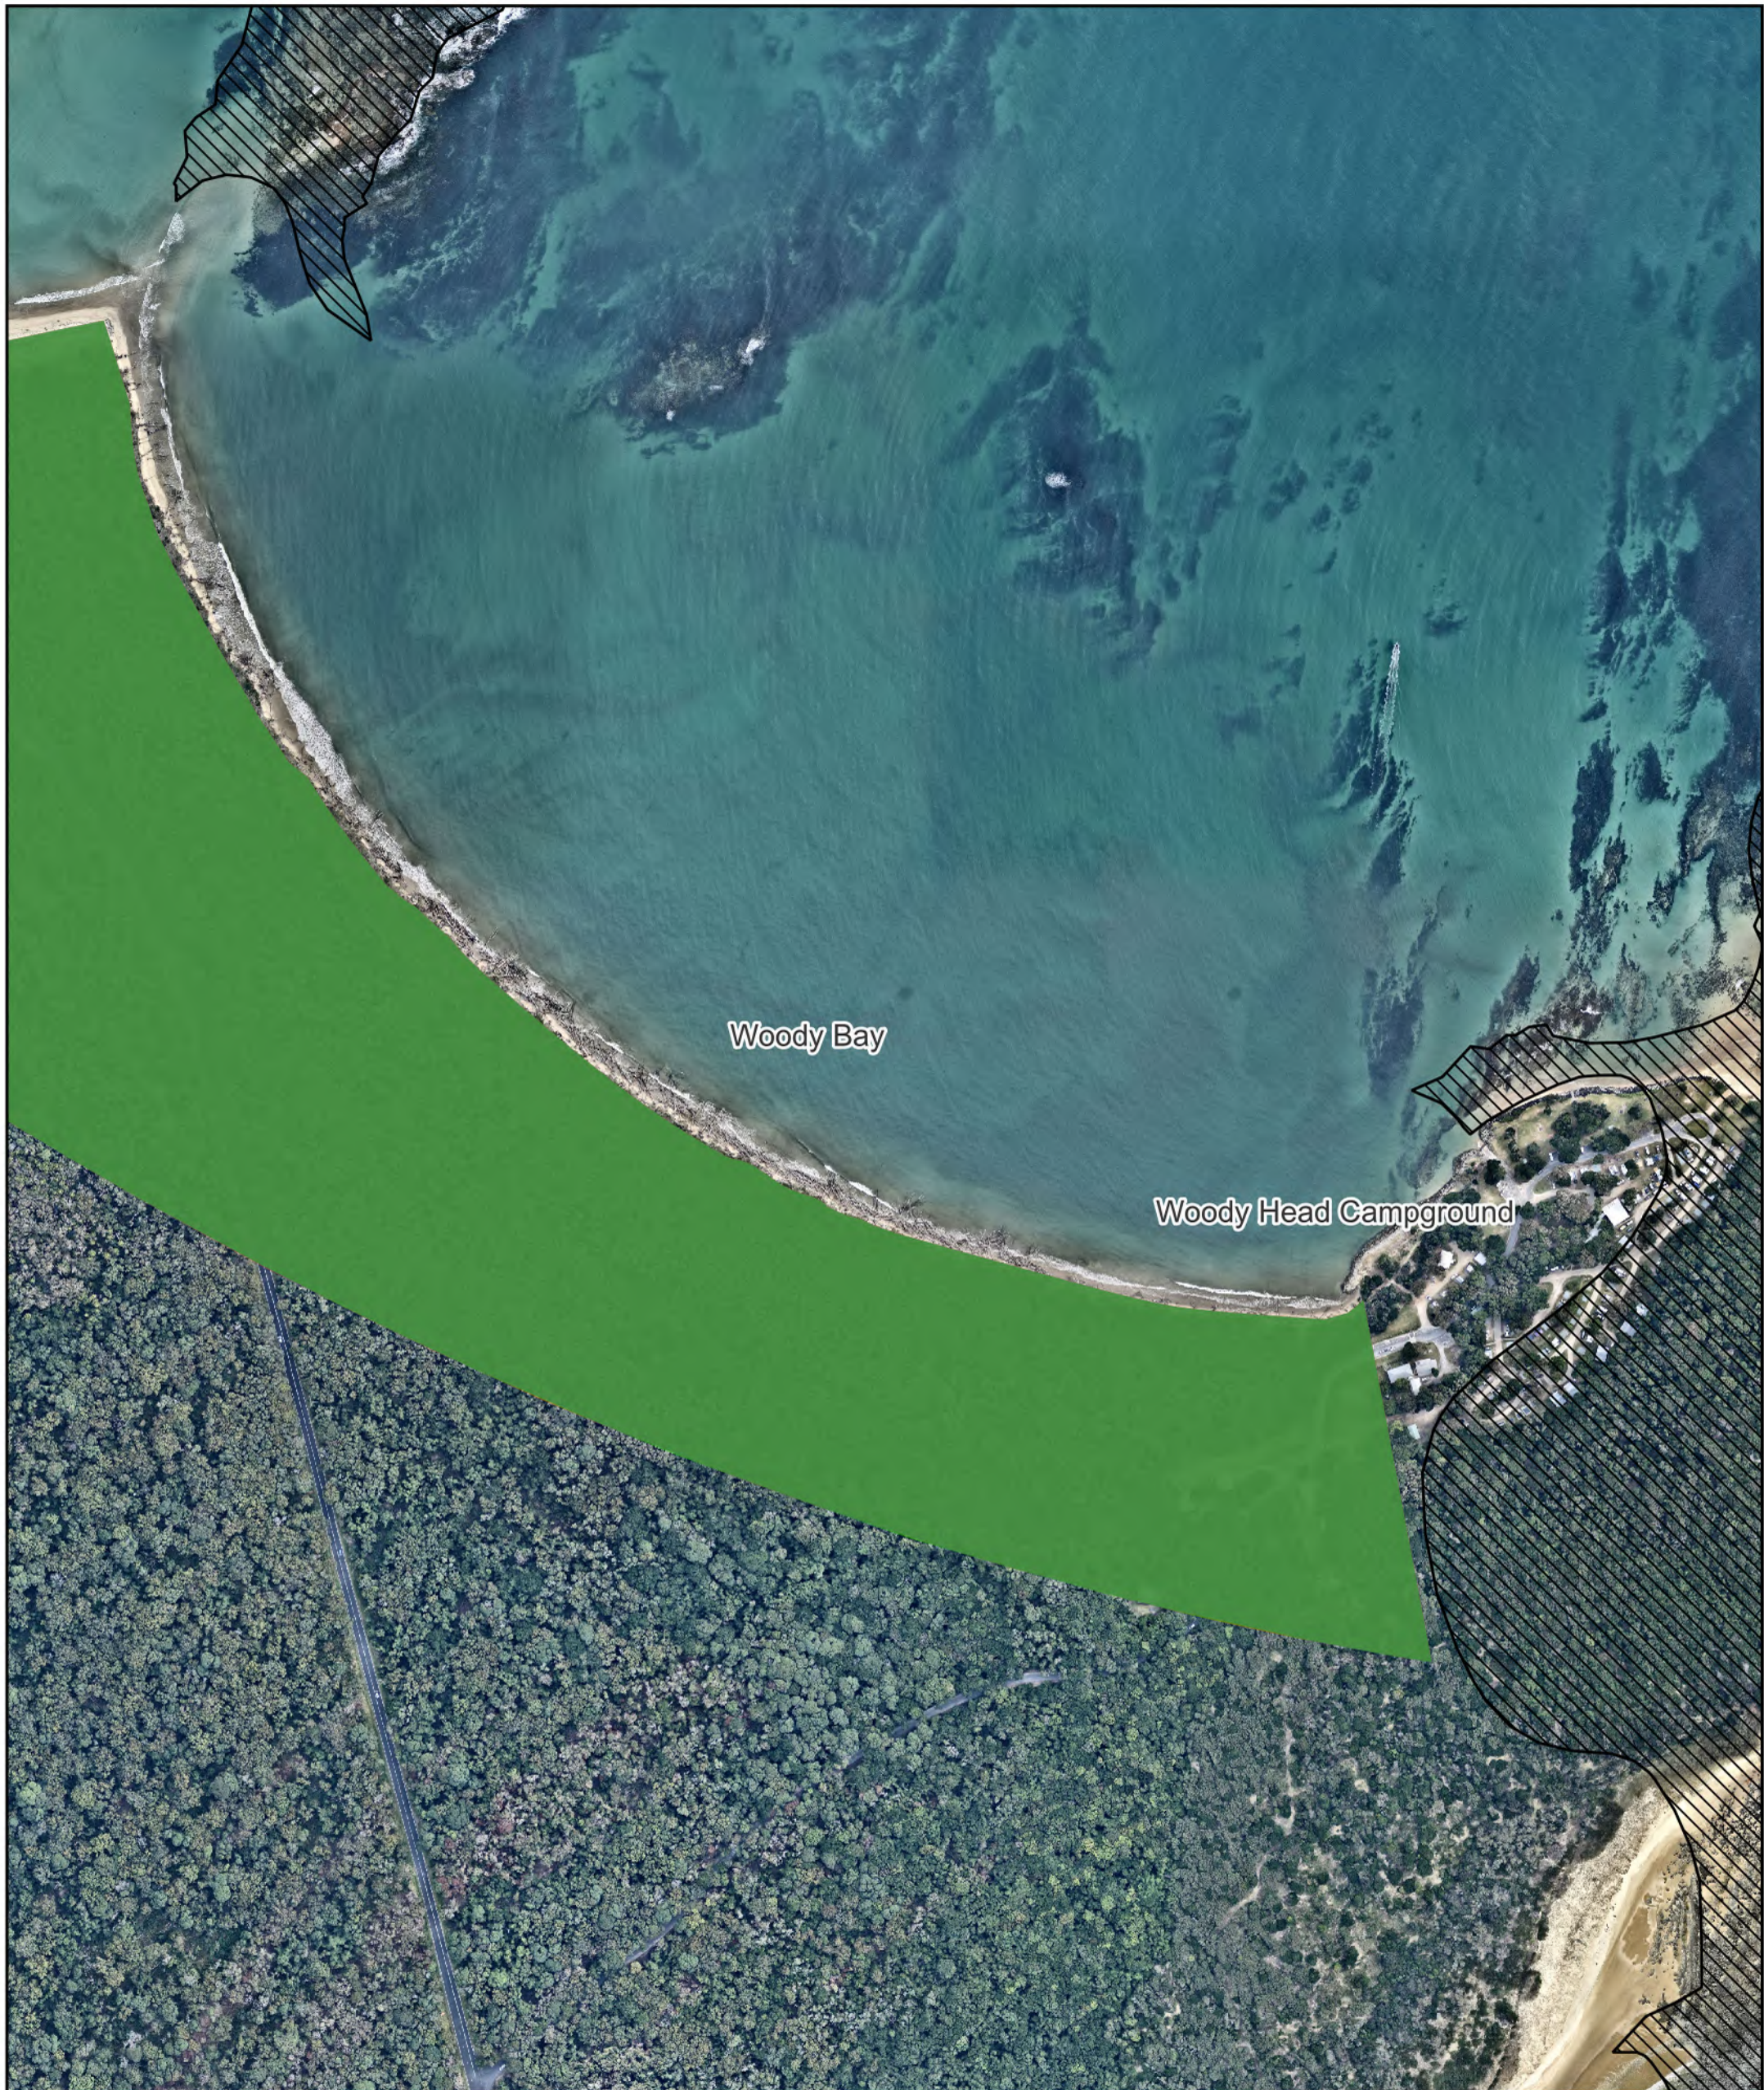
**Title**  
Erosion and recession hazard zones -SSP5 2123: Woody Bay
