Title
Erosion and recession hazard zones - Present Day: Wooli Village

Project
2021s1471 - Hydrosphere - CVC CMP Stage 2 - 4

Client
Hydrosphere Consulting

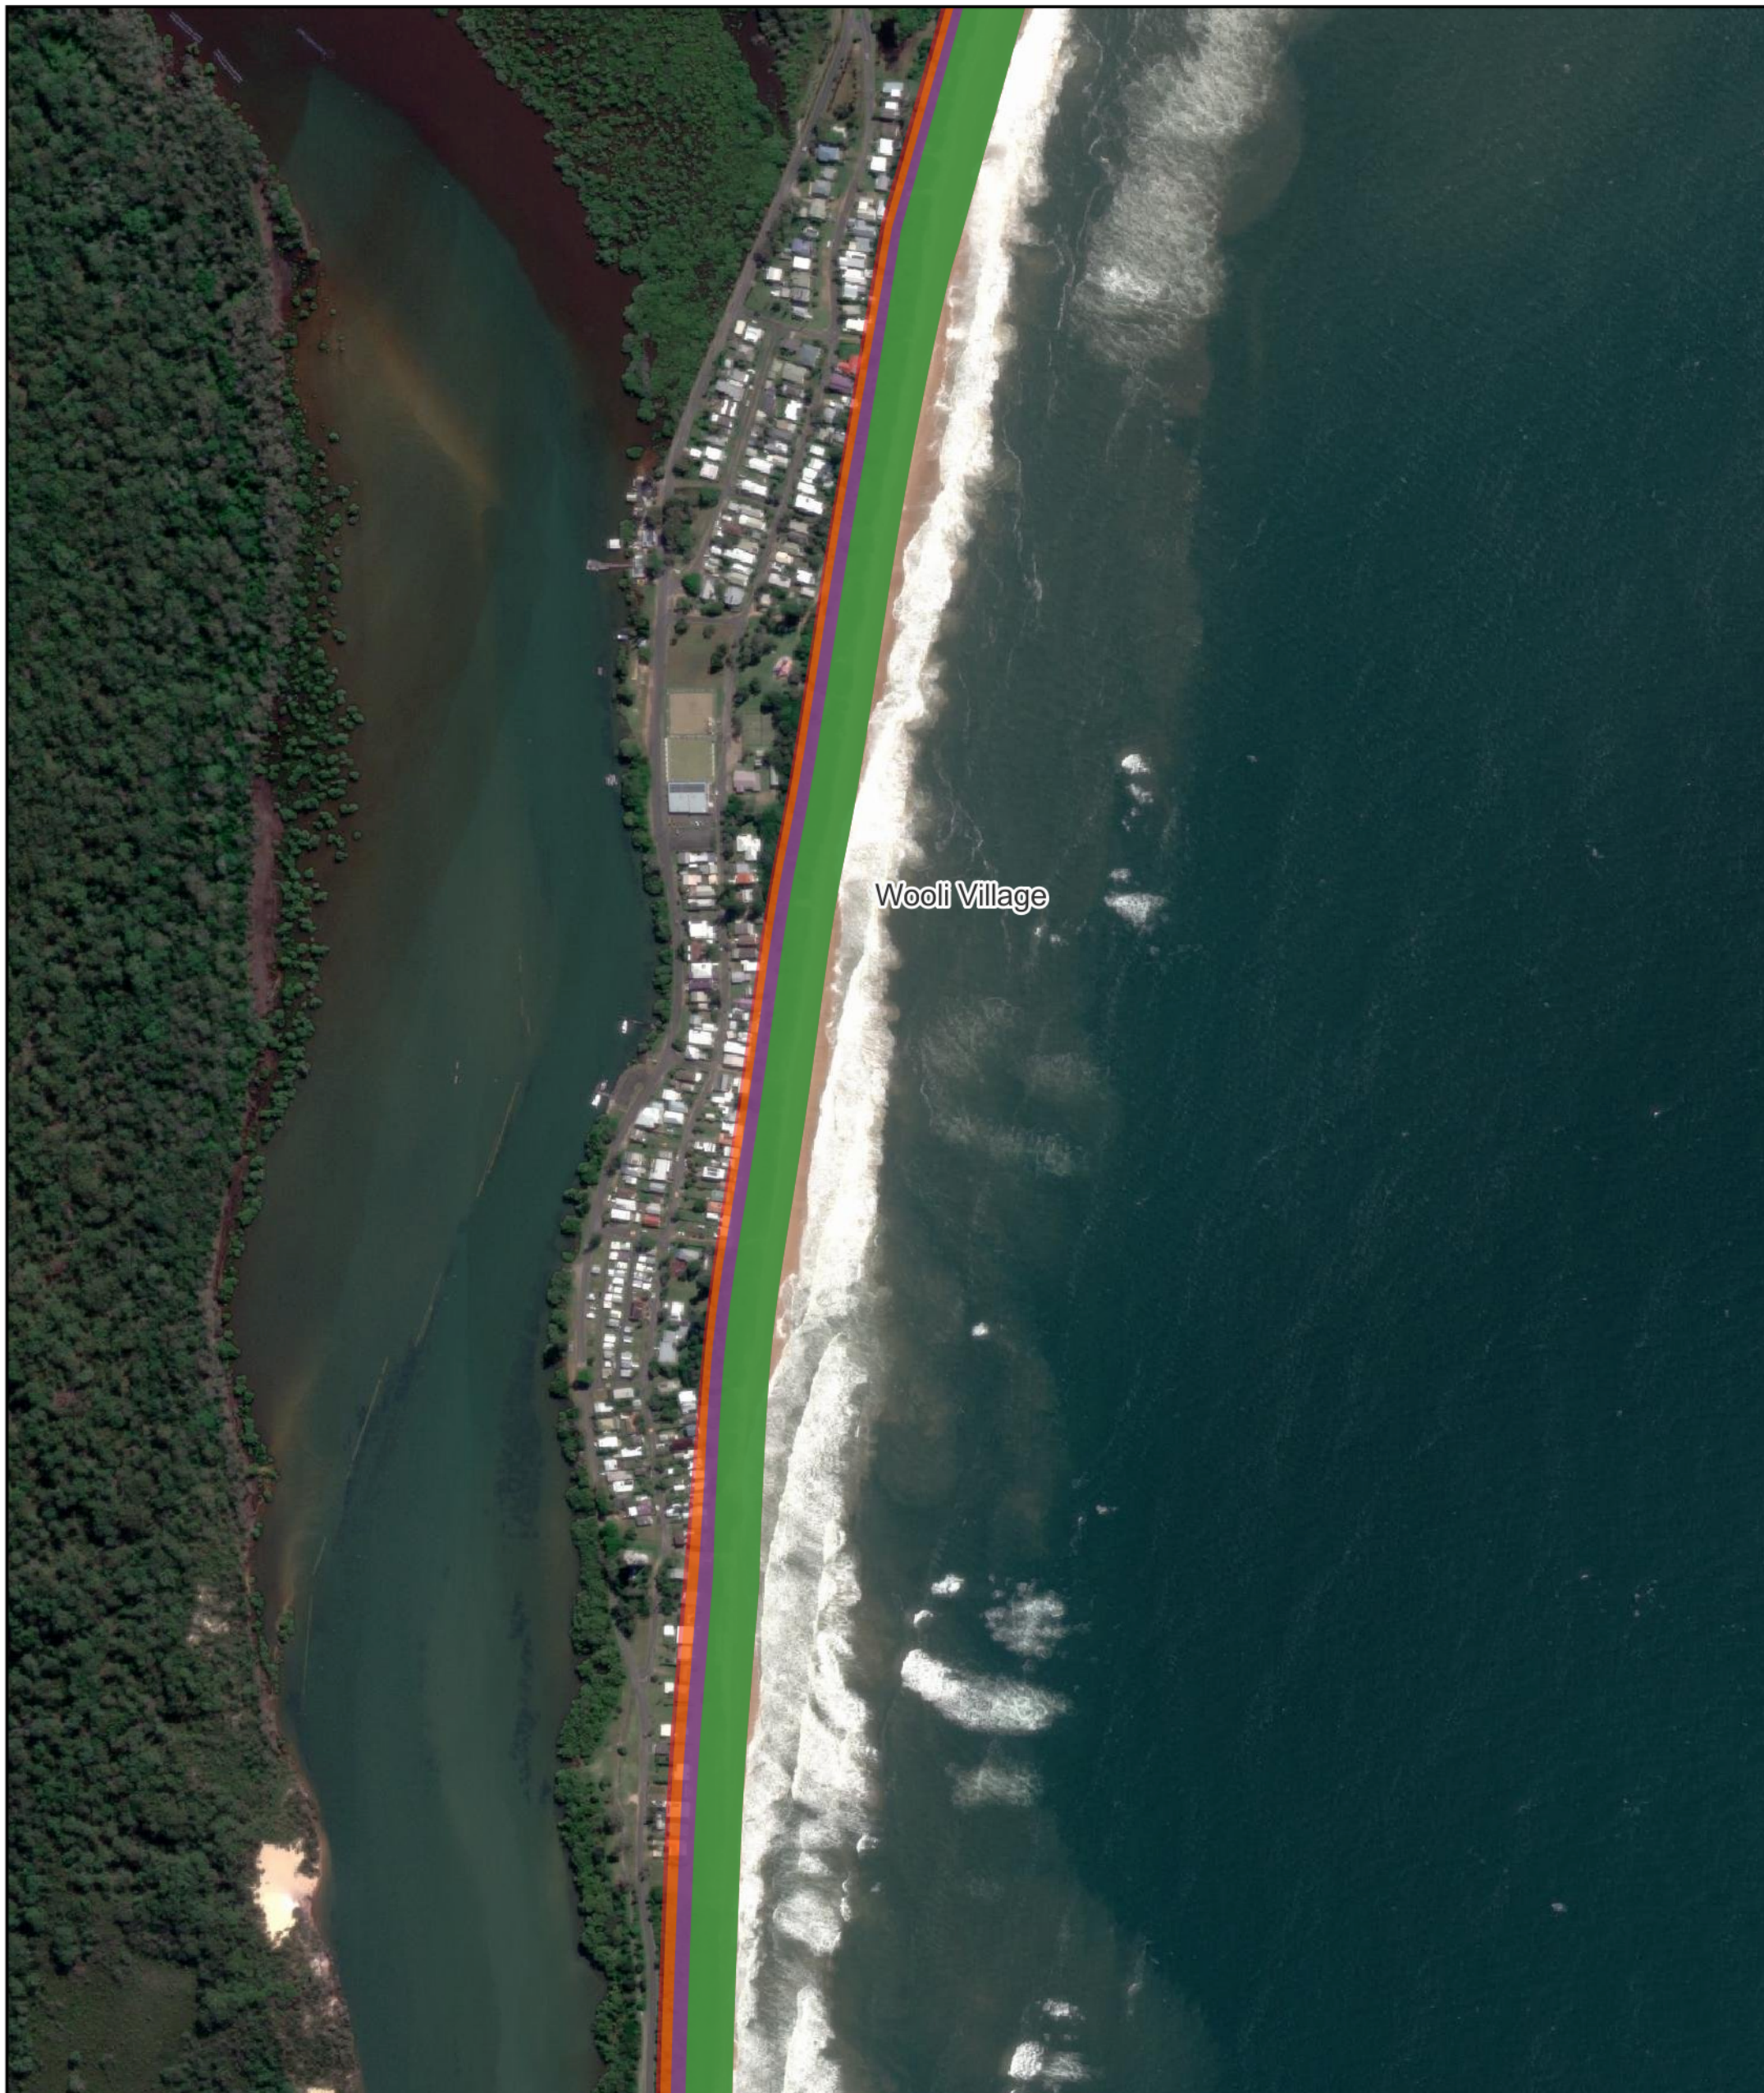
Title
Erosion and recession hazard zones -SSP2 2043: Wooli Village

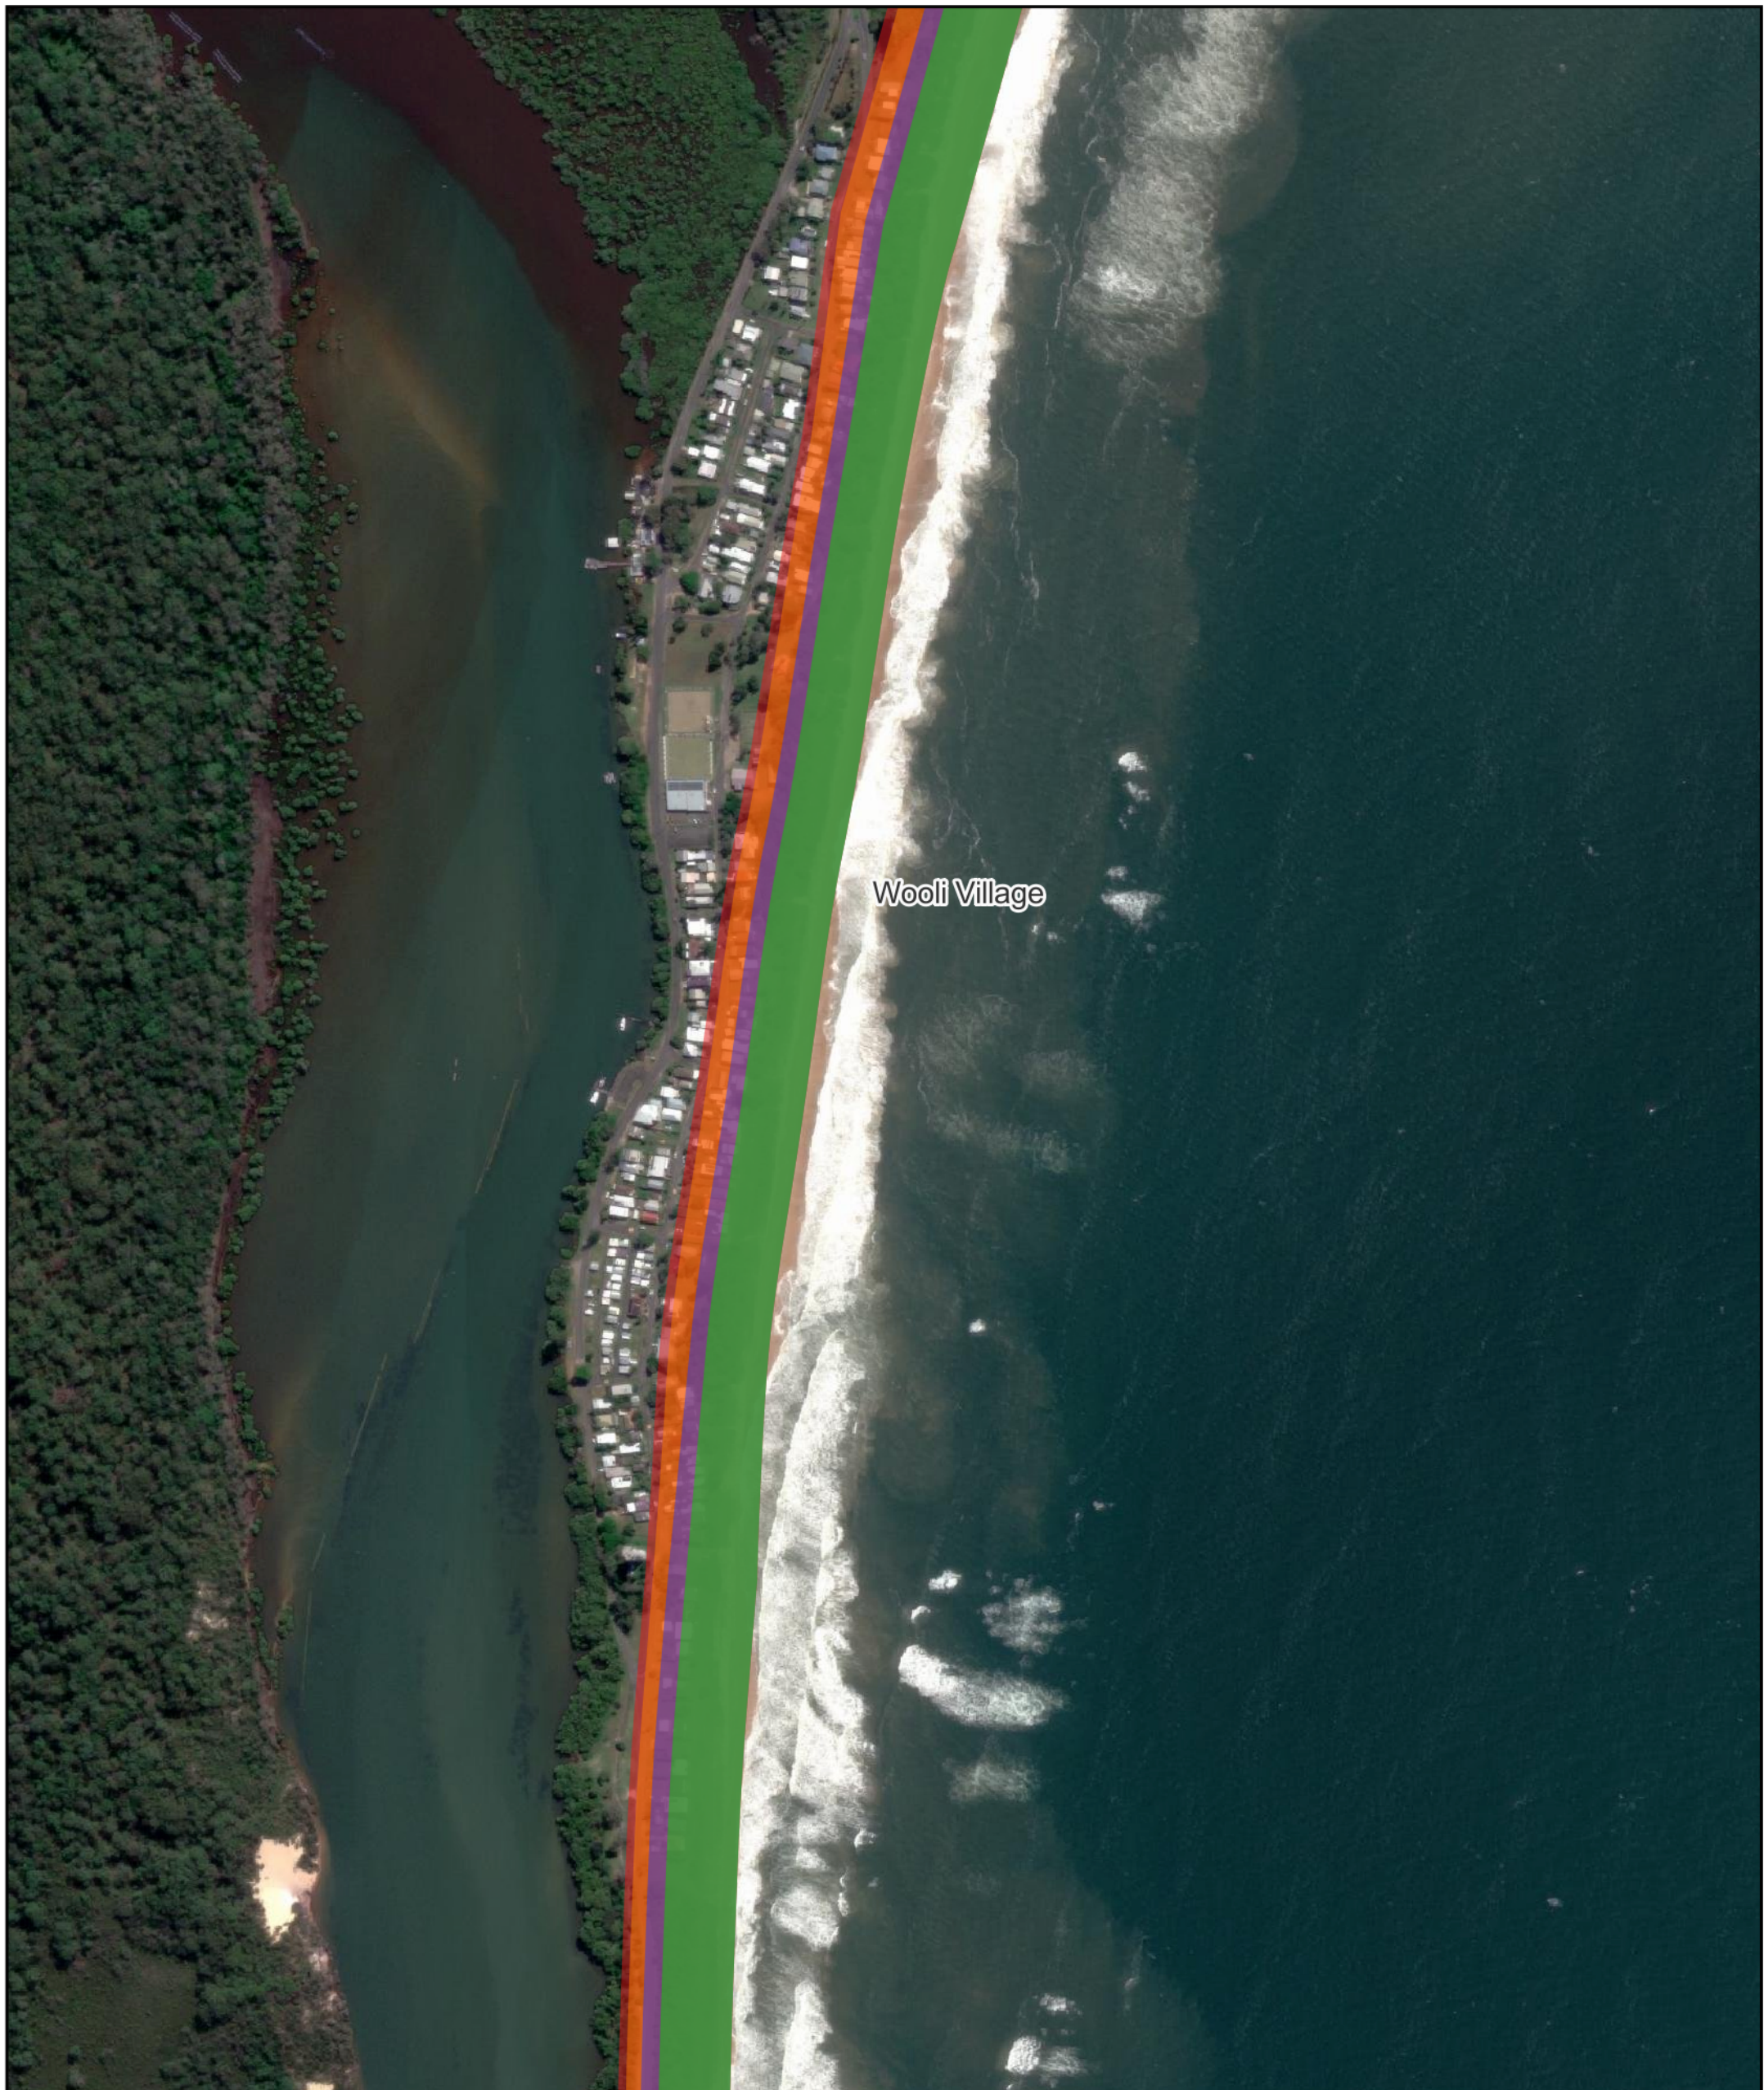
Title
Erosion and recession hazard zones -SSP2 2073: Woolli Village

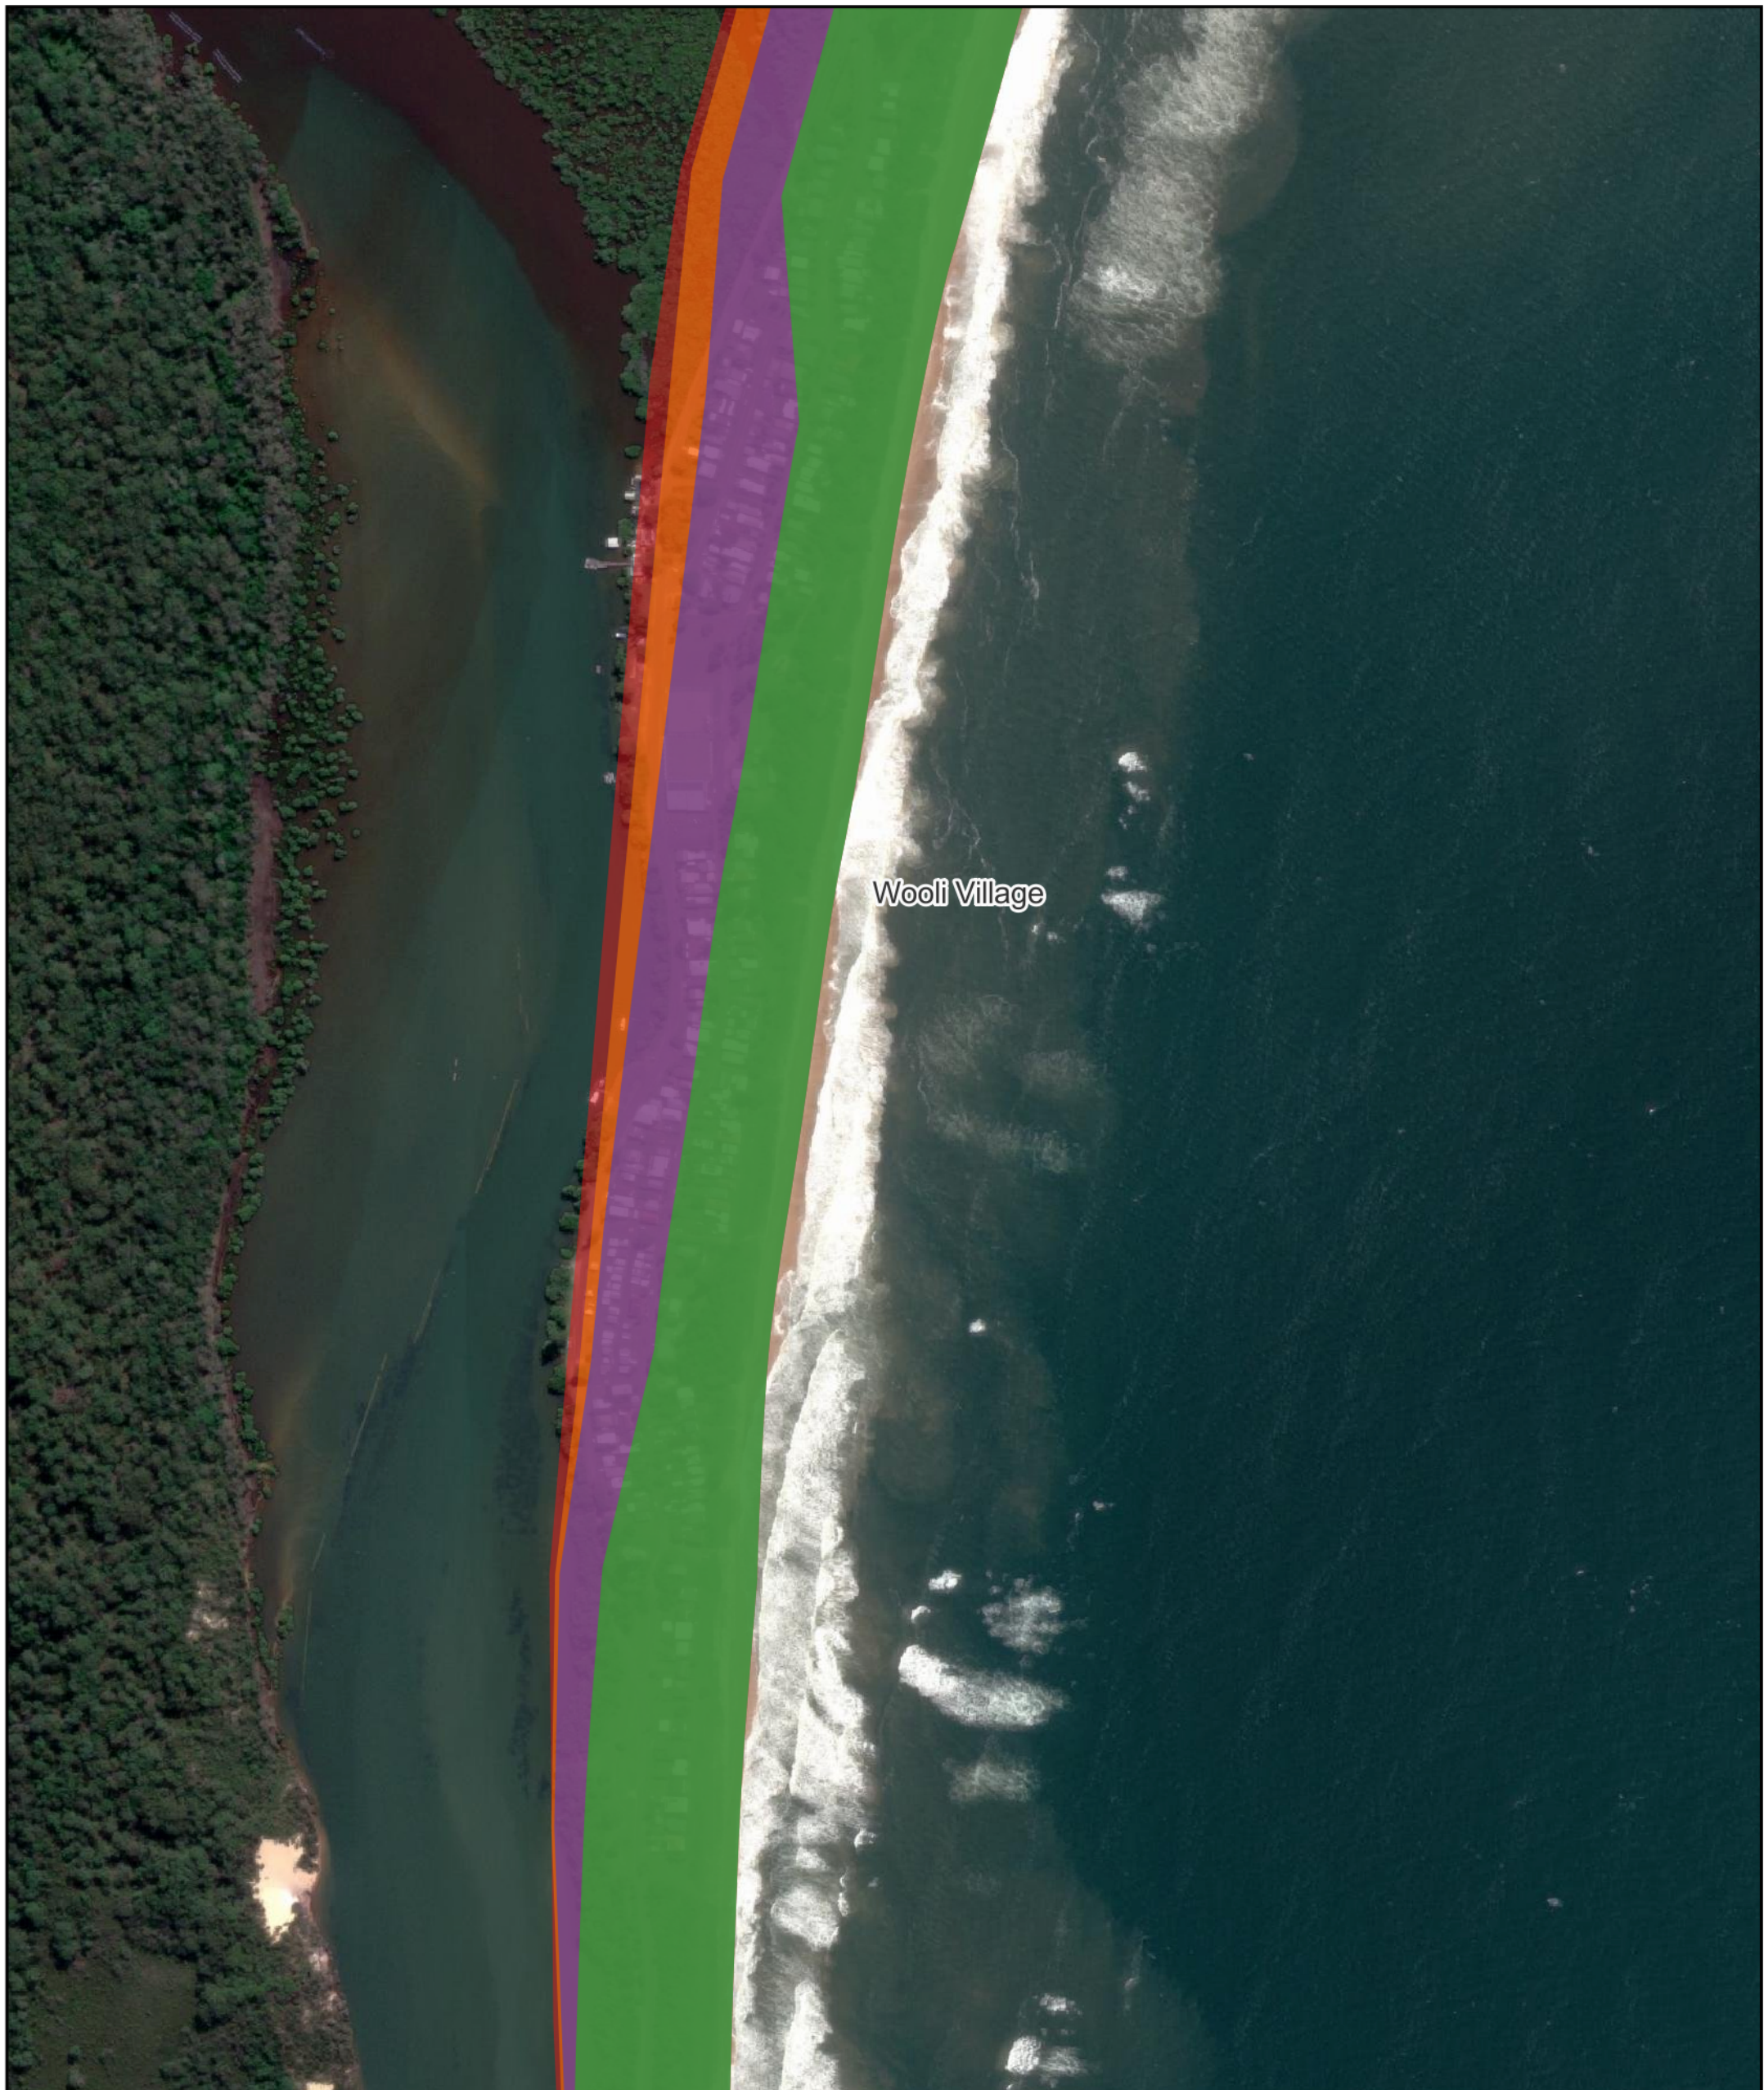
Title
Erosion and recession hazard zones -SSP2 2123: Woolli Village

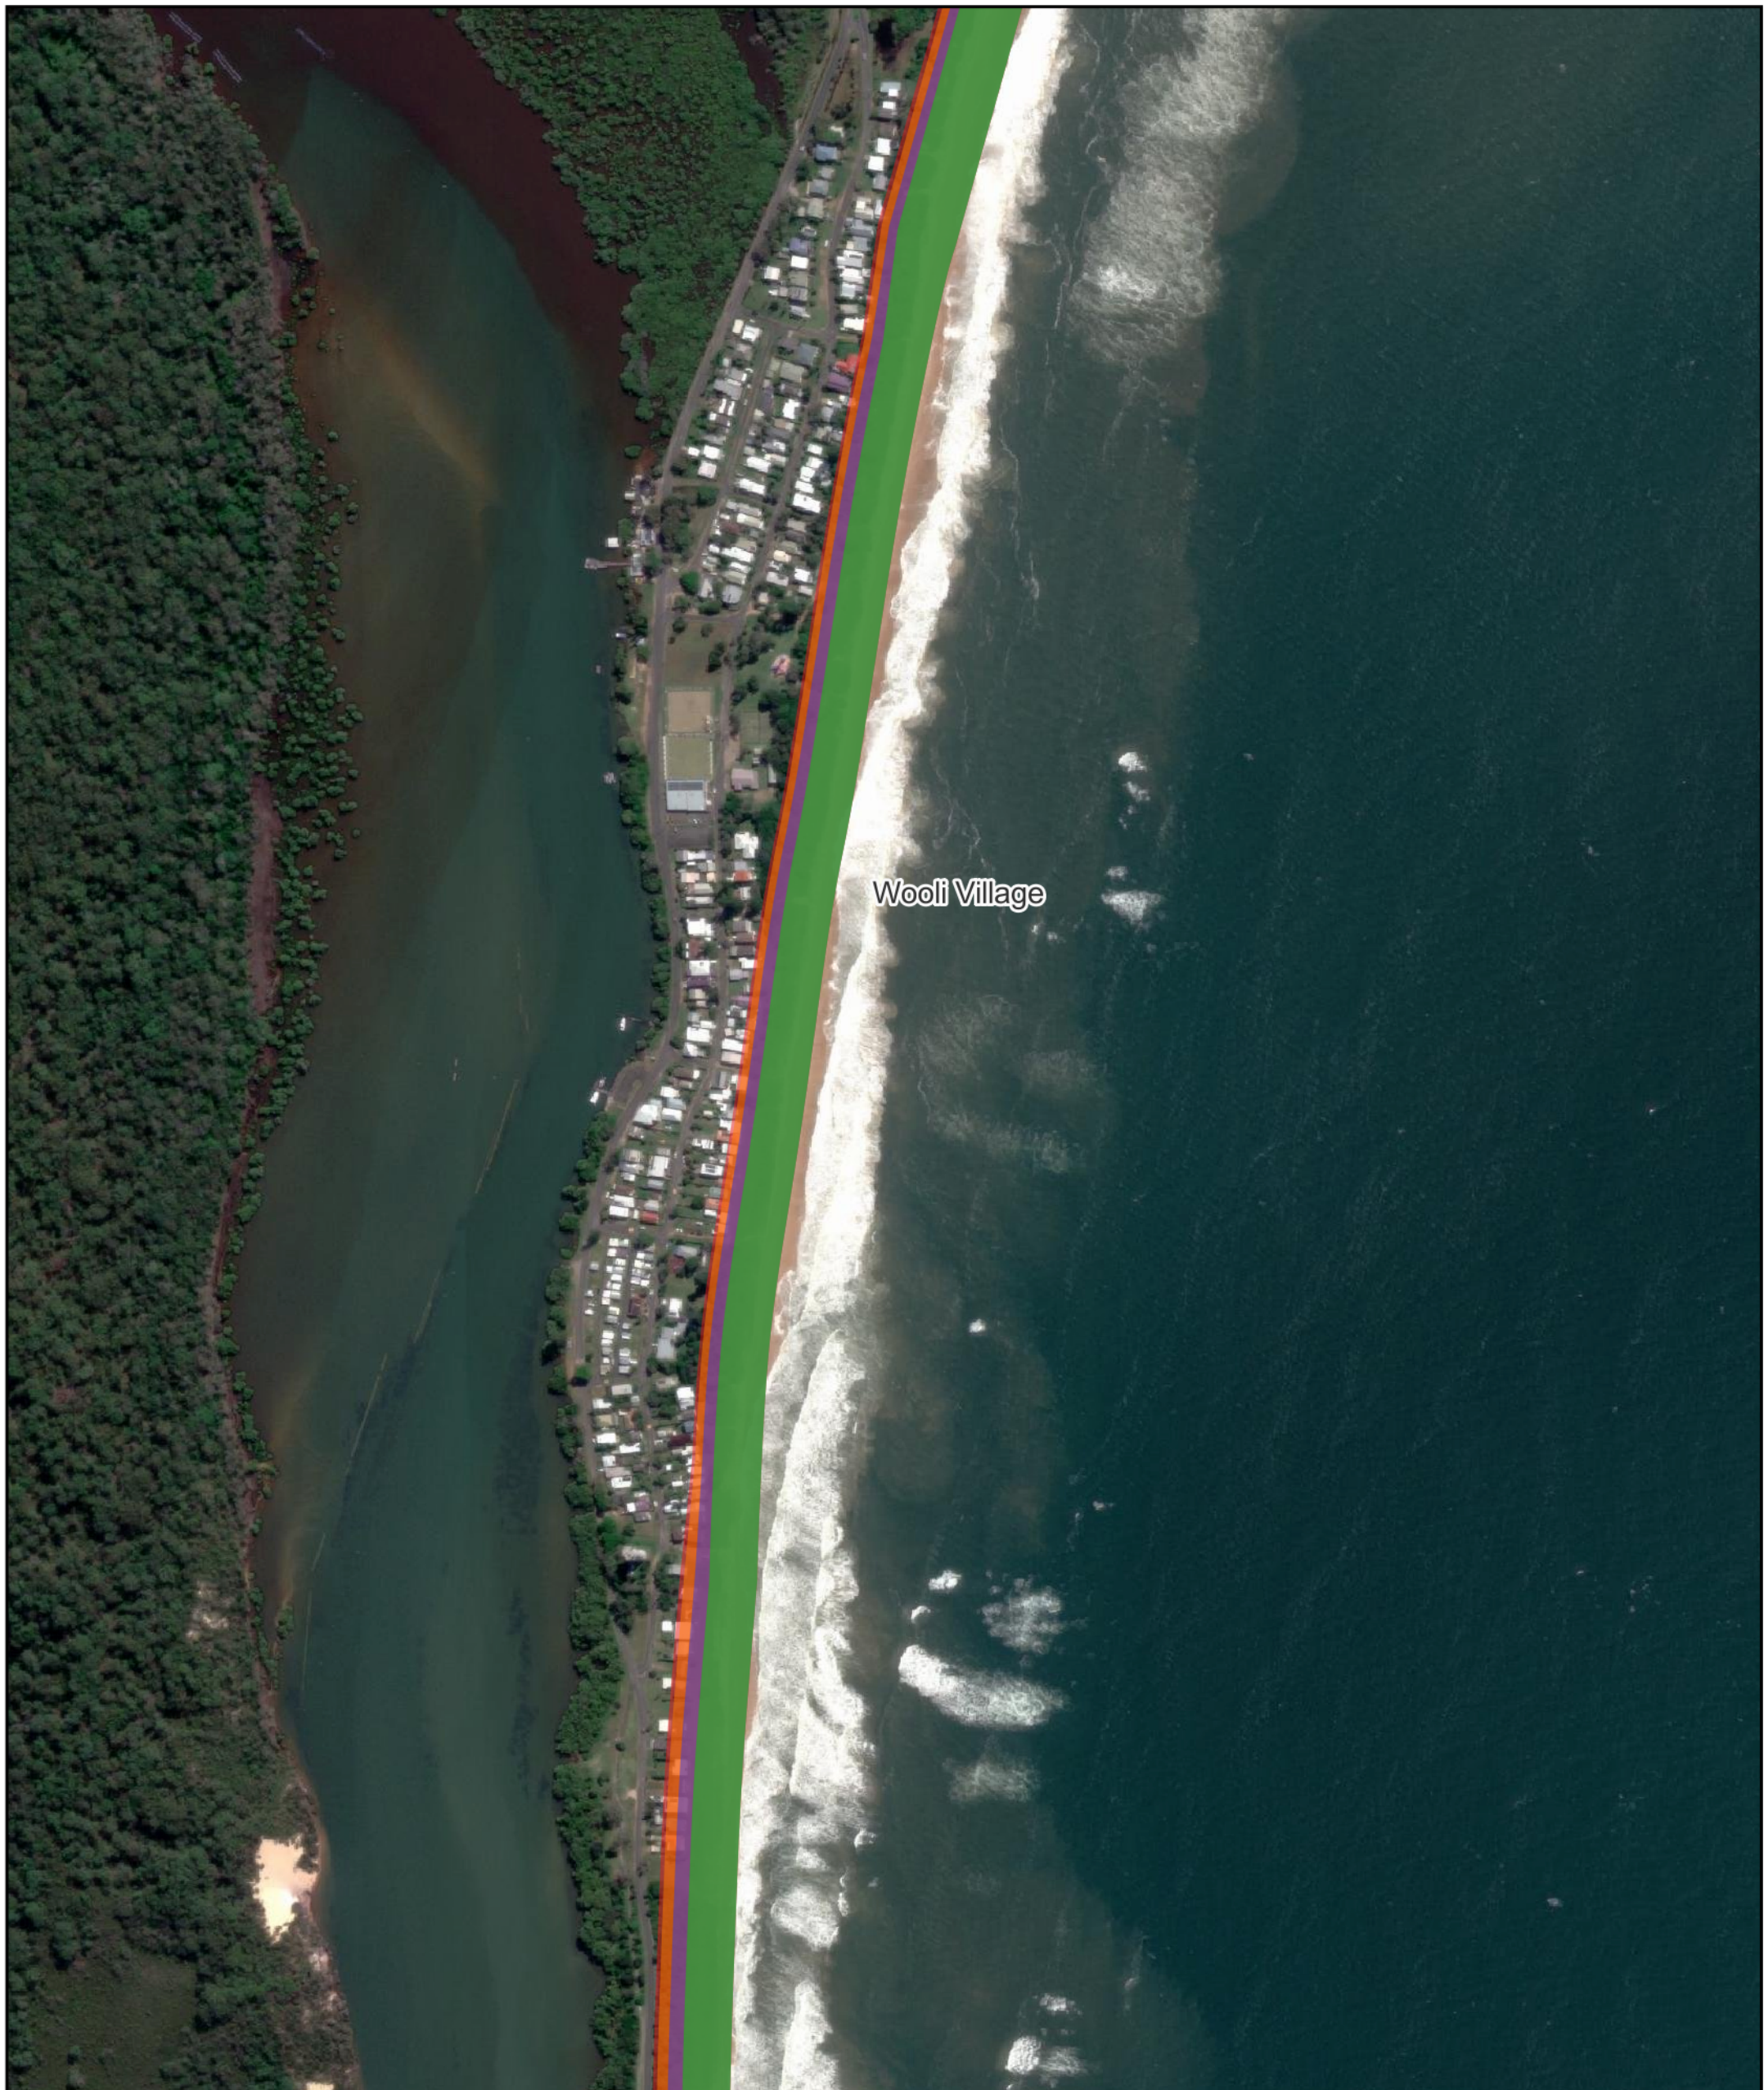
Title
Erosion and recession hazard zones -SSP5 2043: Wooli Village

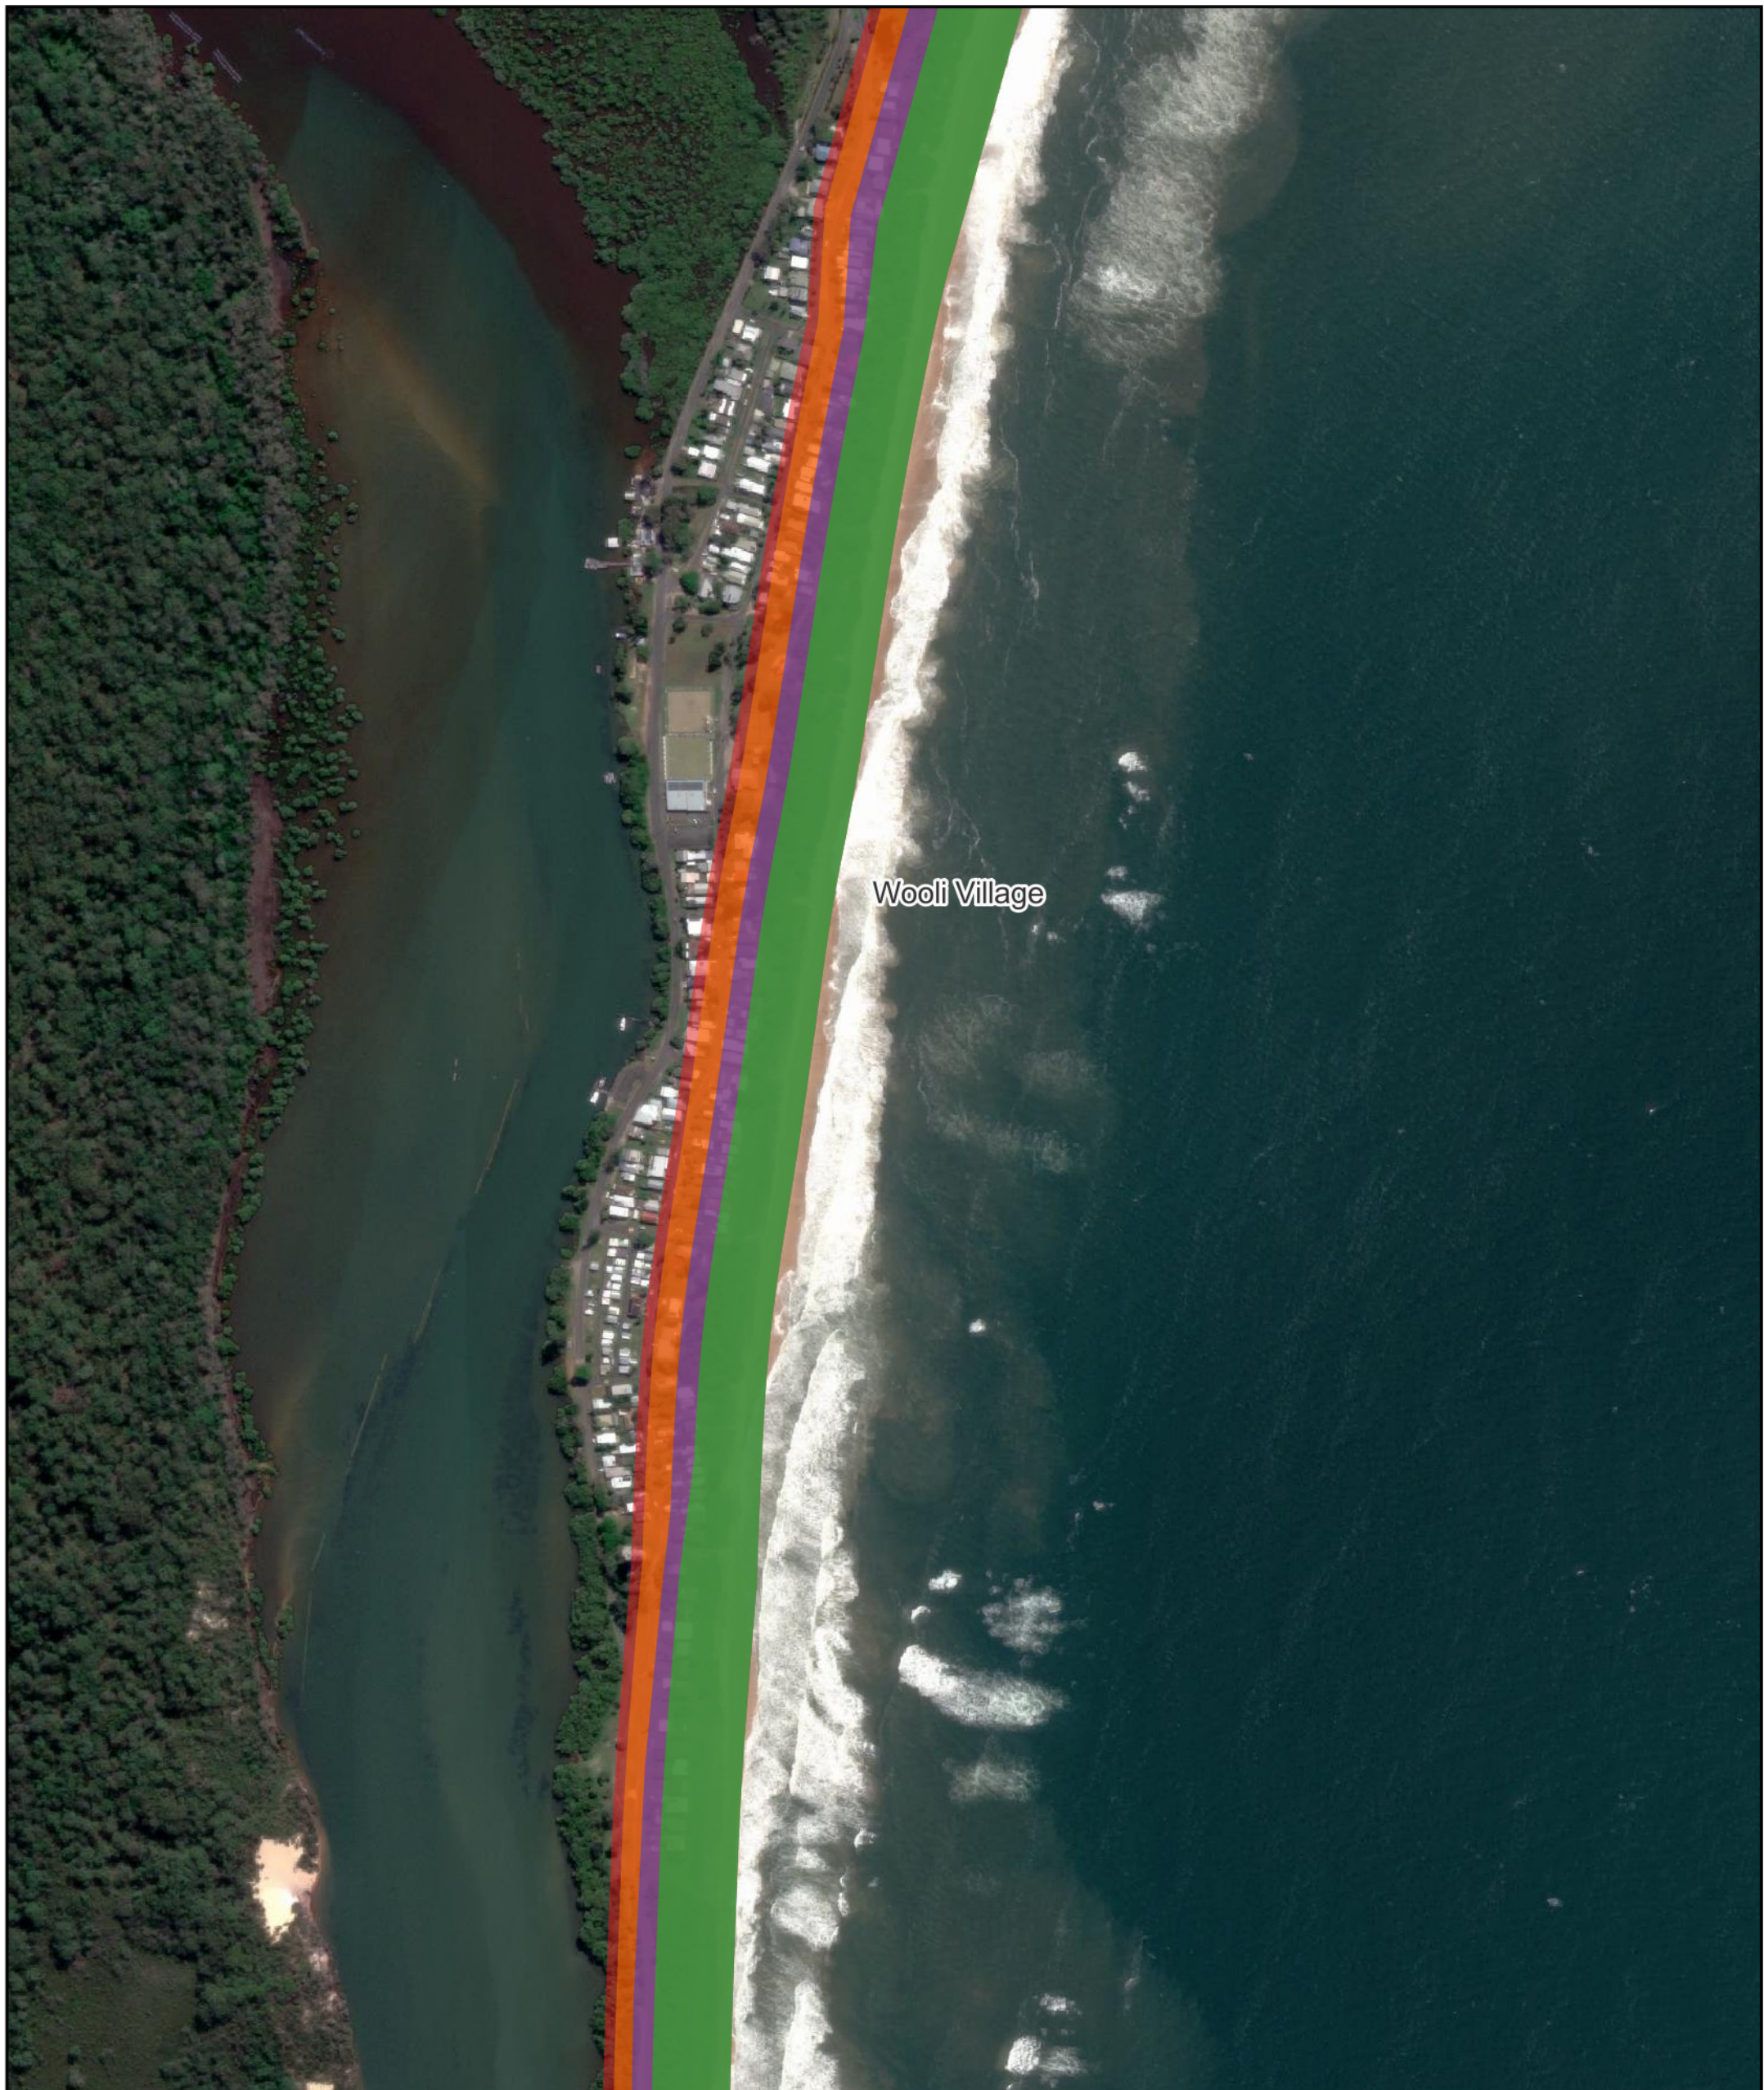
Title
Erosion and recession hazard zones -SSP5 2073: Wooli Village

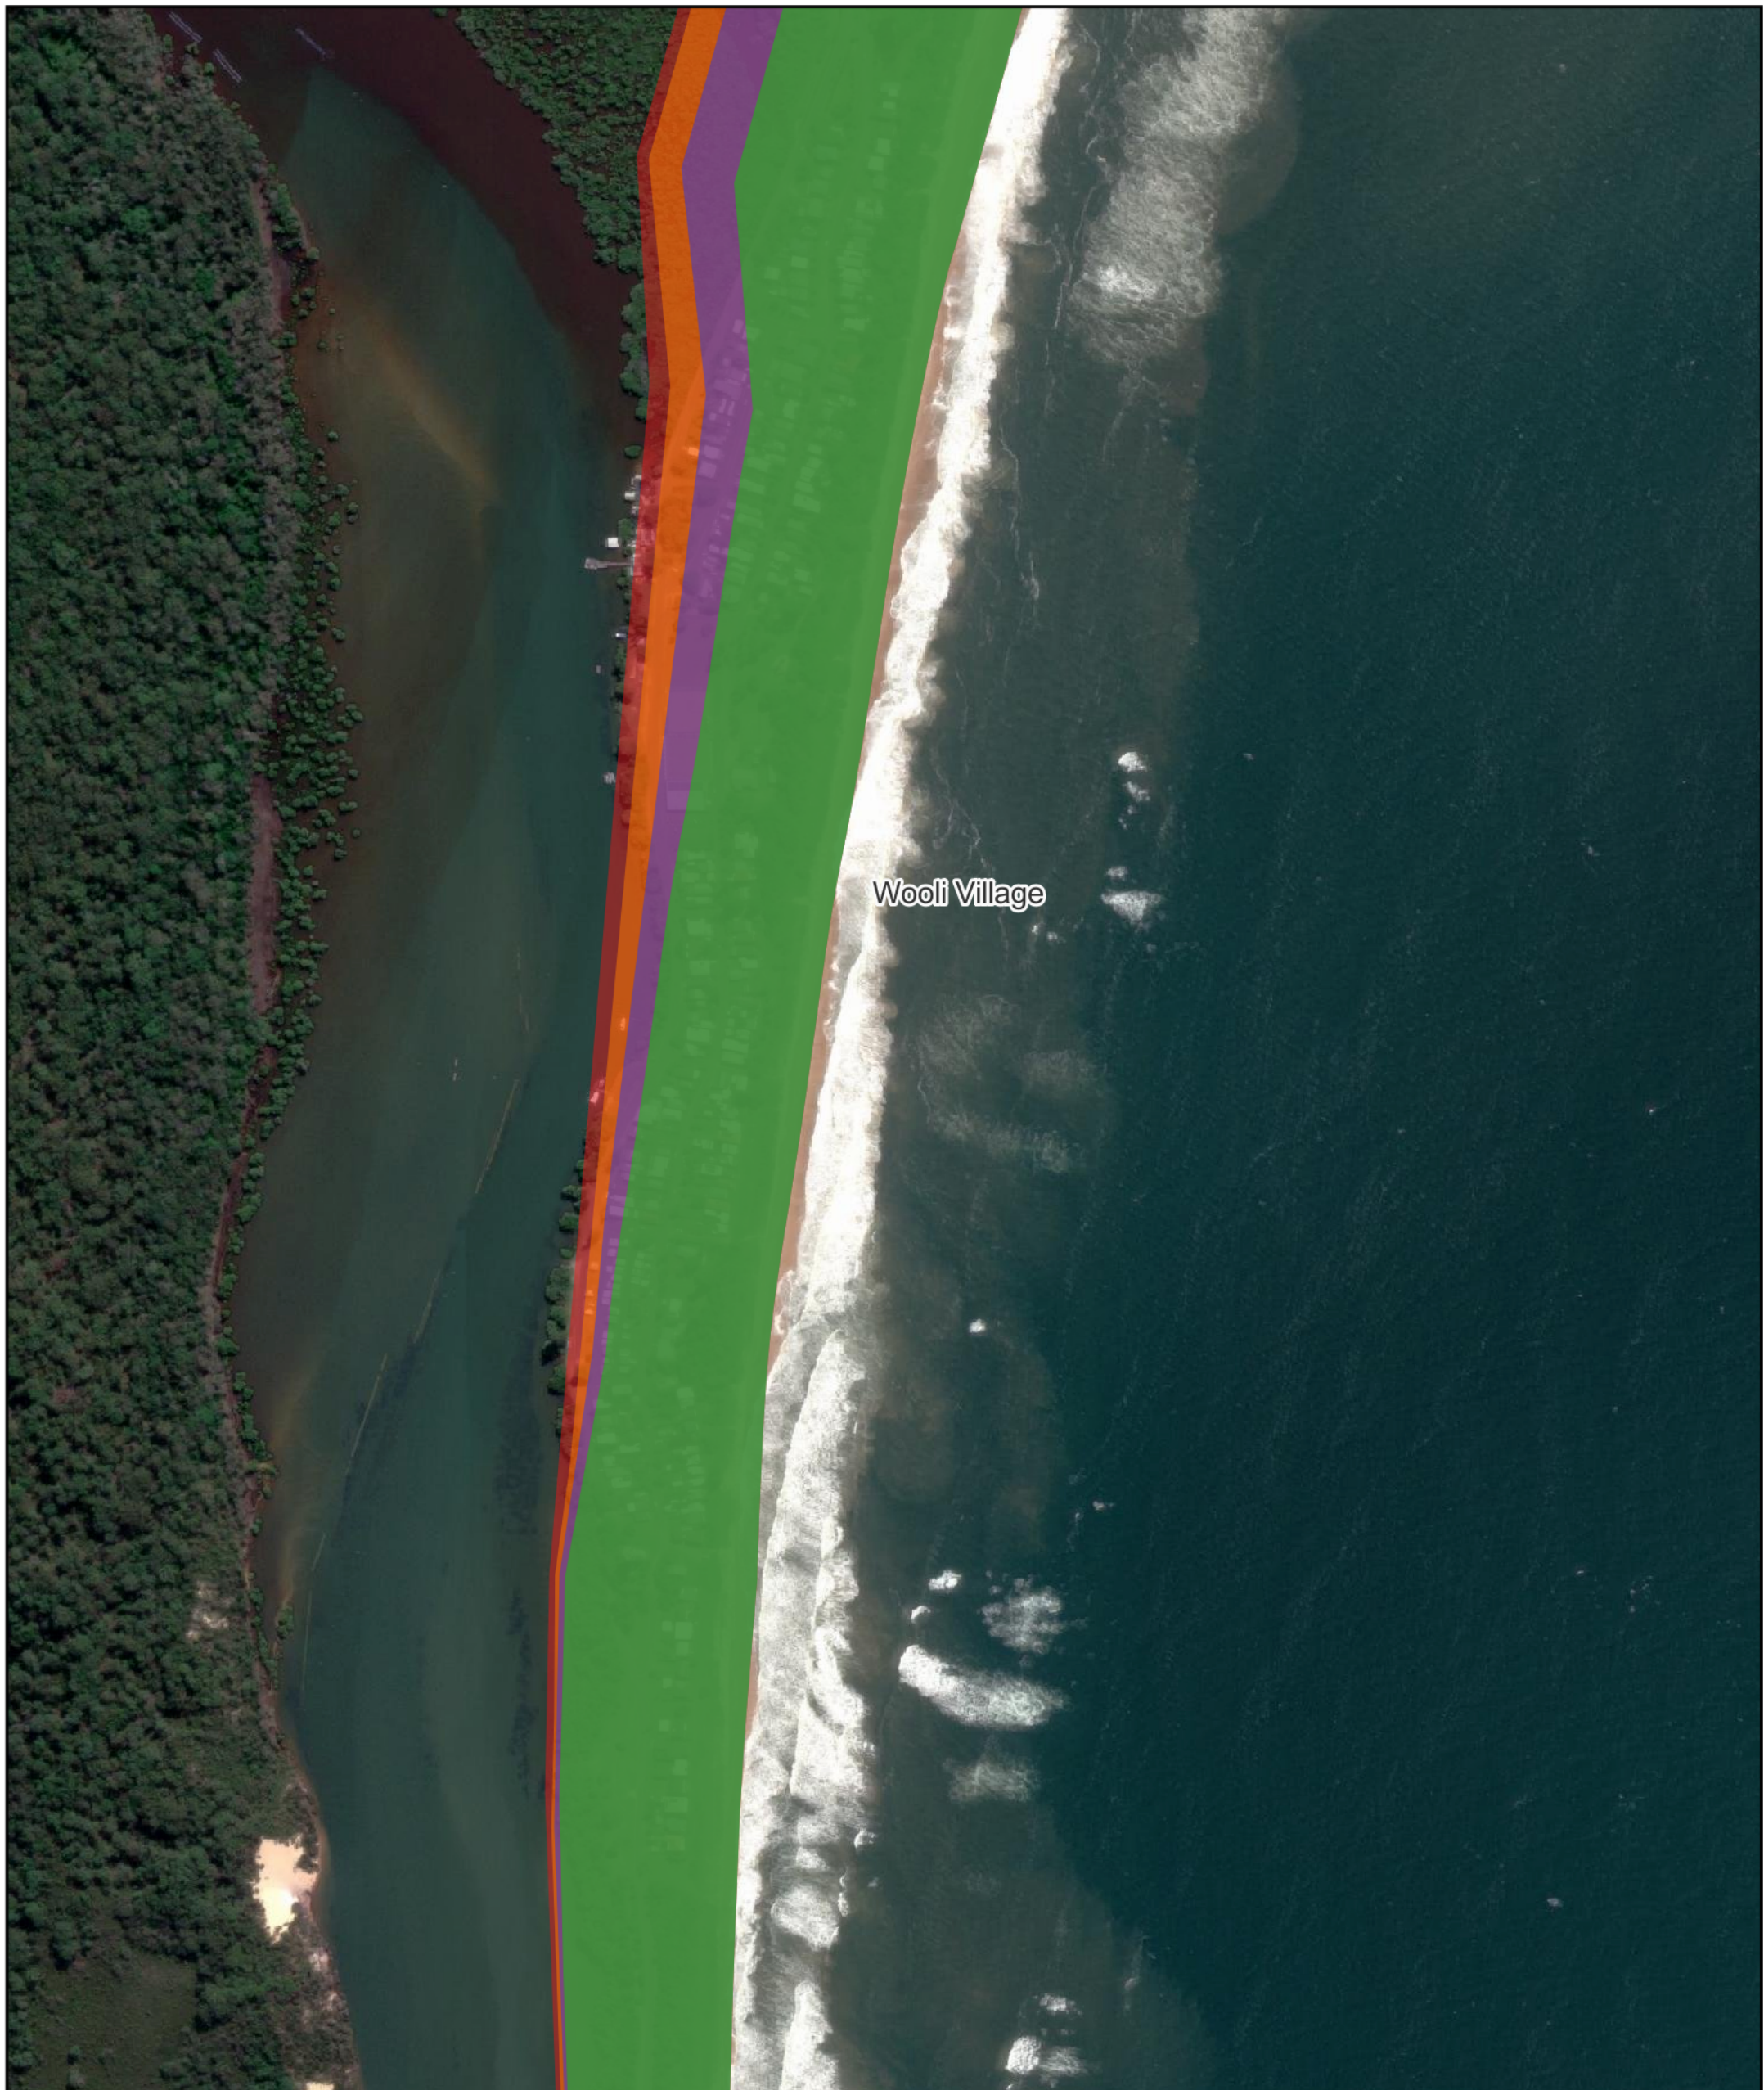
Title
Erosion and recession hazard zones -SSP5 2123: Wooli Village
